Report Date: 2024-04-15 00:00:00 **Test Date:** 2024-04-04 00:00:00

DLAA Test No
 1.1.1
 Source Room:
 2nd Floor Great Room

Test Site
 Gentry apts
 Receiver Room:
 1st Floor Great Room/Kitchen

Client Gentry Builders Test Assembly: Floor-ceiling

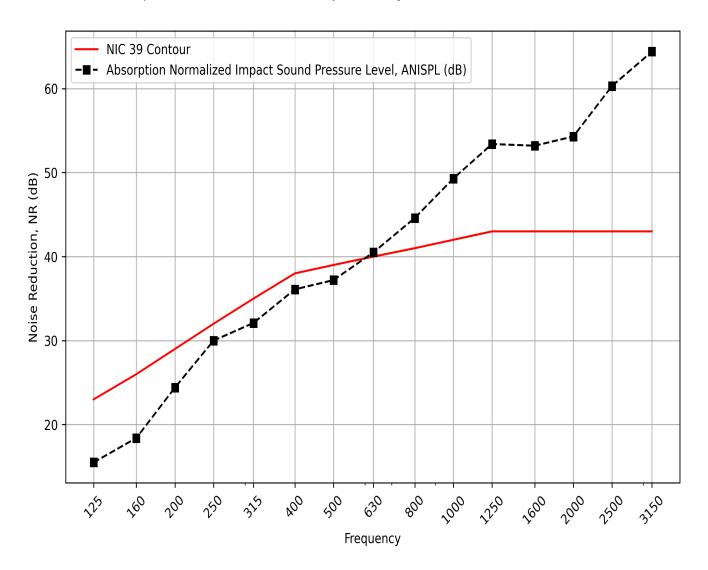
The Noise Isolation Class (NIC) of 39 was calculated. The NIC rating is based on Noise Reduction (NR), and includes the effects of noise flanking. The NIC reference contour is shown on the next page, and has been "fit" to the Noise Reduction values, in accordance with the procedure of ASTC Test Procedure ASTM E336-16. The results stated in this report represent only the specific construction and acoustical conditions present at the time of the test. Measurements performed in accordance with this test method on nominally identical constructions and acoustical conditions may produce different results.
