### **Apparent Impact Insulation Class (AIIC)**

**Report Date:** 2024-04-15 00:00:00 **Test Date:** 2024-04-04 00:00:00

DLAA Test No1.4.1Source Room:2nd Floor Bed 1Test SiteGentry aptsReceiver Room:1st Floor Bed 1ClientGentry BuildersTest Assembly:Floor-ceiling

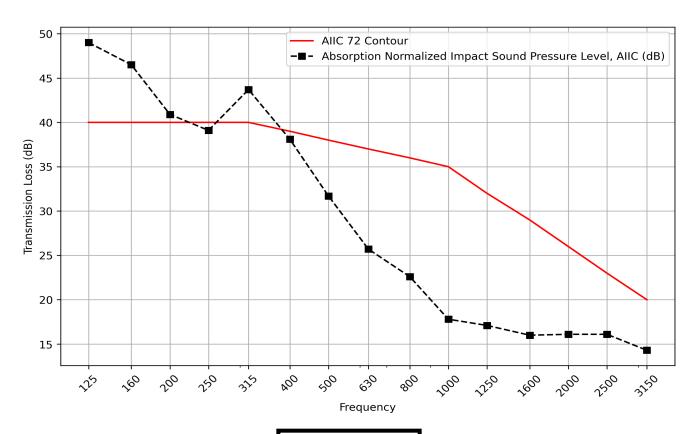
AIIC: 72

The Apparent Impact Insulation Class (AIIC) of 72 was calculated. The AIIC rating is based on Absorption Normalized Impact Sound Pressure Level (ANISPL), and includes the effects of noise flanking. The AIIC reference contour is shown on the next page, and has been fit to the Absorption Normalized Impact Sound Pressure Level values, in accordance with the procedure of ASTC Test Procedure ASTM E336-16 The results stated in this report represent only the specific construction and acoustical conditions present at the time of the test. Measurements performed in accordance with this test method on nominally identical constructions and acoustical conditions may produce different results.
