DLAA Test No 1.3.1

ASTM E1007-14 Standard Test Method for Field Measurement of Tapping Machine Impact Sound Transmission Th

Floor-ceiling

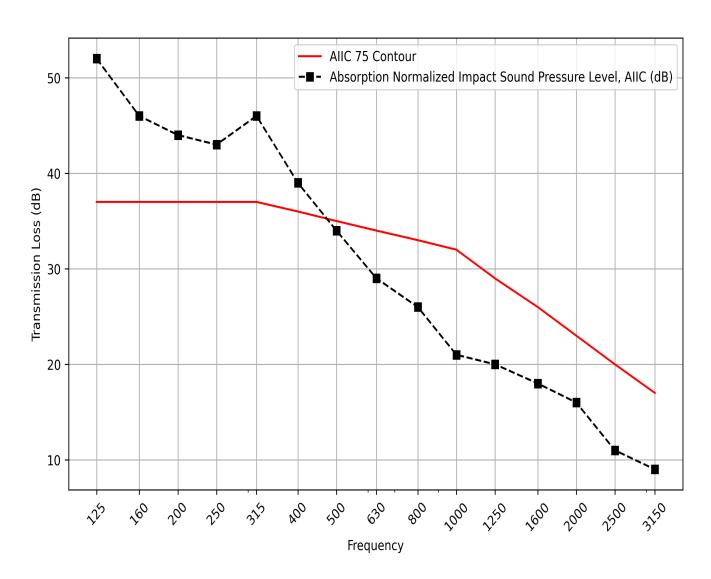
STATEMENT OF TEST RESULTS:

The Apparent Impact Insulation Class (AIIC) was calculated. The AIIC rating is based on Absorption Normalized Impact Sound Pressure Level (ANISPL), and includes the effects of noise flanking. The AIIC reference contour is shown on the next page, and has been "fit" to the Absorption Normalized Impact Sound Pressure Level values, in accordance with the procedure of ASTC Test Procedure ASTM E336-16 The results stated in this report represent only the specific construction and acoustical conditions present at the time of the test. Measurements performed in accordance with this test method on nominally identical constructions and acoustical conditions may produce different results.
