DLAA Test No
 1.3.1
 Source Room:
 2nd Floor Bed 3

Test Site
 Gentry apts
 Receiver Room:
 1st Floor Bed 2

Client
 Gentry Builders
 Test Assembly:
 Floor-ceiling

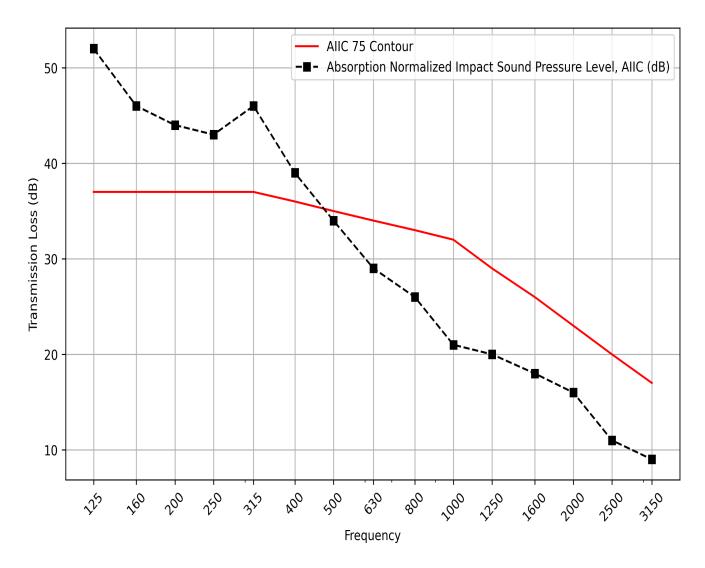
The Apparent Impact Insulation Class (AIIC) of 75 was calculated. The AIIC rating is based on Absorption Normalized Impact Sound Pressure Level (ANISPL), and includes the effects of noise flanking. The AIIC reference contour is shown on the next page, and has been "fit" to the Absorption Normalized Impact Sound Pressure Level values, in accordance with the procedure of ASTC Test Procedure ASTM E336-16 The results stated in this report represent only the specific construction and acoustical conditions present at the time of the test. Measurements performed in accordance with this test method on nominally identical constructions and acoustical conditions may produce different results.
