#### **Apparent Impact Insulation Class (AIIC)**

Report Date:
 4/9/25

DLAA Test No1.3.1Source Room:Unit 3aTest SiteKaanapali ShoresReceiver Room:Unit 3bClientKaanapali AOAOTest Assembly:Floor-ceiling

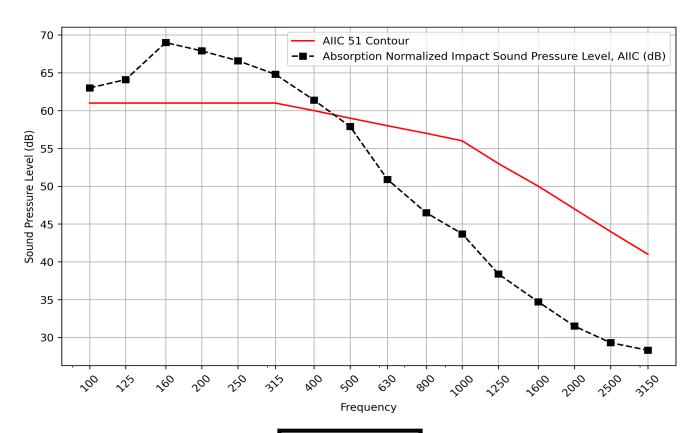
AIIC: 51

The Apparent Impact Insulation Class (AIIC) of 51 was calculated. The AIIC rating is based on Absorption Normalized Impact Sound Pressure Level (ANISPL), and includes the effects of noise flanking. The AIIC reference contour is shown on the next page, and has been fit to the Absorption Normalized Impact Sound Pressure Level values, in accordance with the procedure of ASTC Test Procedure ASTM E336-16 The results stated in this report represent only the specific construction and acoustical conditions present at the time of the test. Measurements performed in accordance with this test method on nominally identical constructions and acoustical conditions may produce different results.
