AUTOMATED TEST REPORT

Multi-Channel Sensor Data Analysis | Test ID: TST-2026-001

Component: Rotating Component — Test Article 01

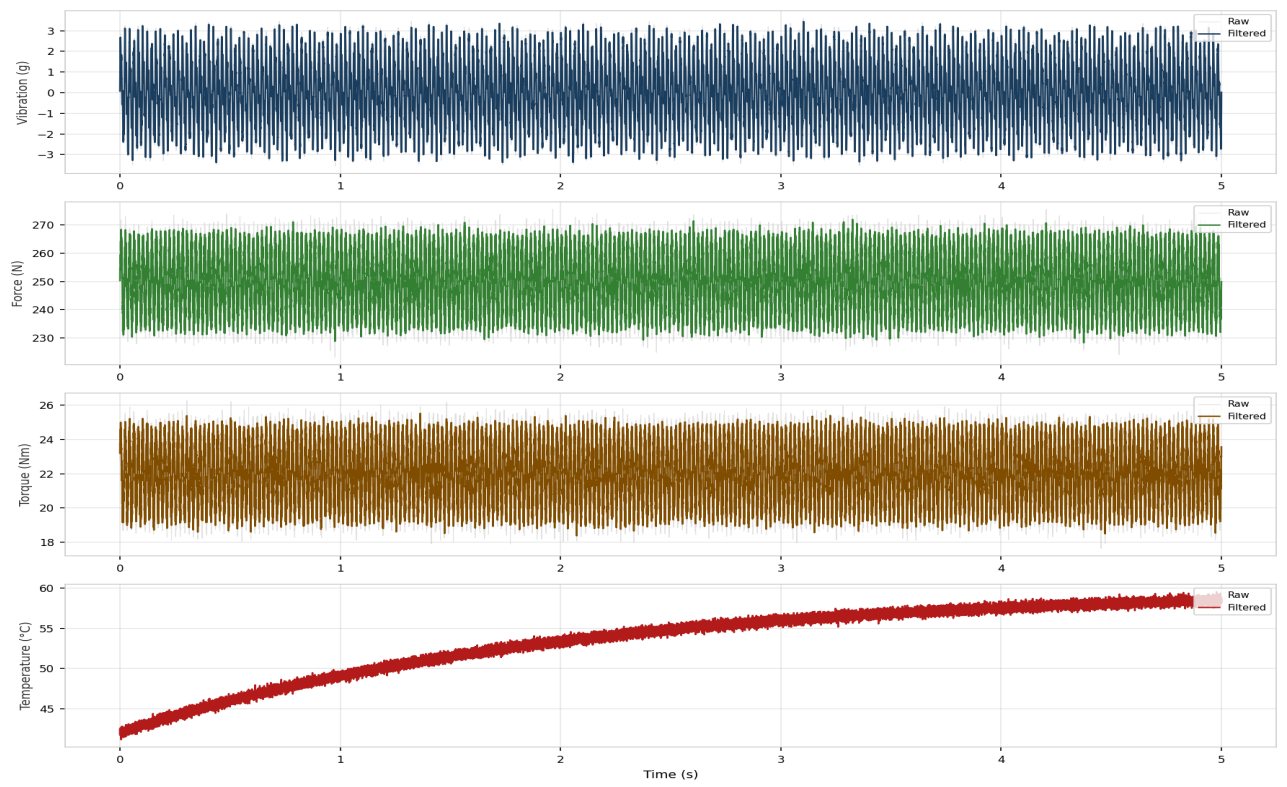
3. Channel Metrics vs. Acceptance Limits

Channel	Metric	Measured	Limit	Result
Vibration	RMS (g)	1.6020	5.0	✓ PASS
Force	Peak (N)	271.95	500.0	✓ PASS
Torque	RMS (Nm)	22.0745	50.0	✓ PASS
Temperature	Max (°C)	59.56	85.0	✓ PASS

Channels within acceptance limits: Vibration RMS, Force Peak, Torque RMS, Temperature.

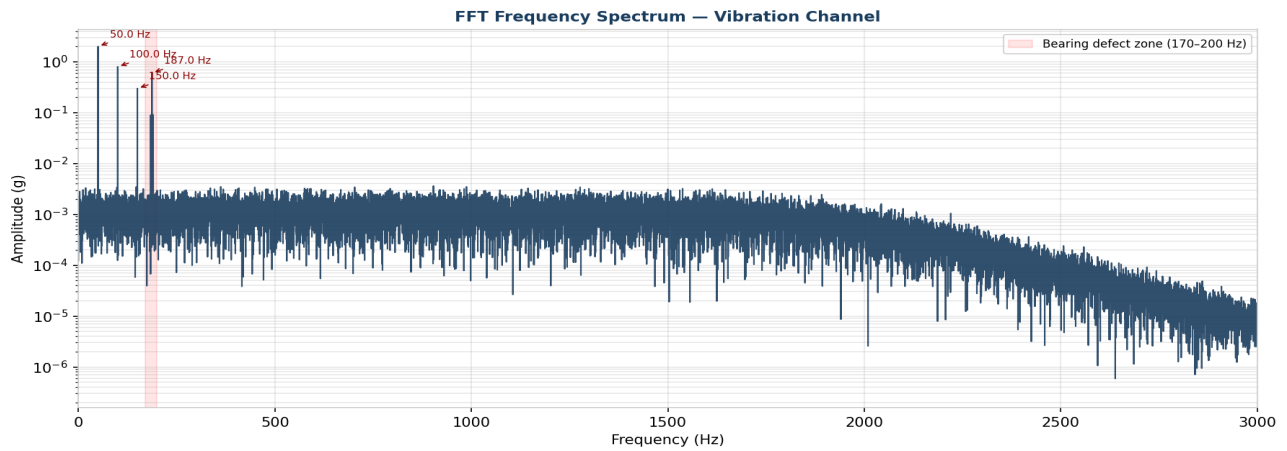
Time-Domain Signal Overview — All Channels

■ FFT analysis identified an unexpected frequency peak at approximately 187 Hz in the vibration channel. This frequency does not correspond to any expected RPM harmonic (50, 100, 150 Hz). It is consistent with a bearing defect frequency signature. Recommendation: inspect bearing condition before next test run. Repeat test after inspection to confirm resolution.
