AI-Powered DDR Generator Output

This report combines the uploaded inspection report and thermal report to produce a client-friendly building diagnosis.

Property Address	Flat 202, UrbanRoof Sample Site, Baner Road, Pune, Maharashtra 411045
Inspector Name	Krushna & Mahesh
Inspection Date	27 September 2022
Property Type	Flat
Floors	11
Property Age	8 years

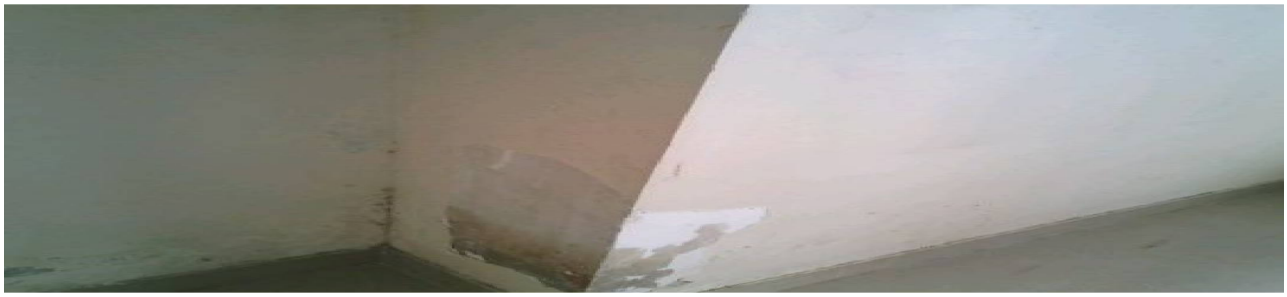
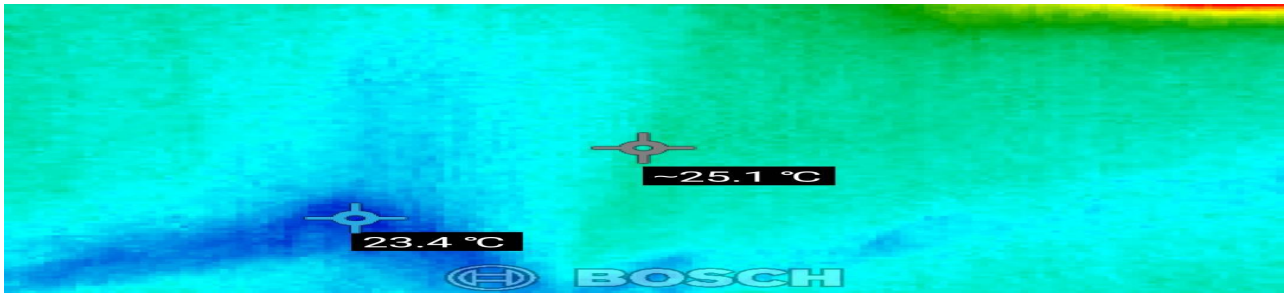
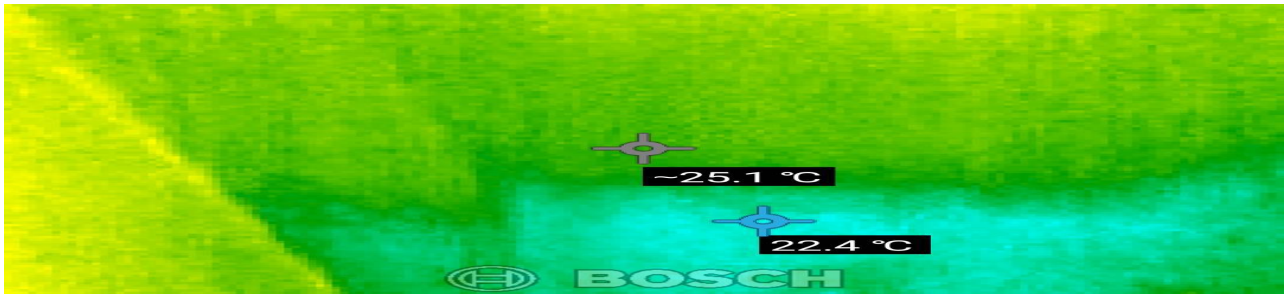
Observation: Skirting level Dampness Thermal review also shows a large blue/cyan area at the bottom of the wall, indicating a significant temperature drop and moisture presence.

Probable Root Cause: Observed gaps between the tile joints of Common Bathroom of Flat No. 103: Dampness in Hall due to gaps in Common Bathroom tile joints.

Severity Assessment: Skirting level Dampness Thermal evidence shows significant moisture ingress or dampness at the base of the wall, likely due to rising damp or water penetration from the floor/ground level. the cold spot temperature is 23.4 °c, which is close to the reflected temperature (23 °c), but still significantly cooler than the hotspot. the visual image confirms visible dampness and mold. at bottom section of the wall. Related source-side evidence points to dampness in hall due to gaps in common bathroom tile joints.. The issue appears active and likely to worsen if it is delayed.

- Treat this area as urgent to prevent further spread of dampness and surface damage.
- Open failed tile joints, repair weak spots, and seal floor-wall junctions in the wet area.

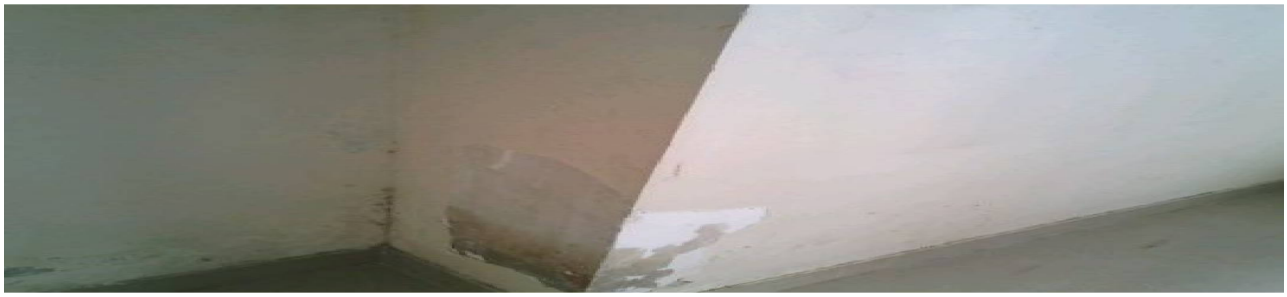
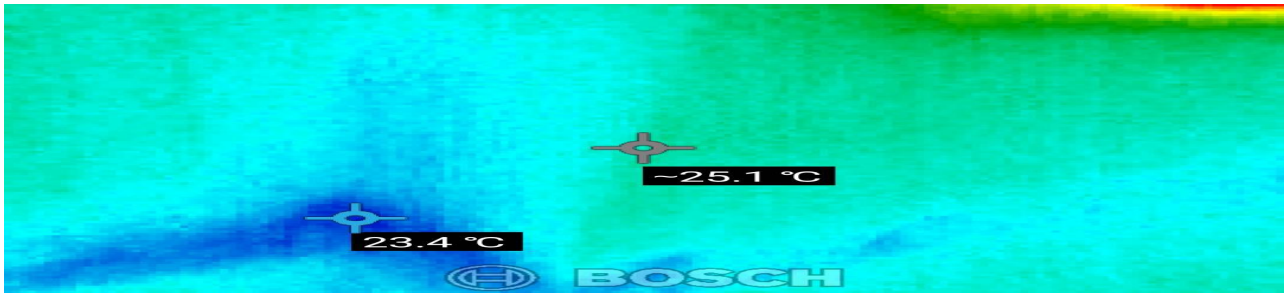
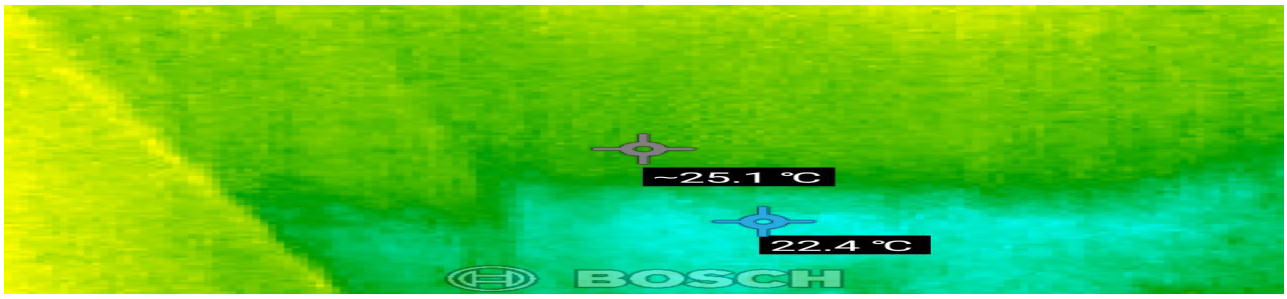
Bedroom

Observation: Skirting level Dampness Thermal review also shows a large blue/cyan area at the bottom of the wall, indicating a significant temperature drop and moisture presence.

Probable Root Cause: Flat No. 203 Bathrooms (Common & Master Bedroom): Open tile joints and gaps between tile joints.

Severity Assessment: Skirting level Dampness Thermal evidence shows significant moisture ingress or dampness at the base of the wall, likely due to rising damp or water penetration from the floor/ground level. the cold spot temperature is 23.4 °c, which is close to the reflected temperature (23 °c), but still significantly cooler than the hotspot. the visual image confirms visible dampness and mold. at bottom section of the wall. Related source-side evidence points to open tile joints and gaps between tile joints.. The issue appears active and likely to worsen if it is delayed.

- Treat this area as urgent to prevent further spread of dampness and surface damage.
- Open failed tile joints, repair weak spots, and seal floor-wall junctions in the wet area.

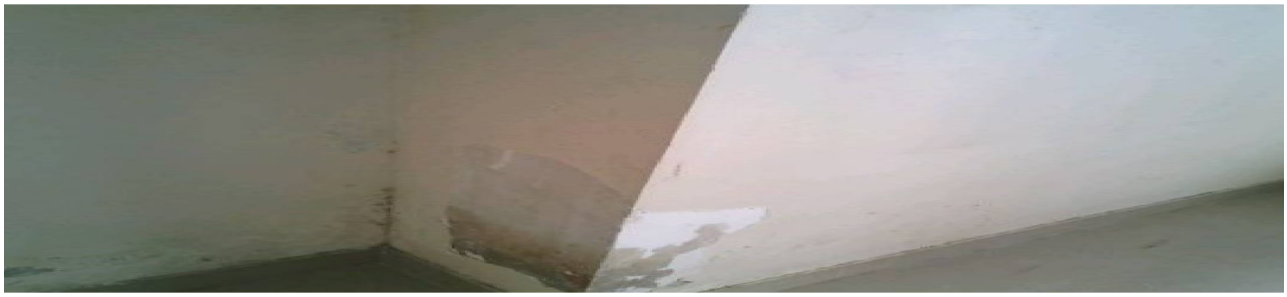
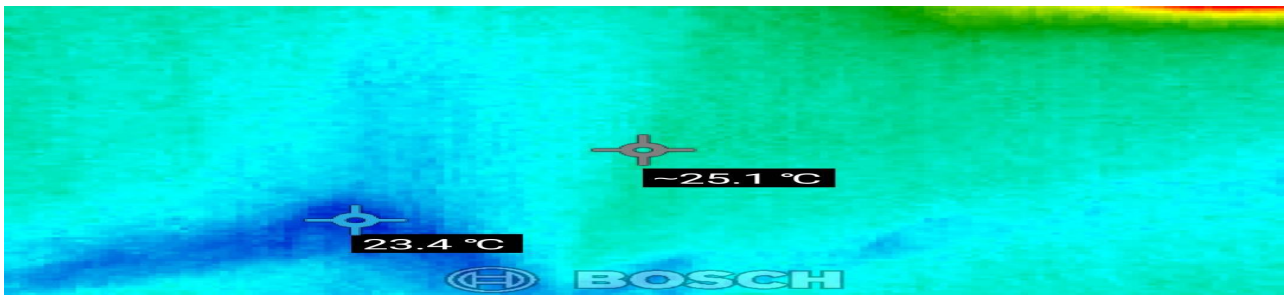
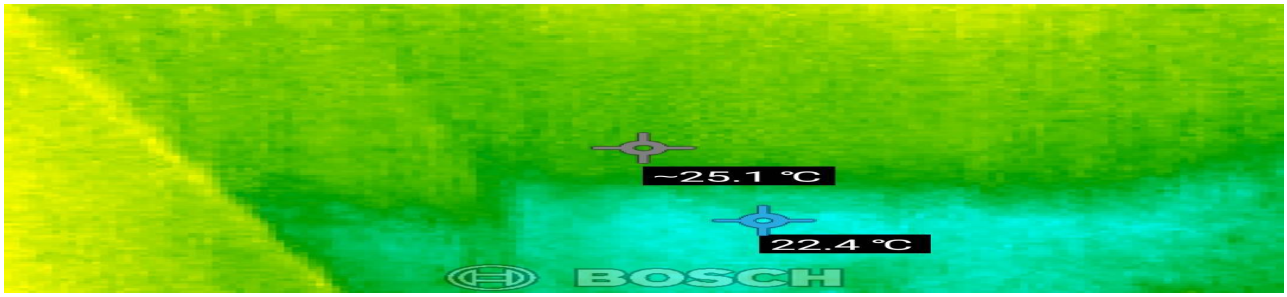
Master Bedroom

Observation: Skirting level Dampness Thermal review also shows a large blue/cyan area at the bottom of the wall, indicating a significant temperature drop and moisture presence.

Probable Root Cause: Flat No. 203 Bathrooms (Common & Master Bedroom): Open tile joints and gaps between tile joints.

Severity Assessment: Skirting level Dampness Thermal evidence shows significant moisture ingress or dampness at the base of the wall, likely due to rising damp or water penetration from the floor/ground level. the cold spot temperature is 23.4 °c, which is close to the reflected temperature (23 °c), but still significantly cooler than the hotspot. the visual image confirms visible dampness and mold. at bottom section of the wall. Related source-side evidence points to open tile joints and gaps between tile joints.. The issue appears active and likely to worsen if it is delayed.

- Treat this area as urgent to prevent further spread of dampness and surface damage.
- Open failed tile joints, repair weak spots, and seal floor-wall junctions in the wet area.

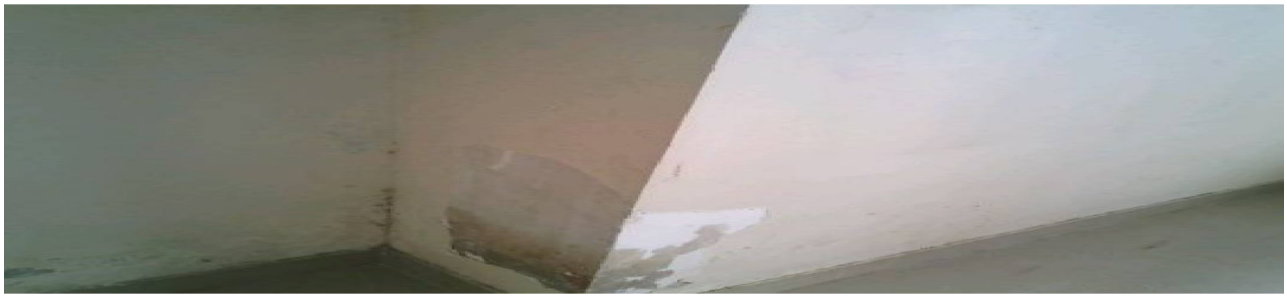
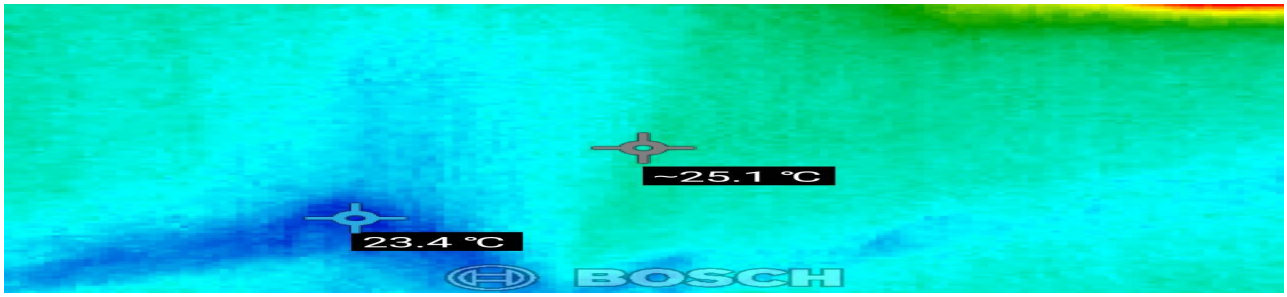
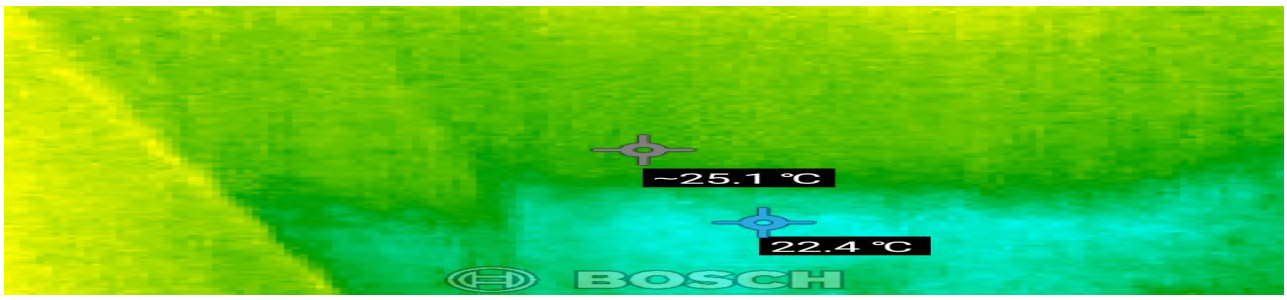
Observation: Skirting level Dampness Thermal review also shows a large blue/cyan area at the bottom of the wall, indicating a significant temperature drop and moisture presence.

Probable Root Cause: Observed gaps between the tile joints of Master Bedroom Bathroom of Flat No. 103: Dampness in Kitchen due to gaps in Master Bedroom Bathroom tile joints.

Severity Assessment: Skirting level Dampness Thermal evidence shows significant moisture ingress or dampness at the base of the wall, likely due to rising damp or water penetration from the floor/ground level. the cold spot temperature is 23.4 °c, which is close to the reflected temperature (23 °c), but still significantly cooler than the hotspot. the visual image confirms visible dampness and mold. at bottom section of the wall. Related source-side evidence points to dampness in kitchen due to gaps in master bedroom bathroom tile joints.. The issue appears active and likely to worsen if it is delayed.

Recommended Actions
- Treat this area as urgent to prevent further spread of dampness and surface damage.
- Open failed tile joints, repair weak spots, and seal floor-wall junctions in the wet area.

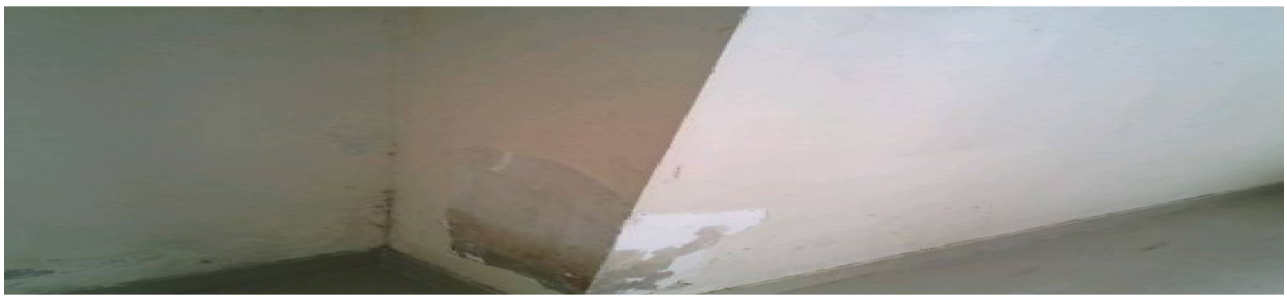
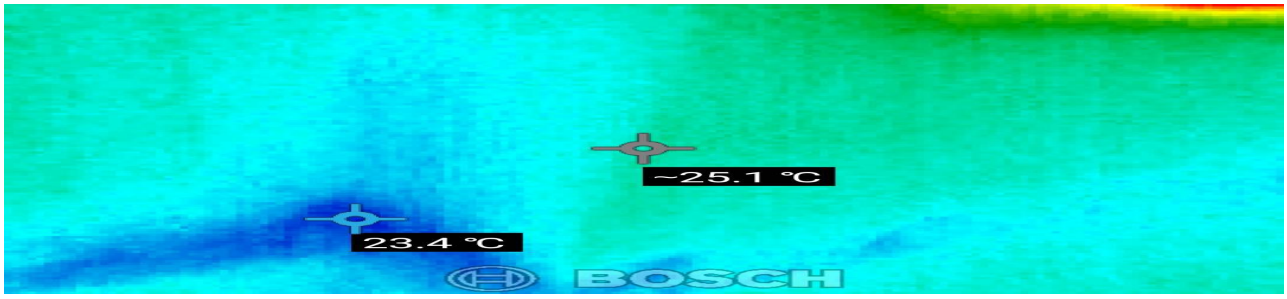
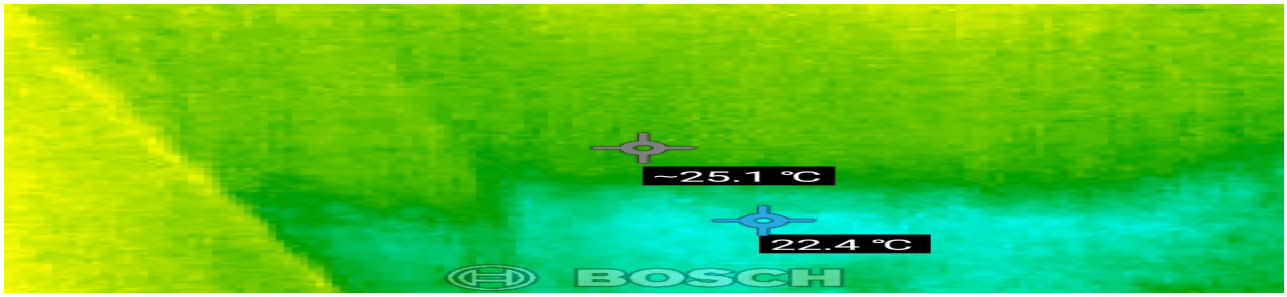
Master Bedroom Wall

Observation: Wall dampness Thermal review also shows a large blue/cyan area at the bottom of the wall, indicating a significant temperature drop and moisture presence.

Probable Root Cause: External Wall: Cracks, duct issue, and external plumbing pipes cracked/leaked.

Severity Assessment: Wall dampness Thermal evidence shows significant moisture ingress or dampness at the base of the wall, likely due to rising damp or water penetration from the floor/ground level. the cold spot temperature is 23.4 °c, which is close to the reflected temperature (23 °c), but still significantly cooler than the hotspot. the visual image confirms visible dampness and mold. at bottom section of the wall. Related source-side evidence points to cracks, duct issue, and external plumbing pipes cracked/leaked.. The issue appears active and likely to worsen if it is delayed.

- Treat this area as urgent to prevent further spread of dampness and surface damage.
- Open failed tile joints, repair weak spots, and seal floor-wall junctions in the wet area.
- Repair wall cracks, stop external water entry, and apply suitable waterproof protection.
- Check nearby plumbing lines and service shafts for hidden leakage.

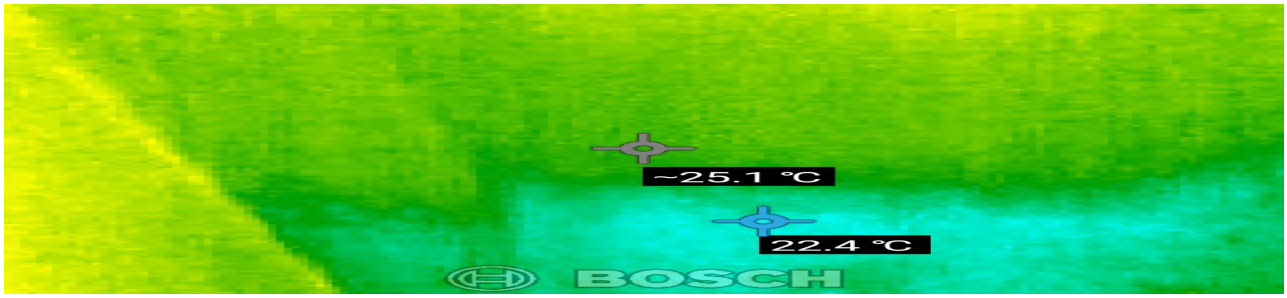
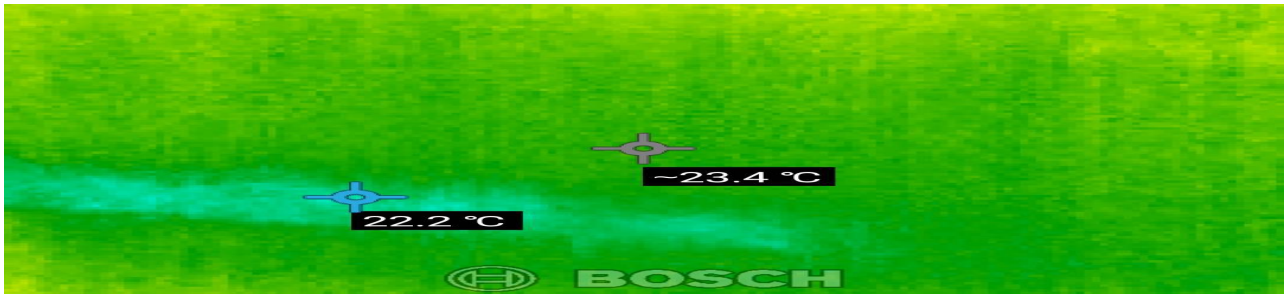
Parking Area

Observation: Seepage is observed at the parking ceiling directly below Flat No. 103.

Probable Root Cause: This seepage is linked to plumbing issues and gaps between the tile joints in the Common Bathroom of Flat No. 103.

Severity Assessment: The inspection report indicates 'immediate' severity for seepage in the parking area, suggesting active water leakage that requires urgent attention to prevent structural damage and safety hazards.

- Immediately investigate and repair the plumbing issues in the Common Bathroom of Flat No. 103.
- Re-grout and seal all tile joints in the Common Bathroom of Flat No. 103.
- Repair the damaged parking ceiling after the source of leakage is resolved.

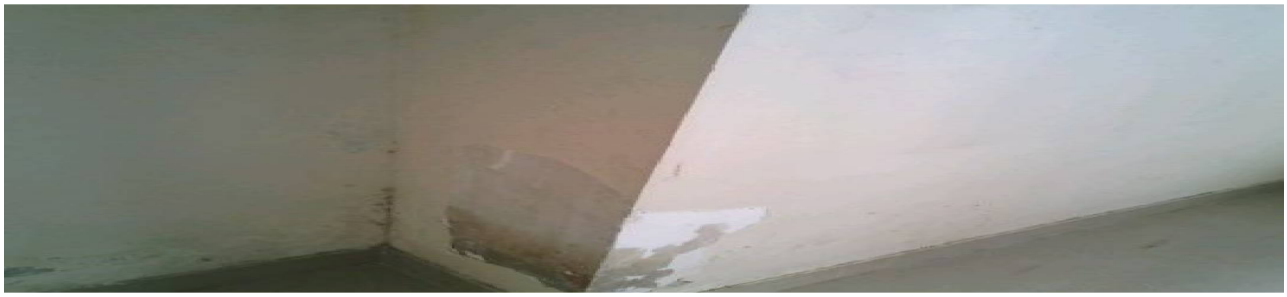
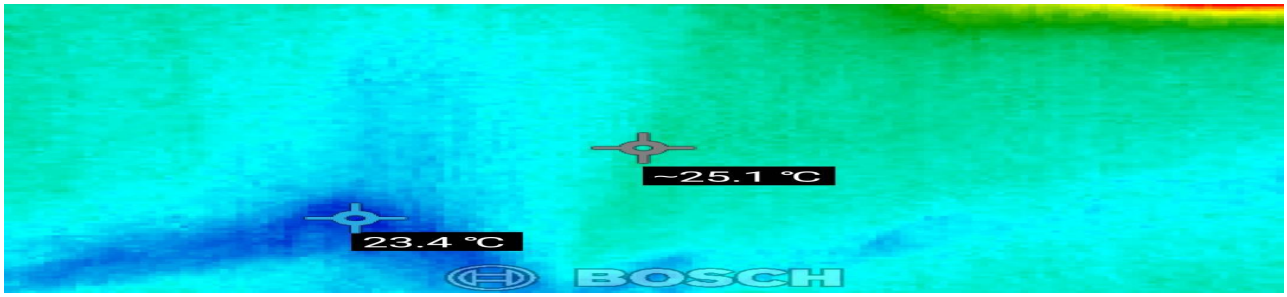
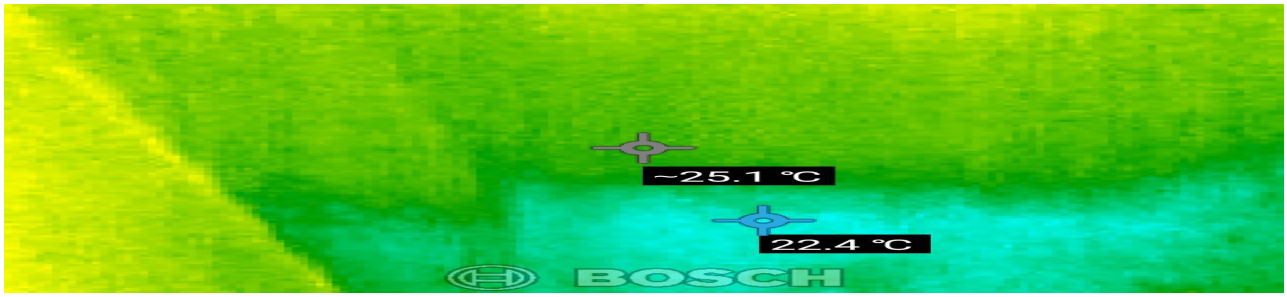
Common Bathroom Ceiling

Observation: Dampness Thermal review also shows a large blue/cyan area at the bottom of the wall, indicating a significant temperature drop and moisture presence.

Probable Root Cause: Common Bathroom (Flat No. 103): Tile hollowness, gaps between tile joints, and plumbing issue.

Severity Assessment: Dampness Thermal evidence shows significant moisture ingress or dampness at the base of the wall, likely due to rising damp or water penetration from the floor/ground level. the cold spot temperature is 23.4 °c, which is close to the reflected temperature (23 °c), but still significantly cooler than the hotspot. the visual image confirms visible dampness and mold. at bottom section of the wall. Related source-side evidence points to tile hollowness, gaps between tile joints, and plumbing issue.. The issue appears active and likely to worsen if it is delayed.

- Treat this area as urgent to prevent further spread of dampness and surface damage.
- Open failed tile joints, repair weak spots, and seal floor-wall junctions in the wet area.
- Check nearby plumbing lines and service shafts for hidden leakage.
