Site Name : Dhandalpur

1.GENERAL DETAILS OF WIND TURBINE :

S.No	Details	Input	S.No	Details	Input
1	PROJECT	End of warranty inspection (Chotila)	2	WINDFARM	End of warranty inspection (Chotila)
3	LOCATION NO	JGBPL-01	4	VILLAGE	Adala /Dhandalpur
5	DIST	surendranagar	6	TALUKA	Chotila
7	STATE	Gujarat	8	COUNTRY	India
9	WINDFARM CAPACITY	-	10	TURBINE GPS COORDINATES	738749N, 2471993E (UTM)
11	TURBINE MANUFACTURER	Suzlon	12	WTG MODEL	S144
13	WTG SERIAL NO	JGBPL-01	14	WTG LOCATION NO	JGBPL-01
15	WTG SCADA NO	JGBPL-01	16	WTG CAPACITY	3.15 (MW)
17	ROTOR DIAMETER	144 (MTR)	18	HUB HEIGHT	140 (MTR)
19	LAST ACTIVITY	2026-03-20

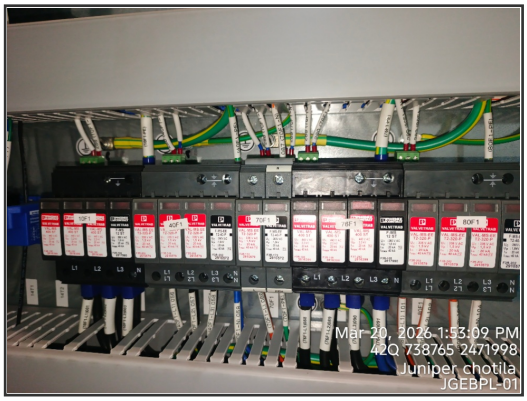
Ref. No.	Observation / Way Forward	Ref. Photos	Risk Category
2.6	Corrosion observed on earth cable hardware at tower foundation. **Way Forward:** Clean or replace corroded hardware, ensure proper tightening, and verify earthing resistance is within acceptable limits.		Low
3.14	In the power panel, the main ACB feedback cable was observed to be disconnected/outside from the terminal. **Way Forward:** Reconnect the feedback cable properly to the designated terminal.		High
3.14	One (01) Surge Arrester was found in a defective condition in the control panel. **Way Forward:** Replace the defective surge arrester with a new unit of the same rating and specification.

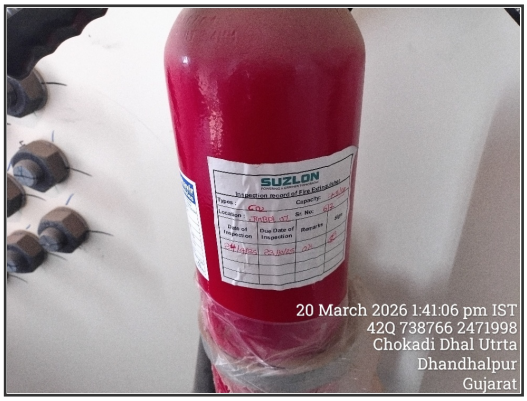
Ref. No.	Observation / Way Forward	Ref. Photos	Risk Category
3.19	Bottom platform fire extinguisher is overdue for servicing. **Way Forward:** Service or replace the fire extinguisher immediately and implement a schedule to track future maintenance dates.

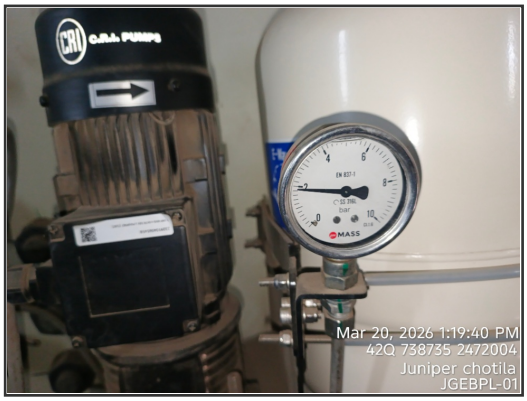
Ref. No.	Observation / Way Forward	Ref. Photos	Risk Category
3.23	Bottom lift control panel push button switches are open/exposed. **Way Forward:** Close or cover the push button switches immediately, inspect for any damage, and implement regular panel inspections.		Medium
3.24	In the middle section radiator, the coolant pressure was observed to be below 2 bar. **Way Forward:** After topping up and rectifying, monitor coolant pressure and system temperature during operation.

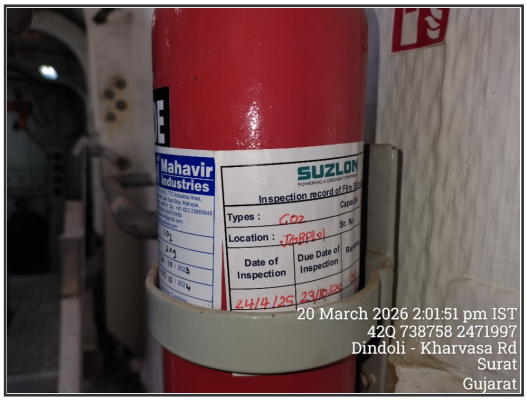
Ref. No.	Observation / Way Forward	Ref. Photos	Risk Category
7.9.4	Fire extinguisher refilling due date has expired. **Way Forward:** Refill or replace the fire extinguisher immediately and implement a tracking system for timely servicing.

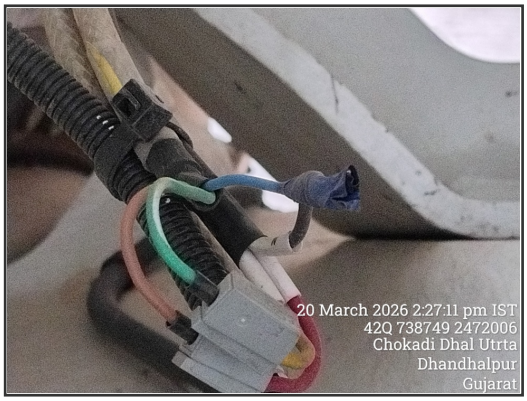
Ref. No.	Observation / Way Forward	Ref. Photos	Risk Category
8.3.4	Hub light cable neutral conductor was found unclamped and in bypass condition. **Way Forward:** Properly secure the neutral cable in designated clamps, eliminate bypass condition, and verify connection integrity.

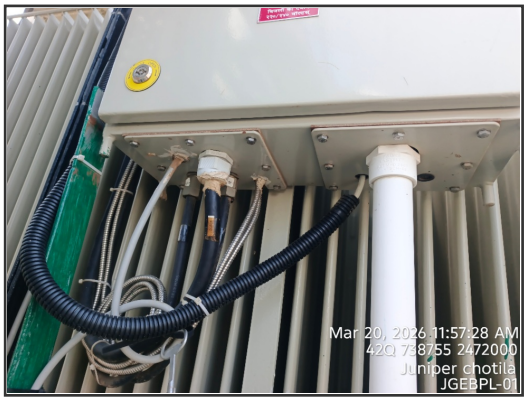
Ref. No.	Observation / Way Forward	Ref. Photos	Risk Category
8.4.6	The transformer MOG (Magnetic Oil Level Gauge) is showing the oil level in full condition. **Way Forward:** The transformer MOG (Magnetic Oil Level Gauge) is indicating full oil level however, it needs to be verified whether this is an actual oil level condition or a possible MOG malfunction.		High
8.4.7	The marshalling box cable gland was observed in a missing condition. **Way Forward:** Install suitable cable gland of correct size and specification.

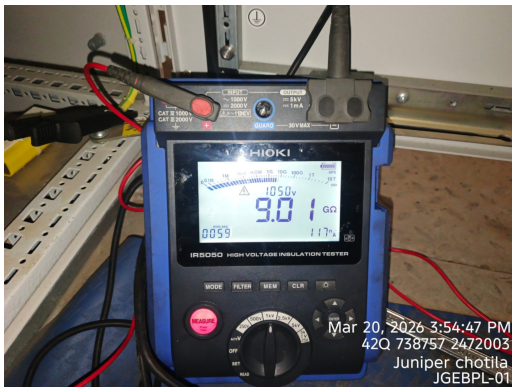
Measurement Point / Method	Measurement Reading	Ref. Photos	Risk Category
2. Power Cable IR test- Phase To Earth	R2 TO E- 8.98 G ohm **Way Forward:** Found ok		Acceptable
3. Power Cable IR test- Phase To Earth	R3 TO E- 9.01 G ohm **Way Forward:** Found ok

Acceptable
4. Power Cable IR test- Phase To Earth	R4 TO E- 9.59 G ohm **Way Forward:** Found ok		Acceptable
5. Power Cable IR test- Phase To Earth	R5 TO E- 10.1 G ohm **Way Forward:** Found ok		Acceptable

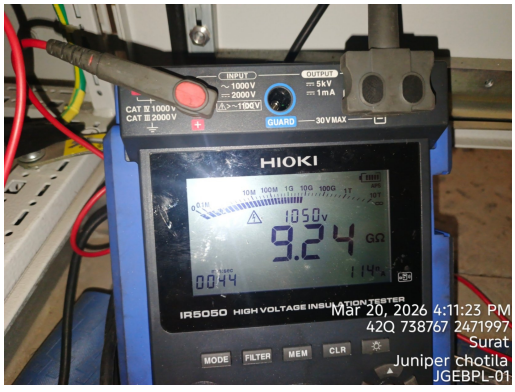
Measurement Point / Method	Measurement Reading	Ref. Photos	Risk Category
14. Power Cable IR test- Phase To Earth	B2 TO E- 9.66 G ohm **Way Forward:** Found ok		Acceptable
15. Power Cable IR test- Phase To Earth	B3 TO E- 9.07 G ohm **Way Forward:** Found ok		Acceptable
16. Power Cable IR test- Phase To Earth	B4 TO E- 9.10 G ohm **Way Forward:** Found ok		Acceptable
17. Power Cable IR test - Phase To Earth	B5 TO E- 9.24 G ohm **Way Forward:** Found ok

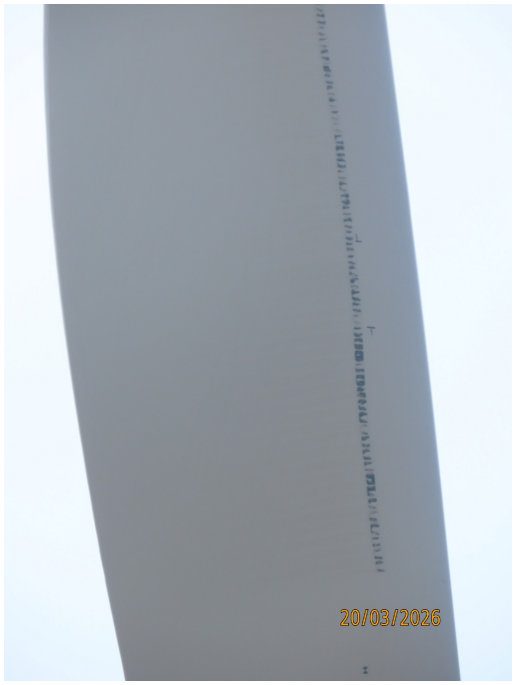
Measurement Point / Method	Measurement Reading	Ref. Photos	Risk Category
Blade 3 (Middle section)	vortex generators (VGs) were observed in a partially removed/damaged condition. **Way Forward:** Inspect all vortex generators (VGs) for condition, alignment, and adhesion.\nRe-fix or replace missing/damaged VGs as per OEM specifications to maintain aerodynamic performance.
