MINISTRY OF WORKS AND TRANSPORT
DEPARTMENT OF NATIONAL ROADS
DIVISION OF DESIGN AND NETWORK ENGINEERING
NETWORK ENGINEERING UNIT

National Road Network Situation Analysis Report

JULY 2024 – JUNE 2025

JULY 2025

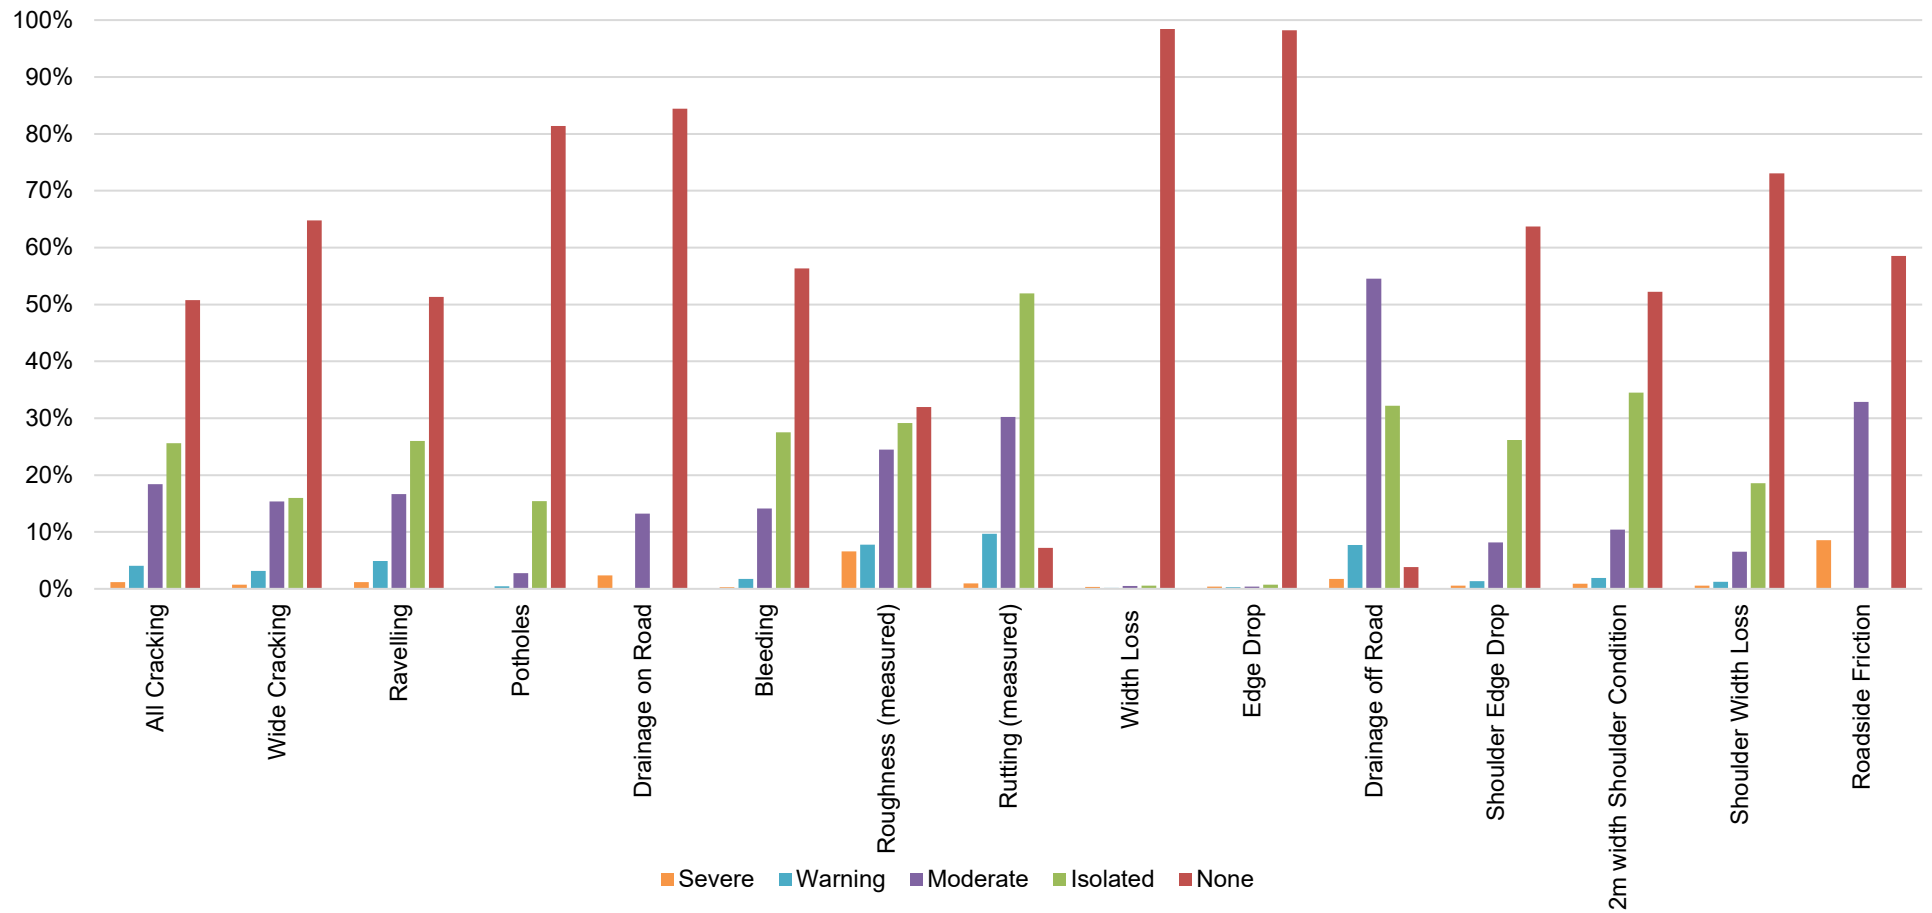
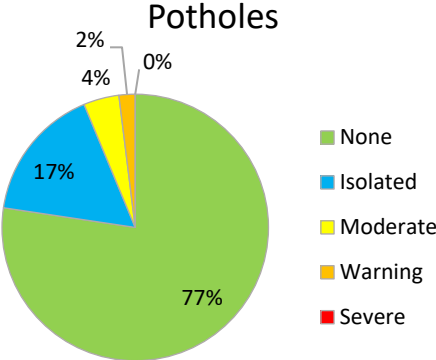
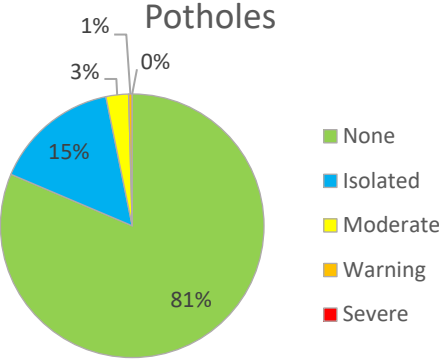
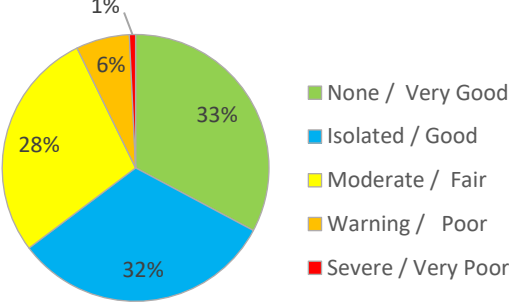
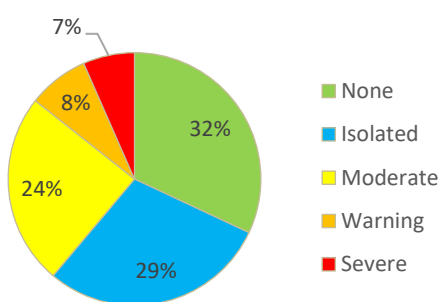
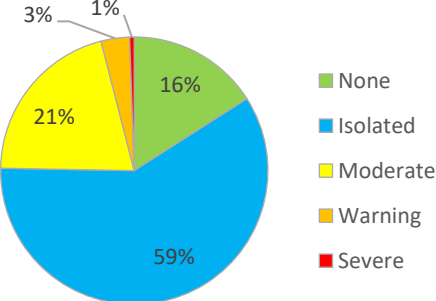
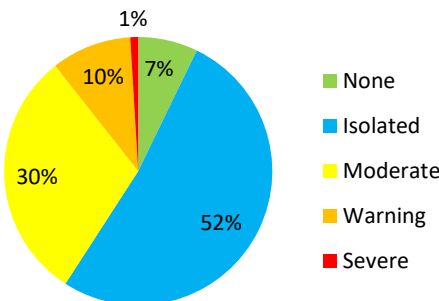
Figure 15: Distress ratings of defects on paved roads, 2025

Global asset management standards suggest that a road network is "healthy" if fewer than 10% of roads are poor or very poor. Therefore, the roads with warning and severe defects should be prioritised for maintenance. The visual and automated evaluations reveal the following findings about the paved roads:

- Cracking
- Moderate to severe 'All Cracking' is noted on 24% (1,424 km) of the paved roads, with 26% (1,540 km) exhibiting isolated cracking and 51% (3,056 km) exhibiting no cracking.
 - 19% (1,160 km) of the paved network presents moderate to severe wide cracking, another 16% (962 km) presents isolated wide cracking, and 65% (3,899 km) presents no wide cracking. Wide cracking is a particular concern because these cracks indicate the disintegration of the structural layers in the wheel paths. Wide cracks also initiate the formation of rutting. Preventive measures should be considered as soon as possible to delay further deterioration and the development of secondary distress.

Ravelling	■ Ravelling is the loss of aggregate material from the road surfacing. In seals, this manifests as stone loss; in asphalts, as surfacing disintegration. ■ 6% (364 km) of roads have severe to warning ravelling and immediate maintenance is required on these roads. ■ 17% (1,002 km) display moderate ravelling. Future maintenance of roads with moderate ravelling is crucial since it accounts for the percentage of roads which could easily deteriorate to a warning condition.
Roughness (measured)	■ ROMDAS surveys for roughness (IRI) and rutting were done on 5,189 km of the paved road network, which accounts for 82% of the paved road network. ■ From the IRI surveys, 14% (745 km) of the road network has severe to warning roughness. These roads typically require medium or heavy rehabilitation. 25% (1,272 km) have moderate roughness, and 61% (3,172 km) have very good and good roughness. Although some of these roads might not require immediate attention, it is crucial to monitor the condition continuously and apply the right treatment at the right time to delay further deterioration.

Drainage off road	■ Referring to the condition of side drainage, mitre drains and cross drainage underneath the road. 10% (569 km) of the paved road network is in a state of severe condition, 55% (3,282 km) is in a moderate state, 32% (1,935 km) has isolated drainage problems, and 4% (229 km) is in good condition.

Generally, the paved road network is in good condition. However, from a pavement management perspective, the roads appear structurally sound; however, increased cracking, ravelling, rutting, and roughness indicate significant pavement deterioration. A preventive maintenance regime of timely patching, crack sealing, diluted emulsions, and resurfacing will significantly delay structural deterioration by preventing water ingress into pavement structures.

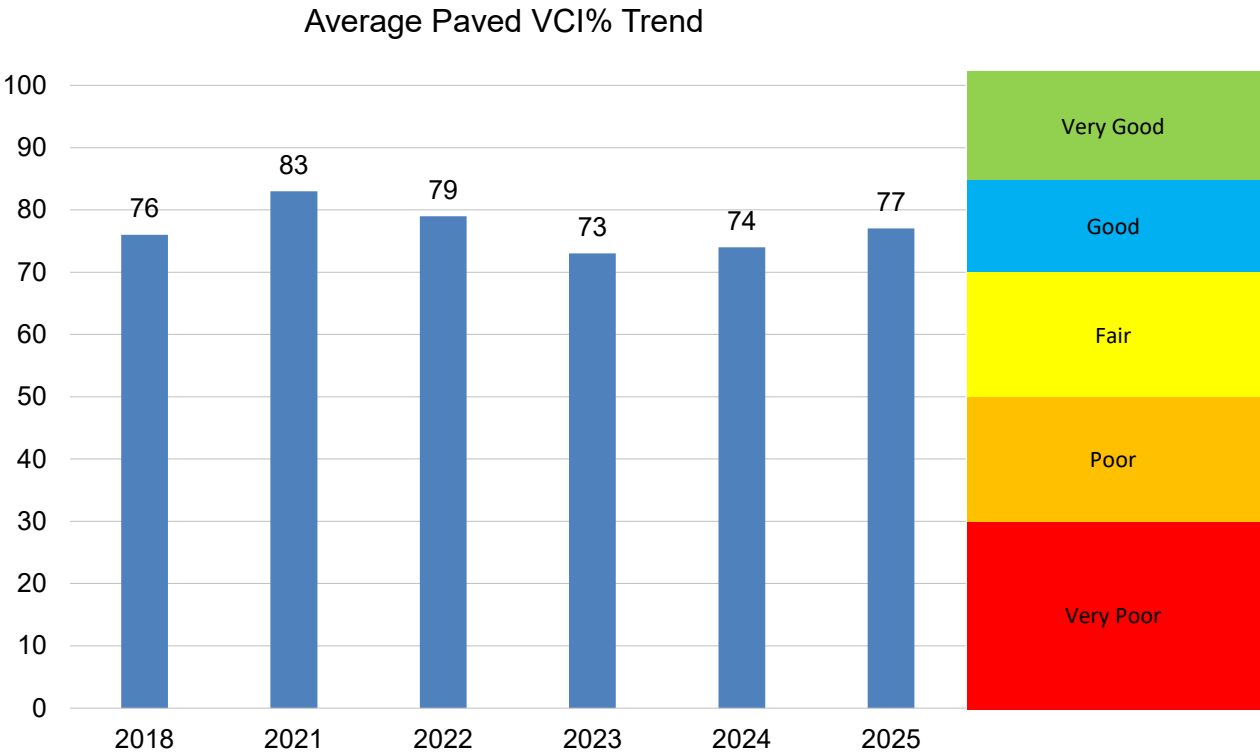
Figure 16: Average Paved VCI comparison

The average VCI for paved roads, based on 2025 data, is 77%, which places the road network in the “good” condition category. In 2024, the average VCI for paved roads was 74%, an increase of 3%. The graph below compares VCI over the years.

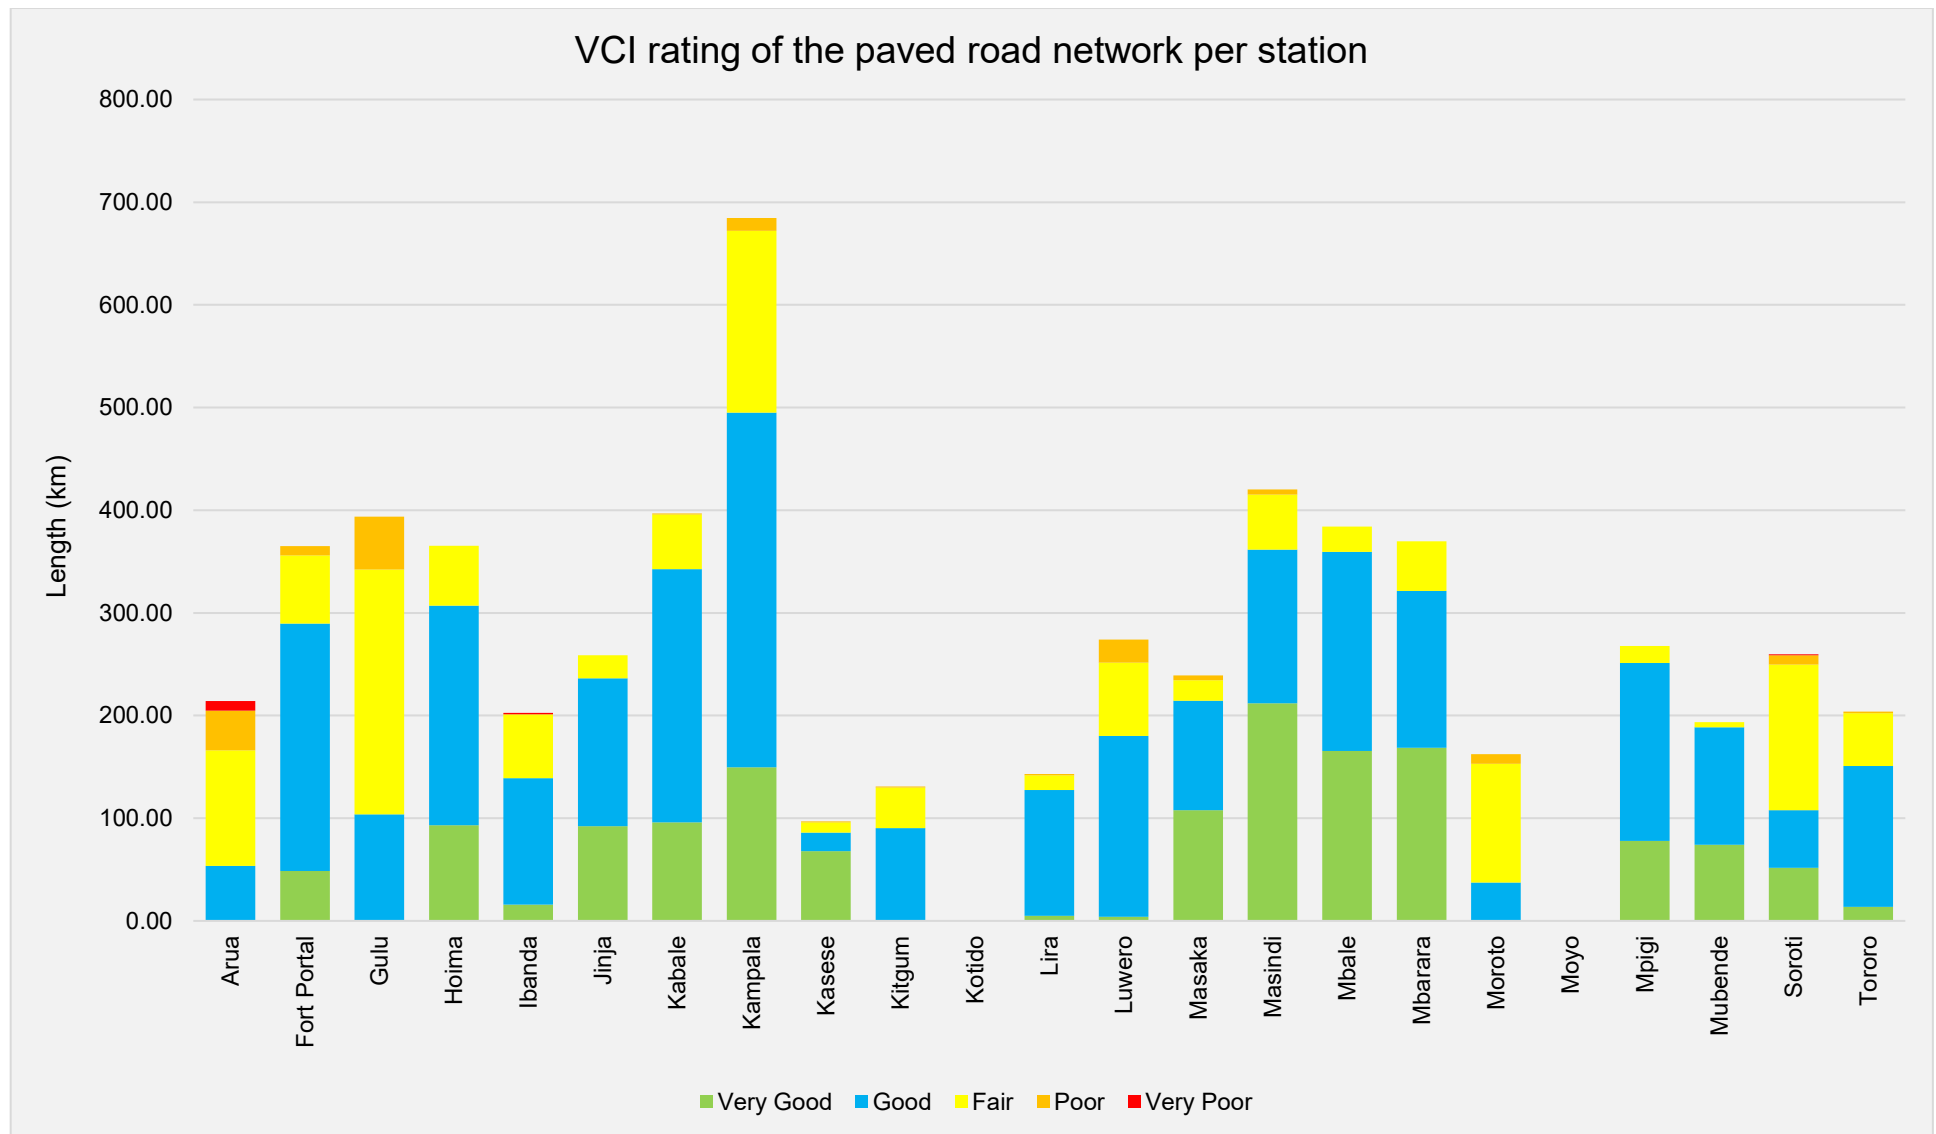
Figure 19: VCI rating of the paved road network per station

The Figure above indicates the performance of the paved road network by station. Most stations maintain the road network in good and fair condition. Masindi (50%, 212 km), Mbarara (46%, 168 km), and Masaka (45% 107 km) stations have the highest percentage of roads in very good condition, while Arua (4% 9 km) station has the highest percentage of roads in very poor conditions.

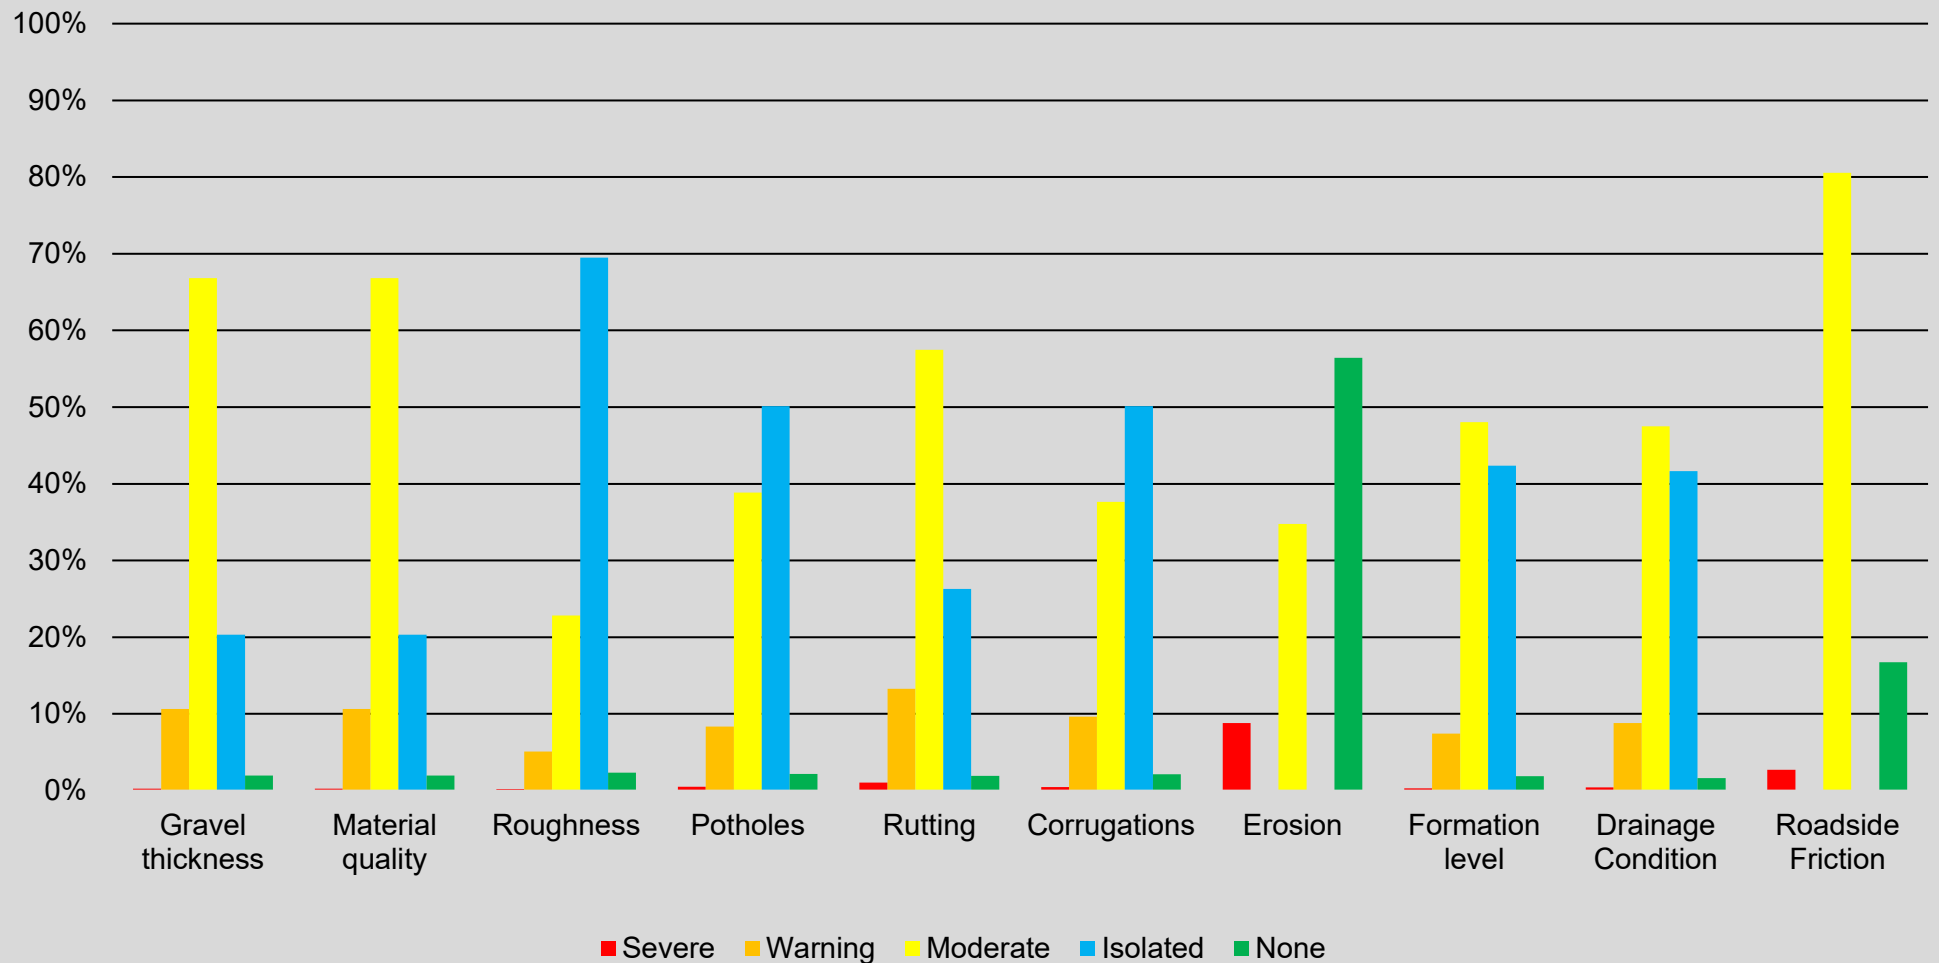
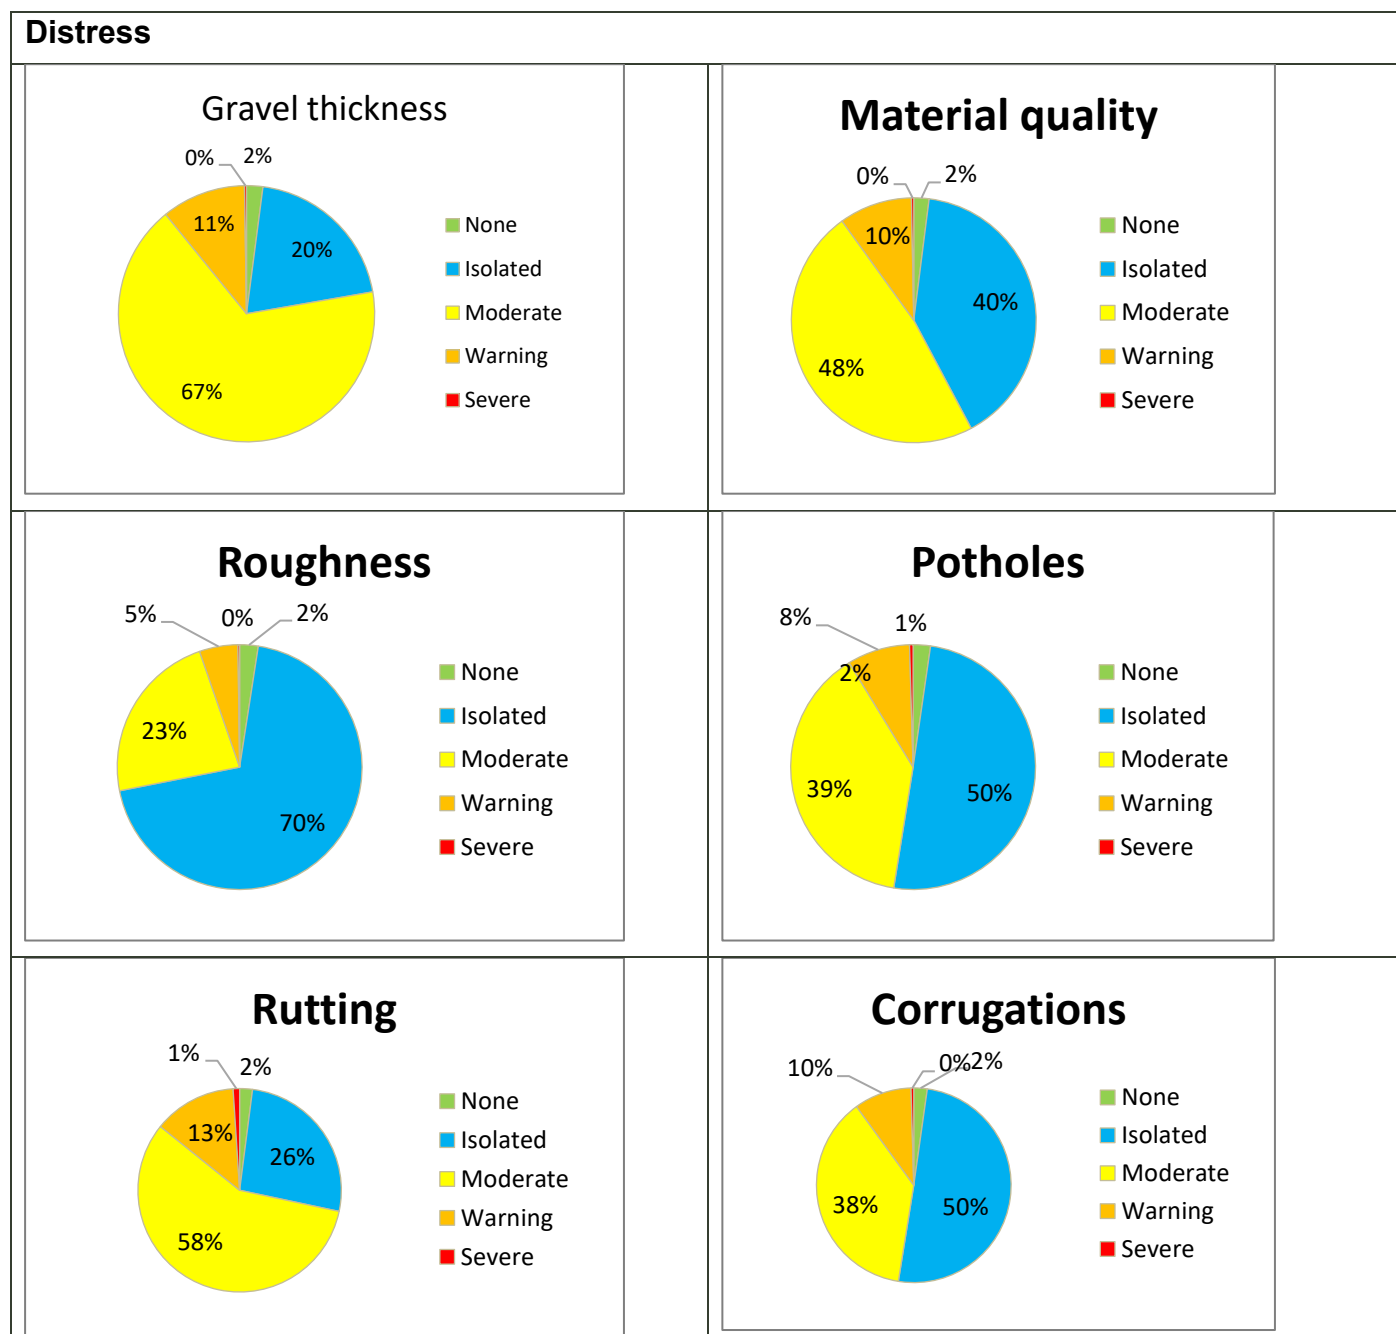
Figure 20: Distress, characteristic and condition ratings of unpaved roads, 2025

| Gravel thickness | ■ 11% (1,511km) of the unpaved road network requires re-gravelling due to low gravel thickness of less than 50mm. 67% (9,272km) is in the moderate condition state, with subgrade exposed in local areas (average of 50 to 100mm gravel thickness). |
| Material quality | ■ 11% (1,511km) of unpaved roads have severe material quality exhibiting a poorly distributed range of particle sizes and/or zero or excessive plasticity. 67% (9,272km) have moderate material quality with cracking, loose material, or stones visible. 22% (3,089km) has good material quality. |
| Potholes | ■ The high occurrence of potholes, especially in severe to moderate states on 48% (6,617km) and 50% (6,952km) in the isolated state, is indicative of inadequate maintenance. |

Erosion	■ Erosion was rated moderate to severe on 44% (6,046km) of the road network. There is a need to repair erosion gullies more regularly.
Drain condition and formation level	■ Drainage condition and formation level indicate the ability of roads to drain water away. Roads with severe or warning formation levels would act as water channels; this is the case for 8% (1,175) of the unpaved road network. 49% (6,846km) of the unpaved roads have moderate formation levels, indicating that the drainage is level with ground level. ■ Furthermore, the drainage condition is considered severe for 9% (1,279km) of the network, with moderate drainage conditions existing on 47% (6,589km) of the network.
Roadside friction	■ 17% (2,320km) of the unpaved road network has no roadside friction, 81% (11,176km) has moderate roadside friction, and 3% (377km) has severe roadside friction.

In summary, the unpaved network is in fair condition. From a road user's perspective, material quality and possibly insufficient maintenance regimes contribute to the development of rough roads with potholes, rutting and corrugations. From an unpaved road management perspective, low gravel thickness, low formation levels and poor drainage conditions result in erosion, which wets the gravel layers and subgrade, which ultimately results in potholes and rutting. A well-planned re-gravelling programme should be supported by an effective maintenance regime of blading (to maintain cambers and limit roughness), cleaning of side drains, mitre drains and cross drainage.

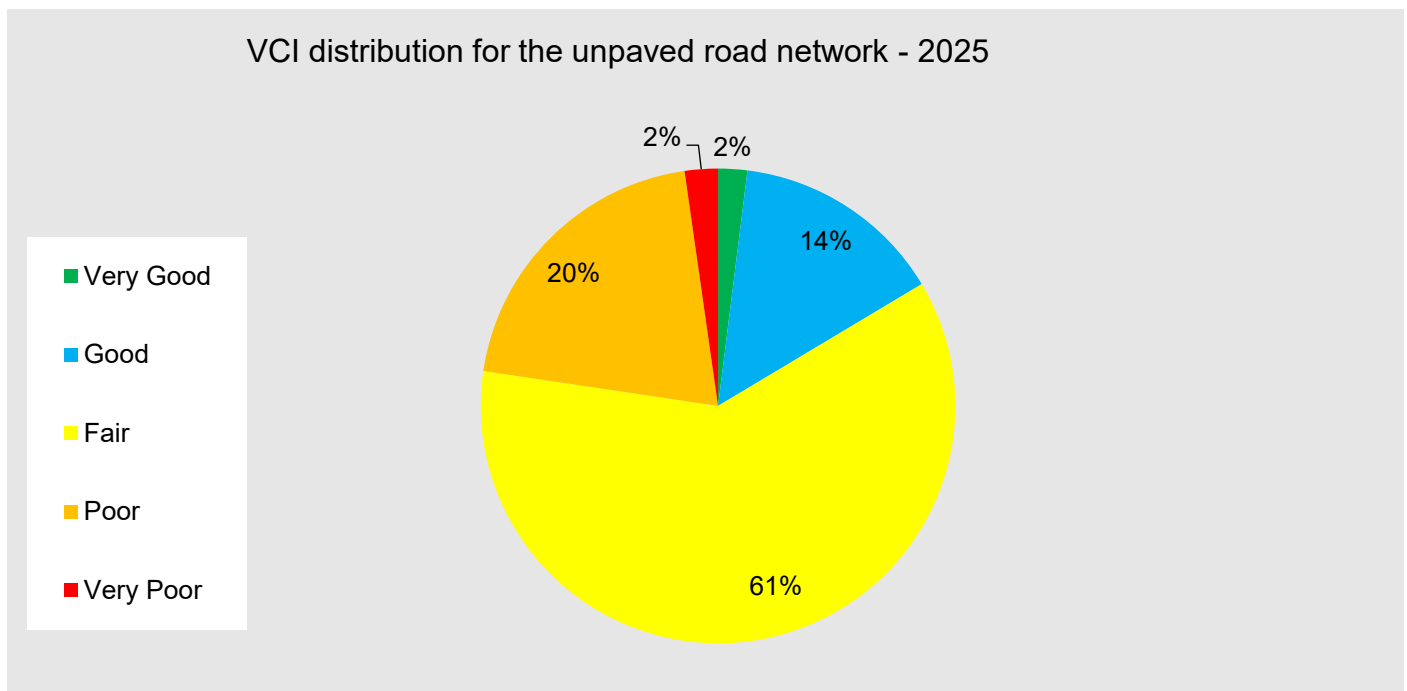
Figure 21: VCI distribution for the unpaved road network

The general condition of the unpaved road network is generally Fair, standing at 61%

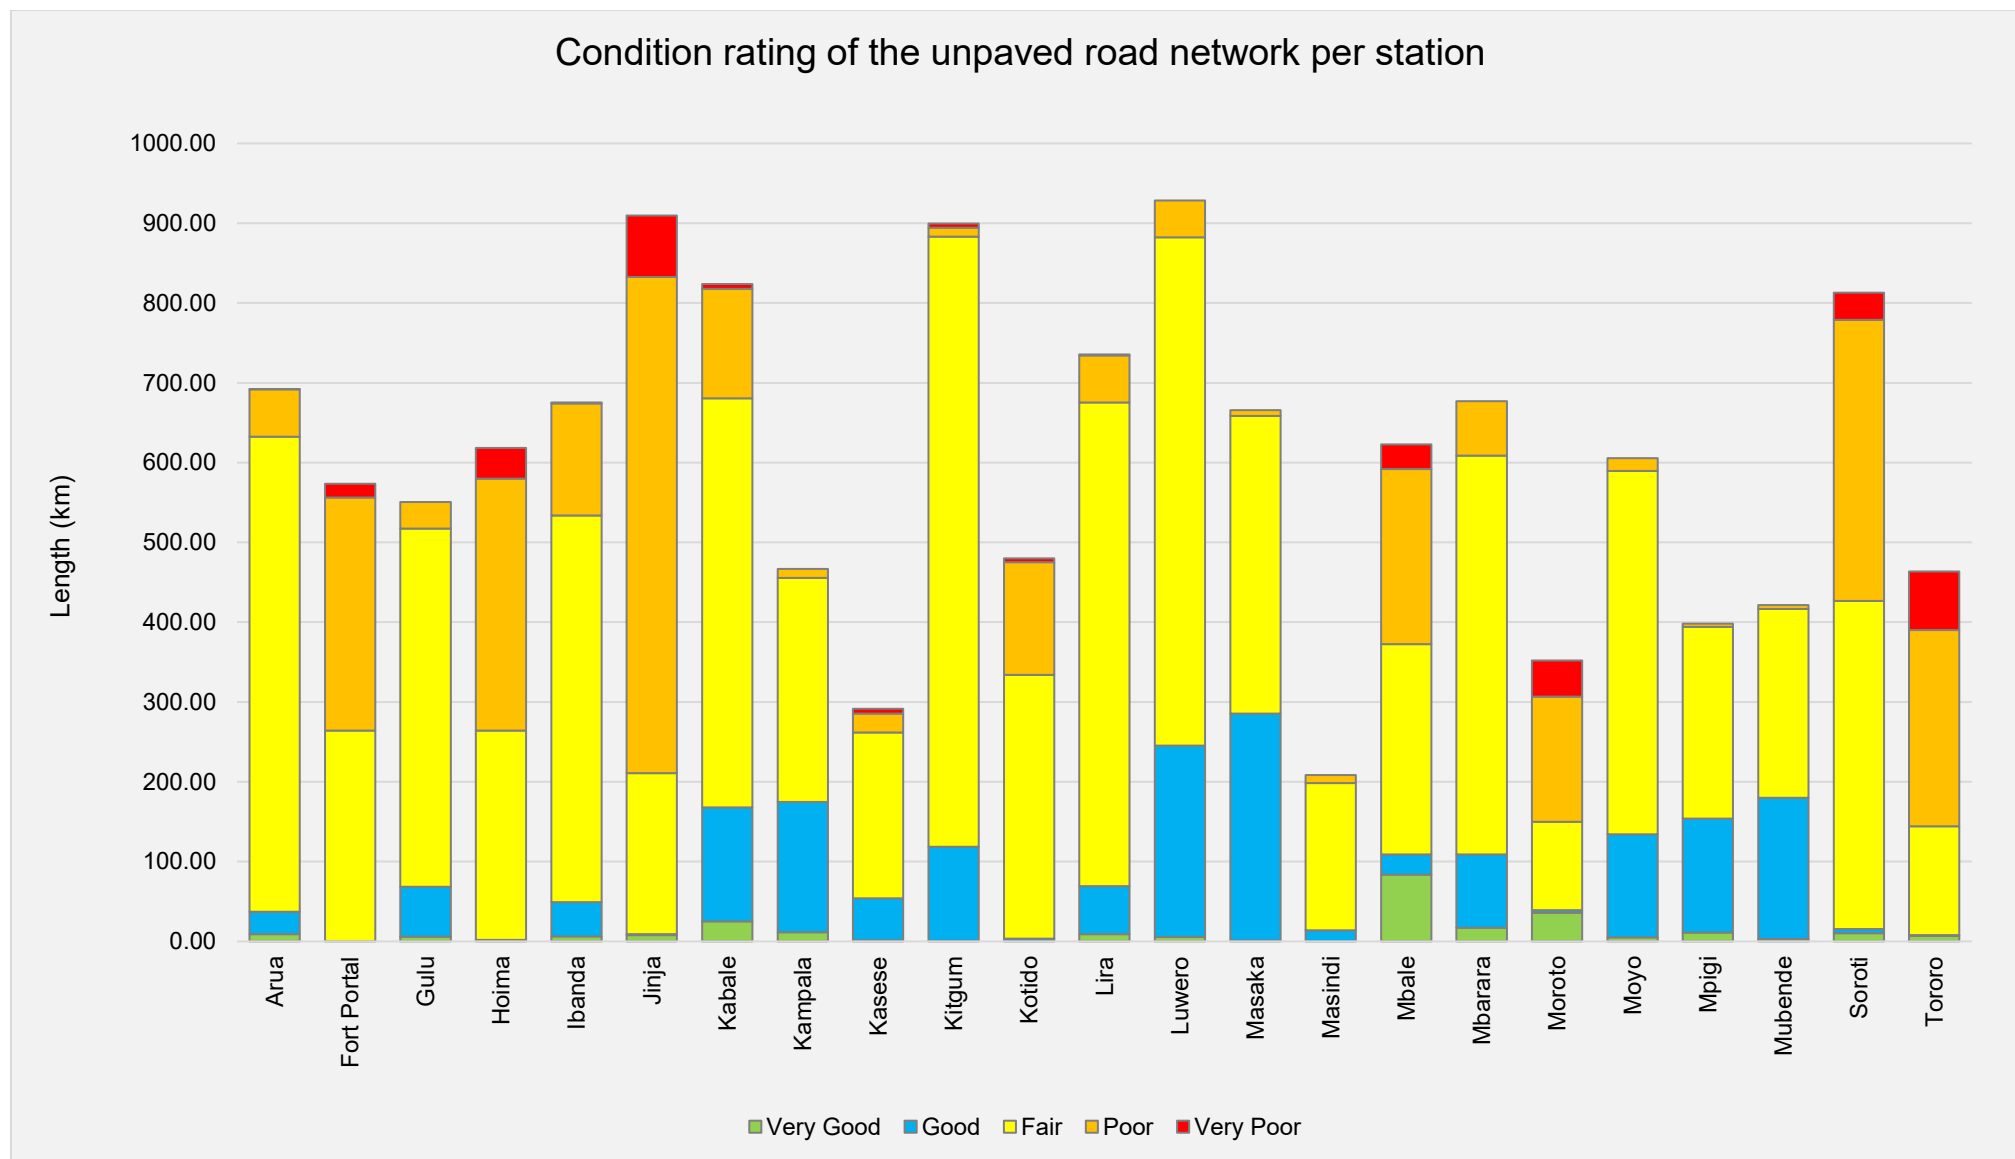
Figure 23: Condition rating of the unpaved road network per station

The Figure above indicates the performance of the unpaved road network by station. All stations maintain the road network in fair to poor condition, which indicates a need for improved maintenance and further investigation into the causes of defects. Mbale (13%), Moroto (10%), and Kabale (3%) stations have the highest percentage of roads in very good condition, while Tororo (16%), Moroto (13%) and Jinja (8%) stations have the highest percentage of roads in very poor conditions.
