# P1 Project Drawing Updates - 10/22/2019

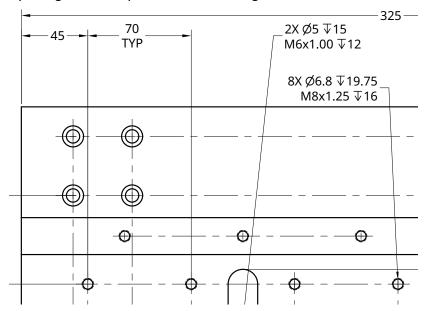
#### BR-549-A-002

Groove diameter was missing. Also there are 7 (not 6) 0.5 x 45° chamfers.
