P1 Project Drawing Updates - 10/23/2019

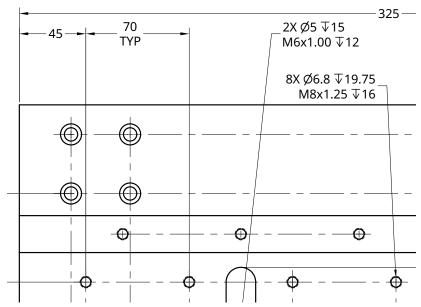
BR-549-A-002

Groove diameter was missing. Also there are 7 (not 6) 0.5 x 45° chamfers.
