Consultancy Services for the Plant Audit in various Pump Stations and Reservoirs (OP18REFCS03)

Technical Report for Cherry[®]-inline Pump Station
reference: OP18REFCS03-GHD-CHE-REP-G001A

Title:
Preliminary Report for Cherry-Inline Pump Station

Theme:
Plant Audit and Asset Management

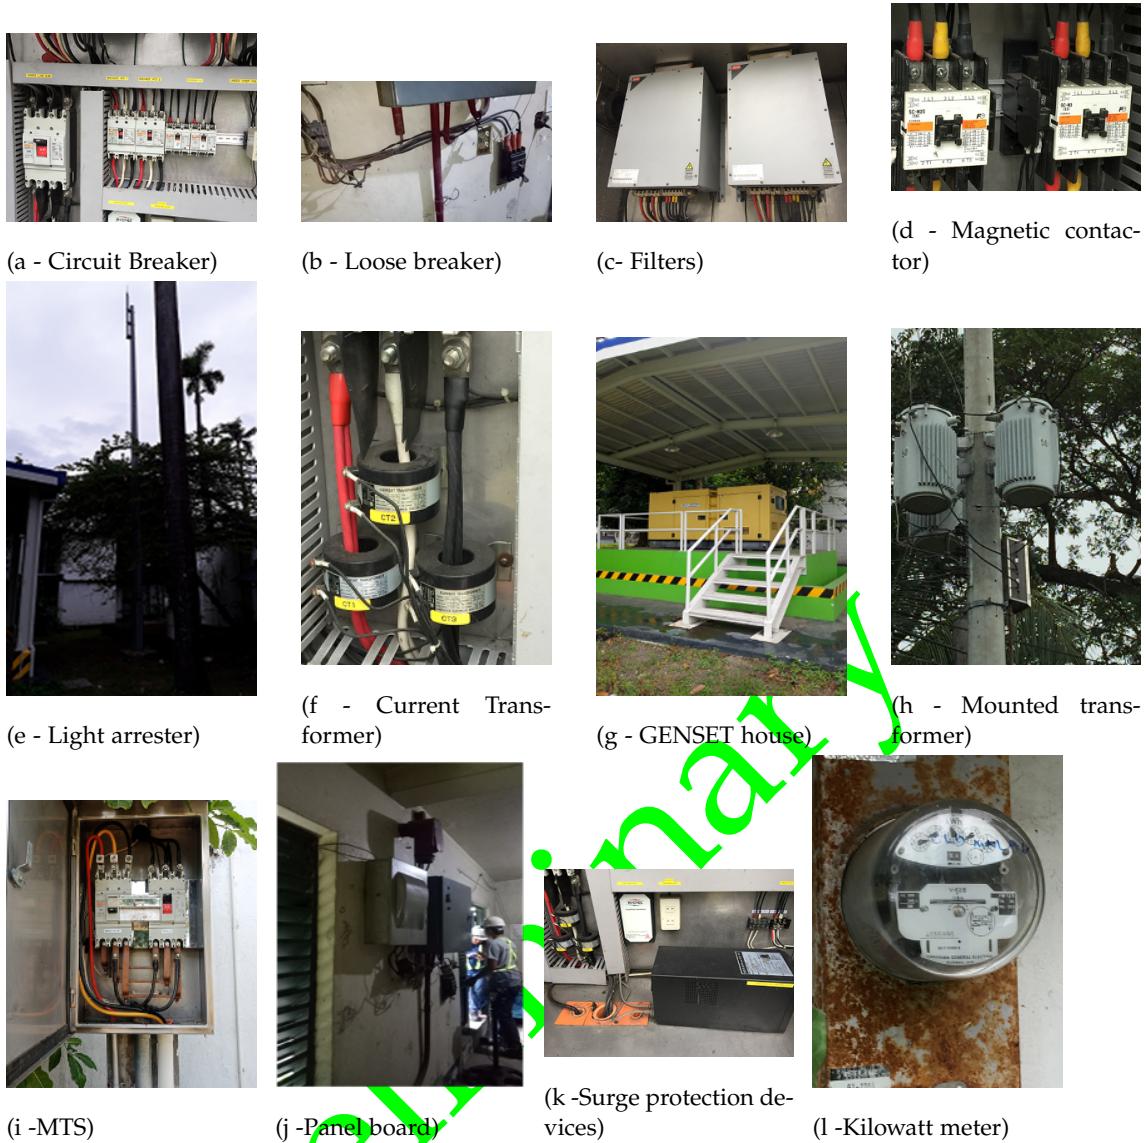
Figure 4.3: Existing electrical assets

Results of the visual inspection are reflected in the database that describes also the Asset Registry. Highlights of the outcome for this station are shown in Table 4.3 with visual images shown in Figure 4.3.

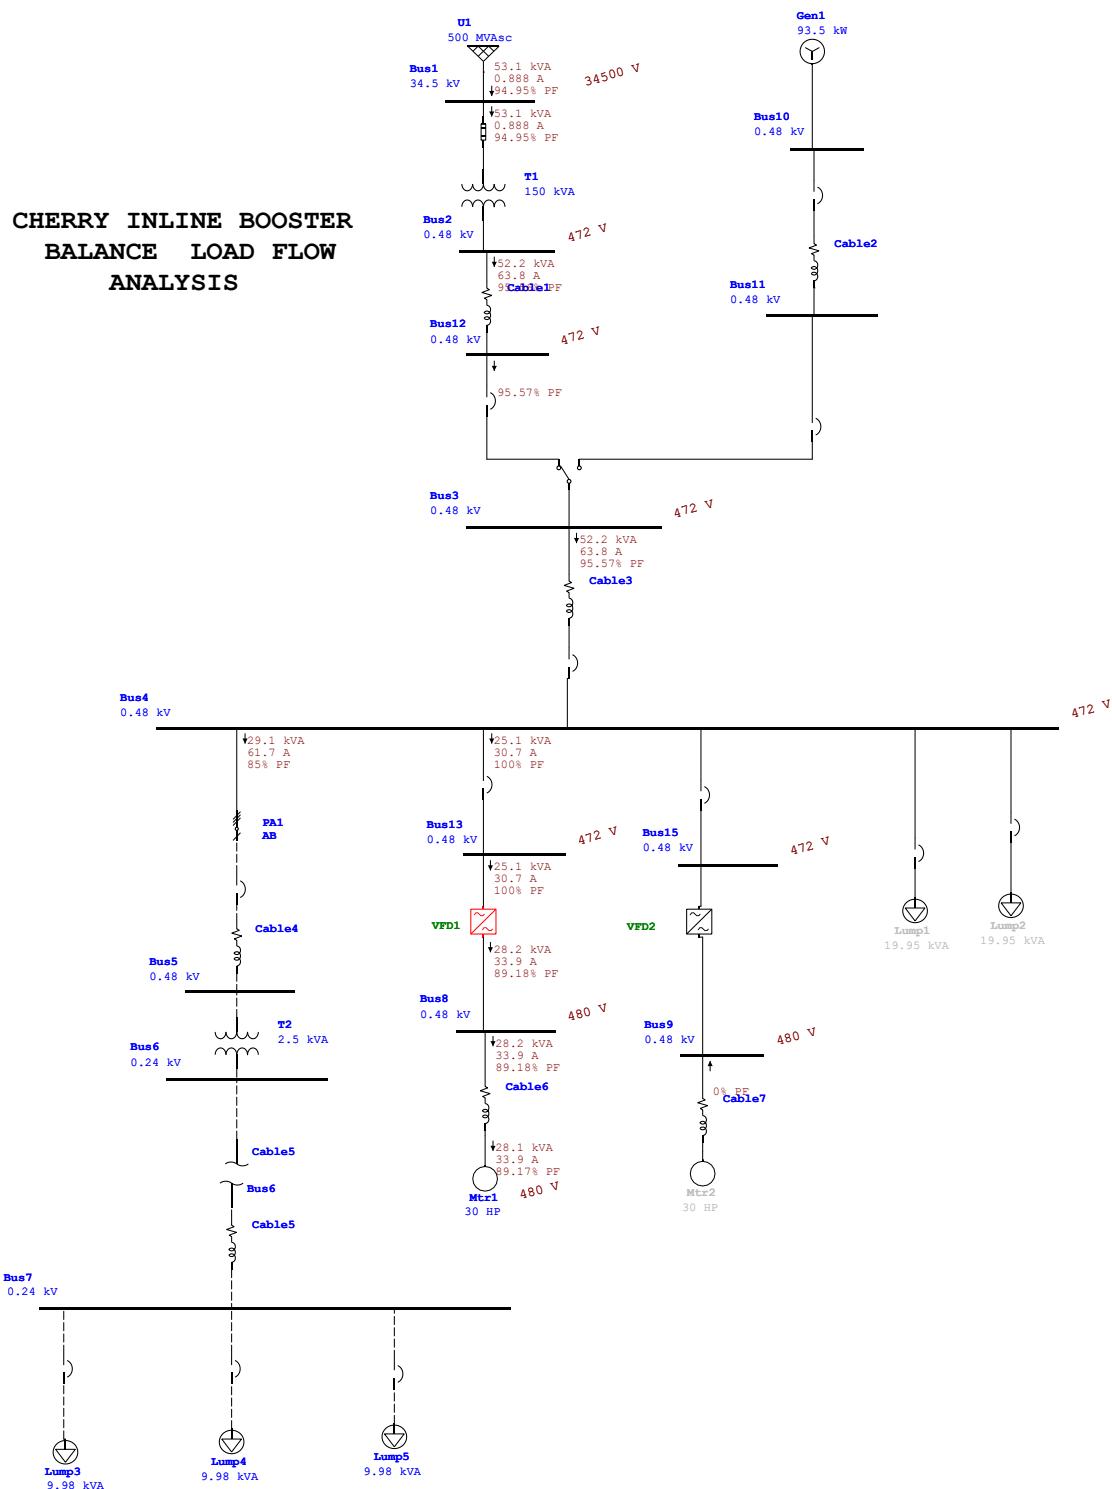
Figure 4.6: Load flow analysis

- For the overall system, the maximum loading reached about 54 (A) (Figure 4.7), which is lower than the theoretical values (63.8 A) obtained from ETAB software (Figure 4.6). This indicates that actual parameter values are within the acceptance range;
- For the VFD1, the maximum loading reached about 54 (A) (Figure 4.8), which is lower than the theoretical values (33.9 A) obtained from ETAB software (Figure 4.6). This indicates that actual parameter values are not within the acceptance range;
- For the VFD2, the maximum loading reached about 32 (A) (Figure 4.9), which is lower than the theoretical values (33.9 A) obtained from ETAB software (Figure 4.6). This indicates that actual parameter values are within the acceptance range.

From this analysis, it is recommended that continuous monitoring on VFD1 shall be implemented to ensure that the loading is not going to exceed the limit. Furthermore, continuity test on VFD shall be conducted to determine the probable issue.

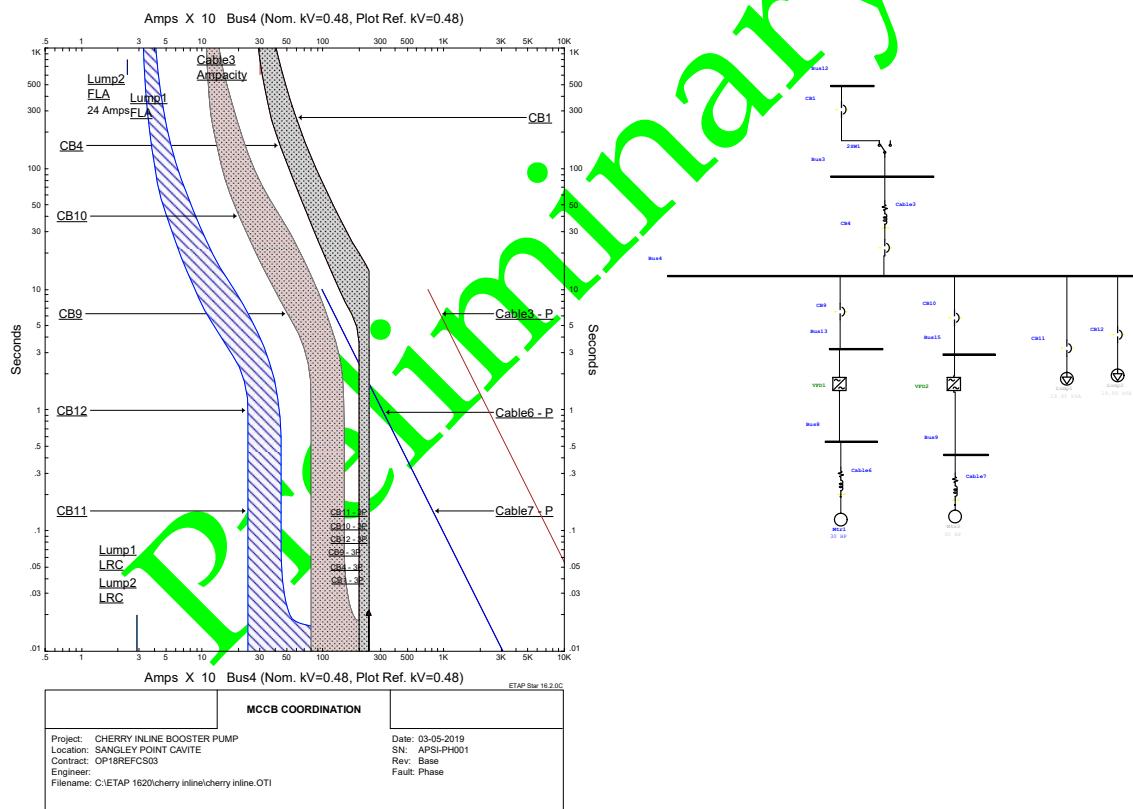
**Figure 4.10:** Coordination plot

Results of study on protection coordination are presented in subsection 4.6. With reference to the coordination plot shown in Figure 4.10, it is remarked that partial coordination only for the main and feeder breakers. TCC of feeders crosses the TCC of enclosed circuit breaker upstream of the feeders.

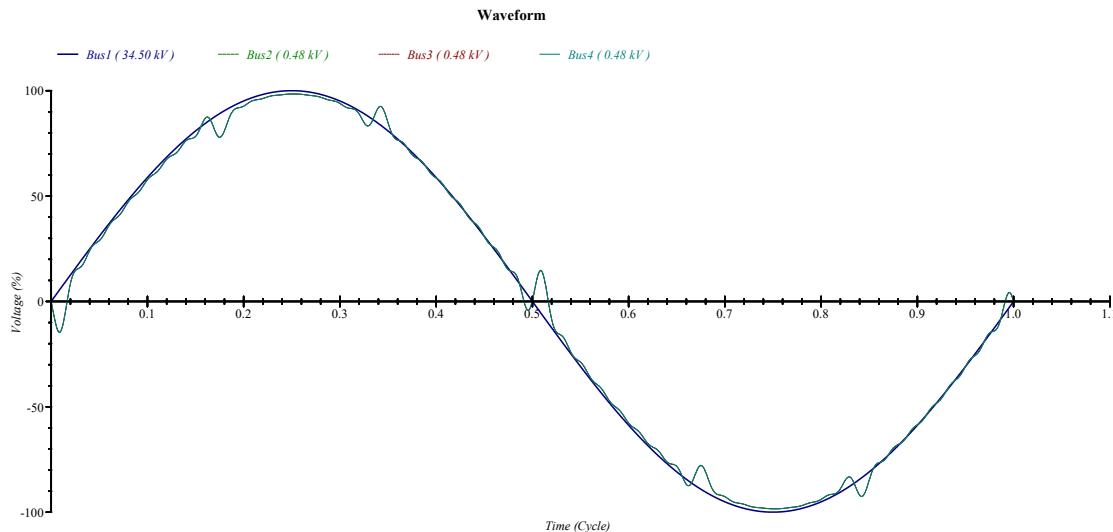
Figure 4.11: Bus wave form

concern, particularly for the harmonic orders of 3rd, 5th, and 7th being dominant registers. This might cause heating on the equipment.

Recommendation shall be realized together with the recommendation from the study of Power Quality Analysis (refer to subsection 4.8)

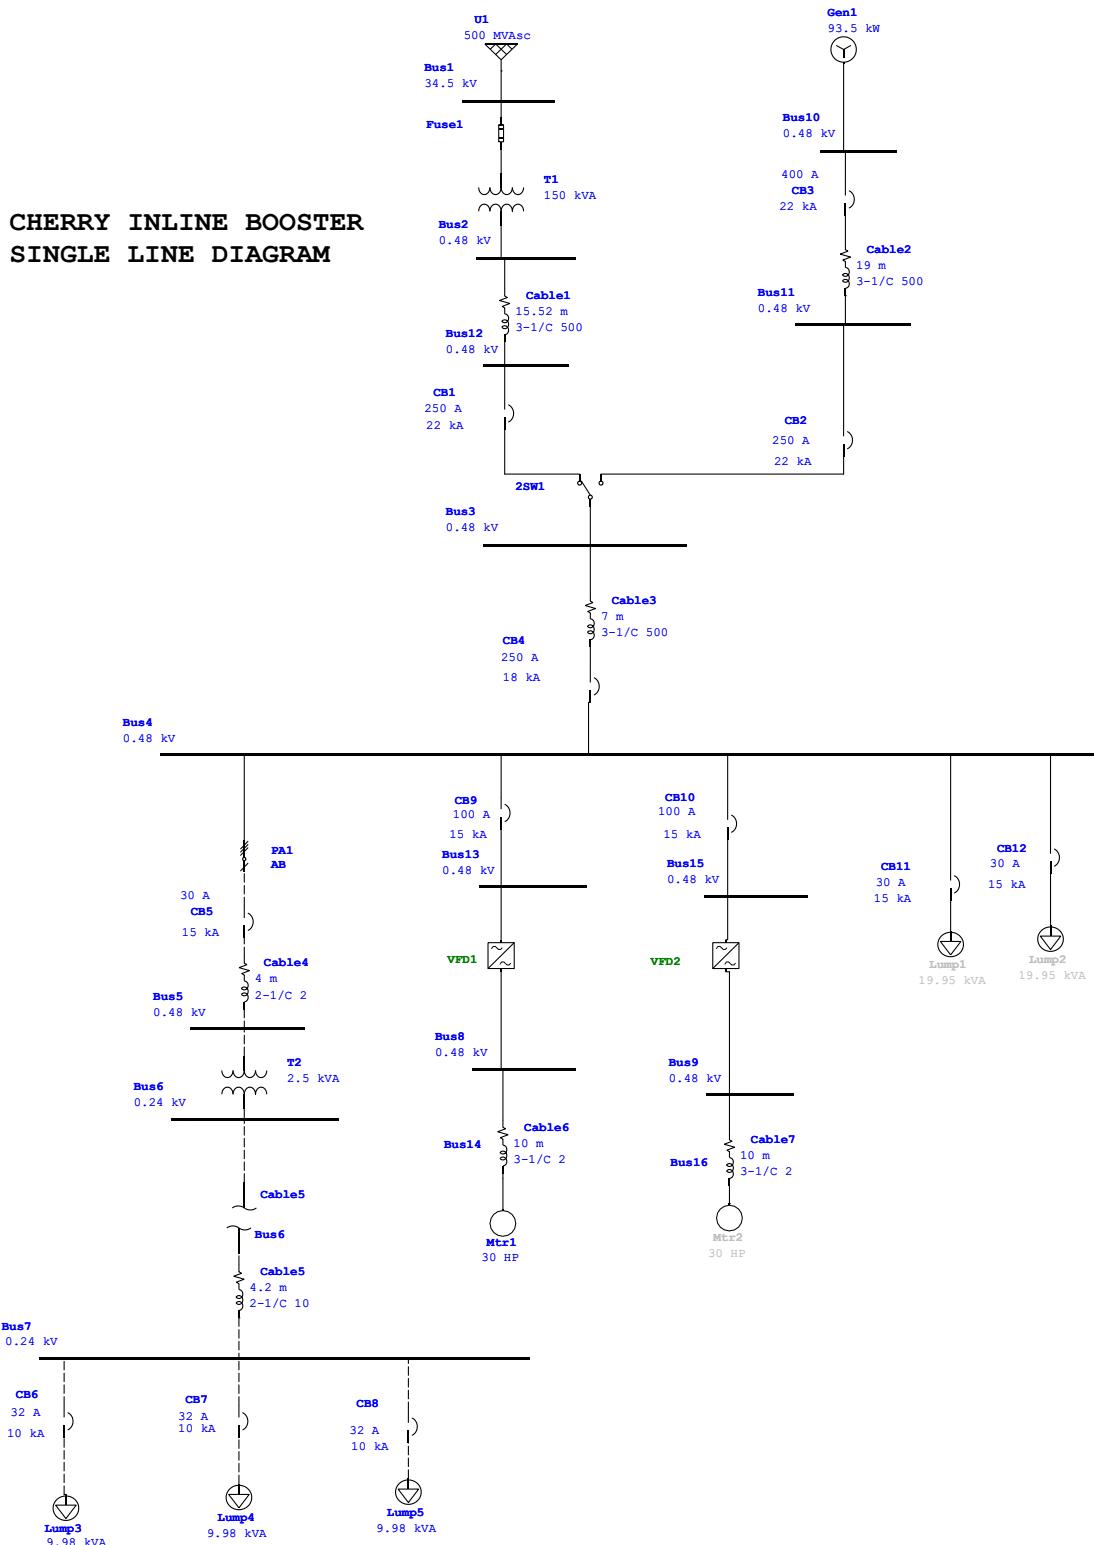
Figure 4.22: Single line diagram

Figure 4.22 shows the SLD with values associated with each nodes and links.

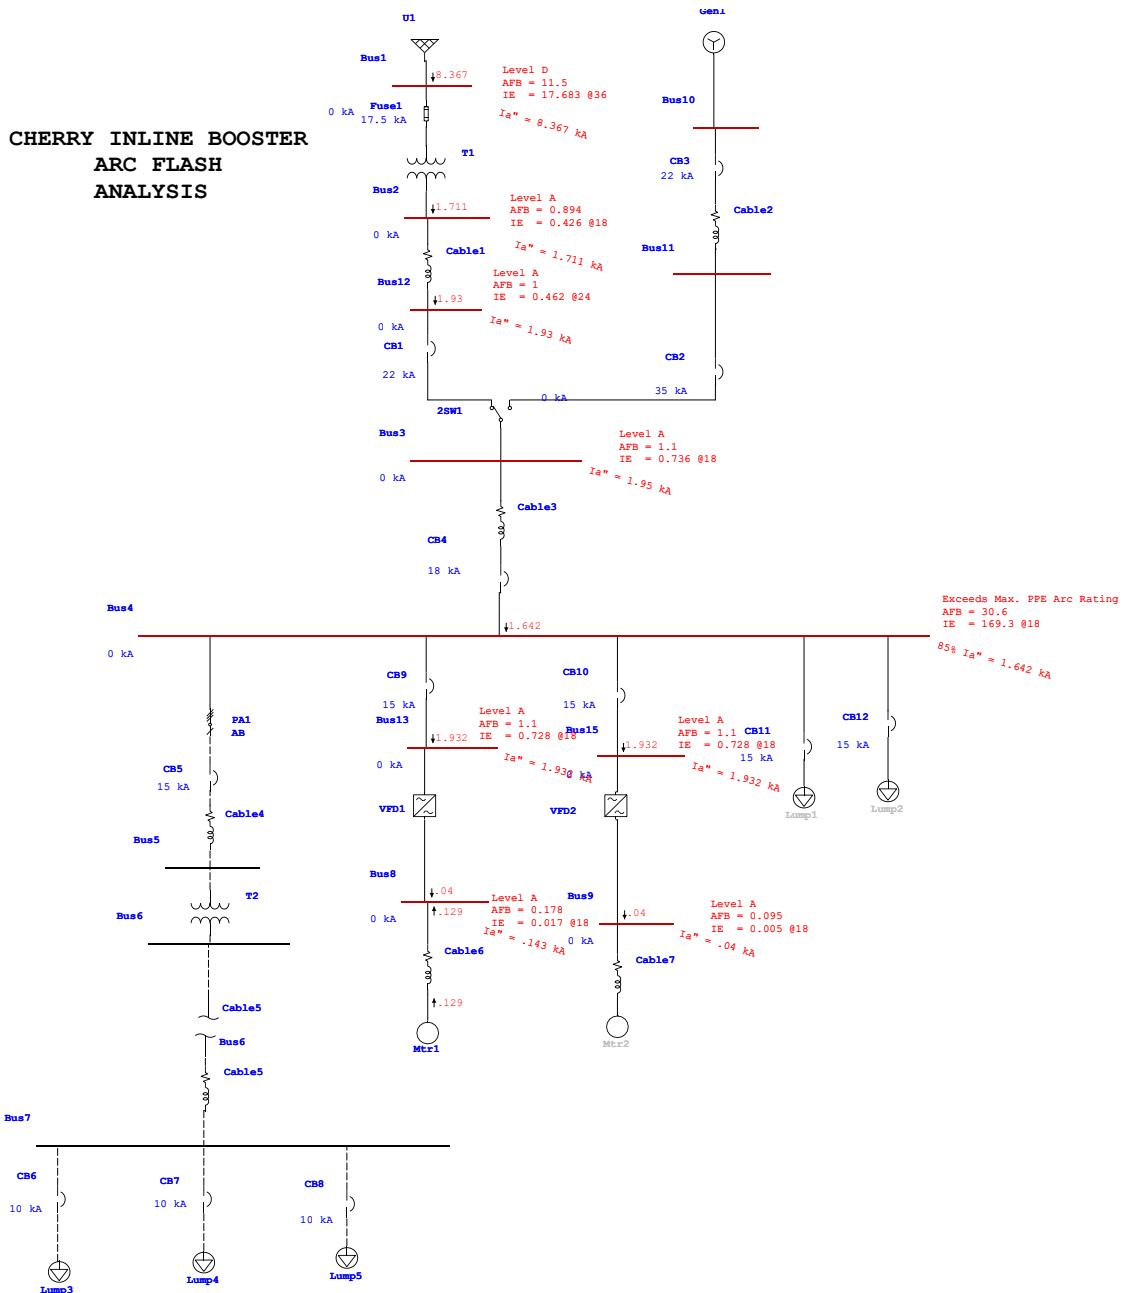
Figure 4.23: ARC flash analysis

Bus			Total Fault Current (kA)		Arc-Flash Analysis Results			
ID	Nom. kV	Type	Bolted	Arcing	FCT (cycles)	Incident E (cal/cm²)	AFB (ft)	Energy Level
# Bus1	34.500	Open Air	8.367	8.367	6.000	17.683	11.54	Level D
Bus2	0.480	Open Air	2.479	1.711	6.000	0.426	0.89	Level A
Bus3	0.480	MCC	2.418	1.950	6.000	0.736	1.11	Level A
Bus4	0.480	MCC	2.391	1.642	1662.737	169.313	30.61	>Max.
# Bus8	0.480	MCC	0.143	0.143	6.000	0.017	0.18	Level A
# Bus9	0.480	MCC	0.040	0.040	6.000	0.005	0.09	Level A
Bus12	0.480	Switchboard	2.418	1.930	6.000	0.462	1.05	Level A
Bus13	0.480	MCC	2.391	1.932	6.000	0.728	1.11	Level A
# Bus14	0.480	Other	0.144	0.144				
Bus15	0.480	MCC	2.391	1.932	6.000	0.728	1.11	Level A
# Bus16	0.480	Other	0.040	0.040

An Arc flash label (refer to Figure 4.24) should be placed on the MCC as per requirement of the Philippine Electrical code.
