Bathroom 1.20 — section along the door wall
vertical ×10, horizontal true
RD Šíma 1.NP

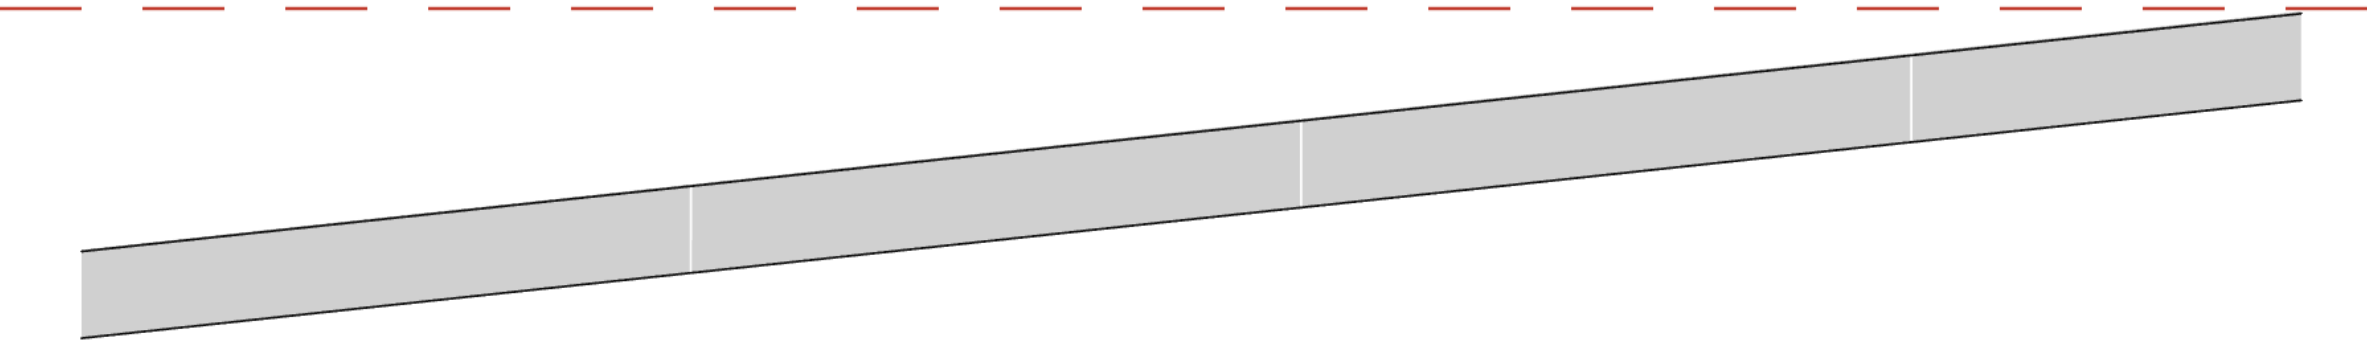
1.0735% east-west, door leaf fall 9.662 mm / 900 mm

west -23.847 mm

elevation 0, unsloped floor

east -0.498 mm

tile 8.5 mm; screed thickness not measured
