Bathroom 1.20 — section along the door wall
vertical ×10, horizontal true
RD Šíma 1.NP

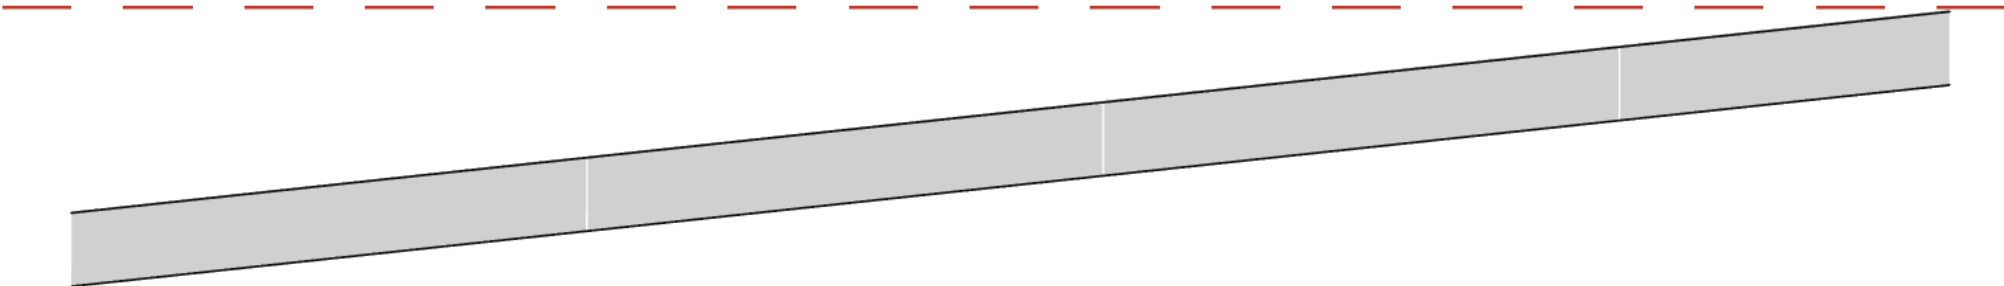
1.0735% east-west
door leaf fall 9.662 mm / 900 mm

west -23.847 mm

elevation 0, unsloped floor

east -0.498 mm

tile 8.5 mm; screed thickness not measured
