Nebula Vision Inspection

Place one 150 mm end-to-end ruler flat beside one mechanical component. Photograph from directly above.

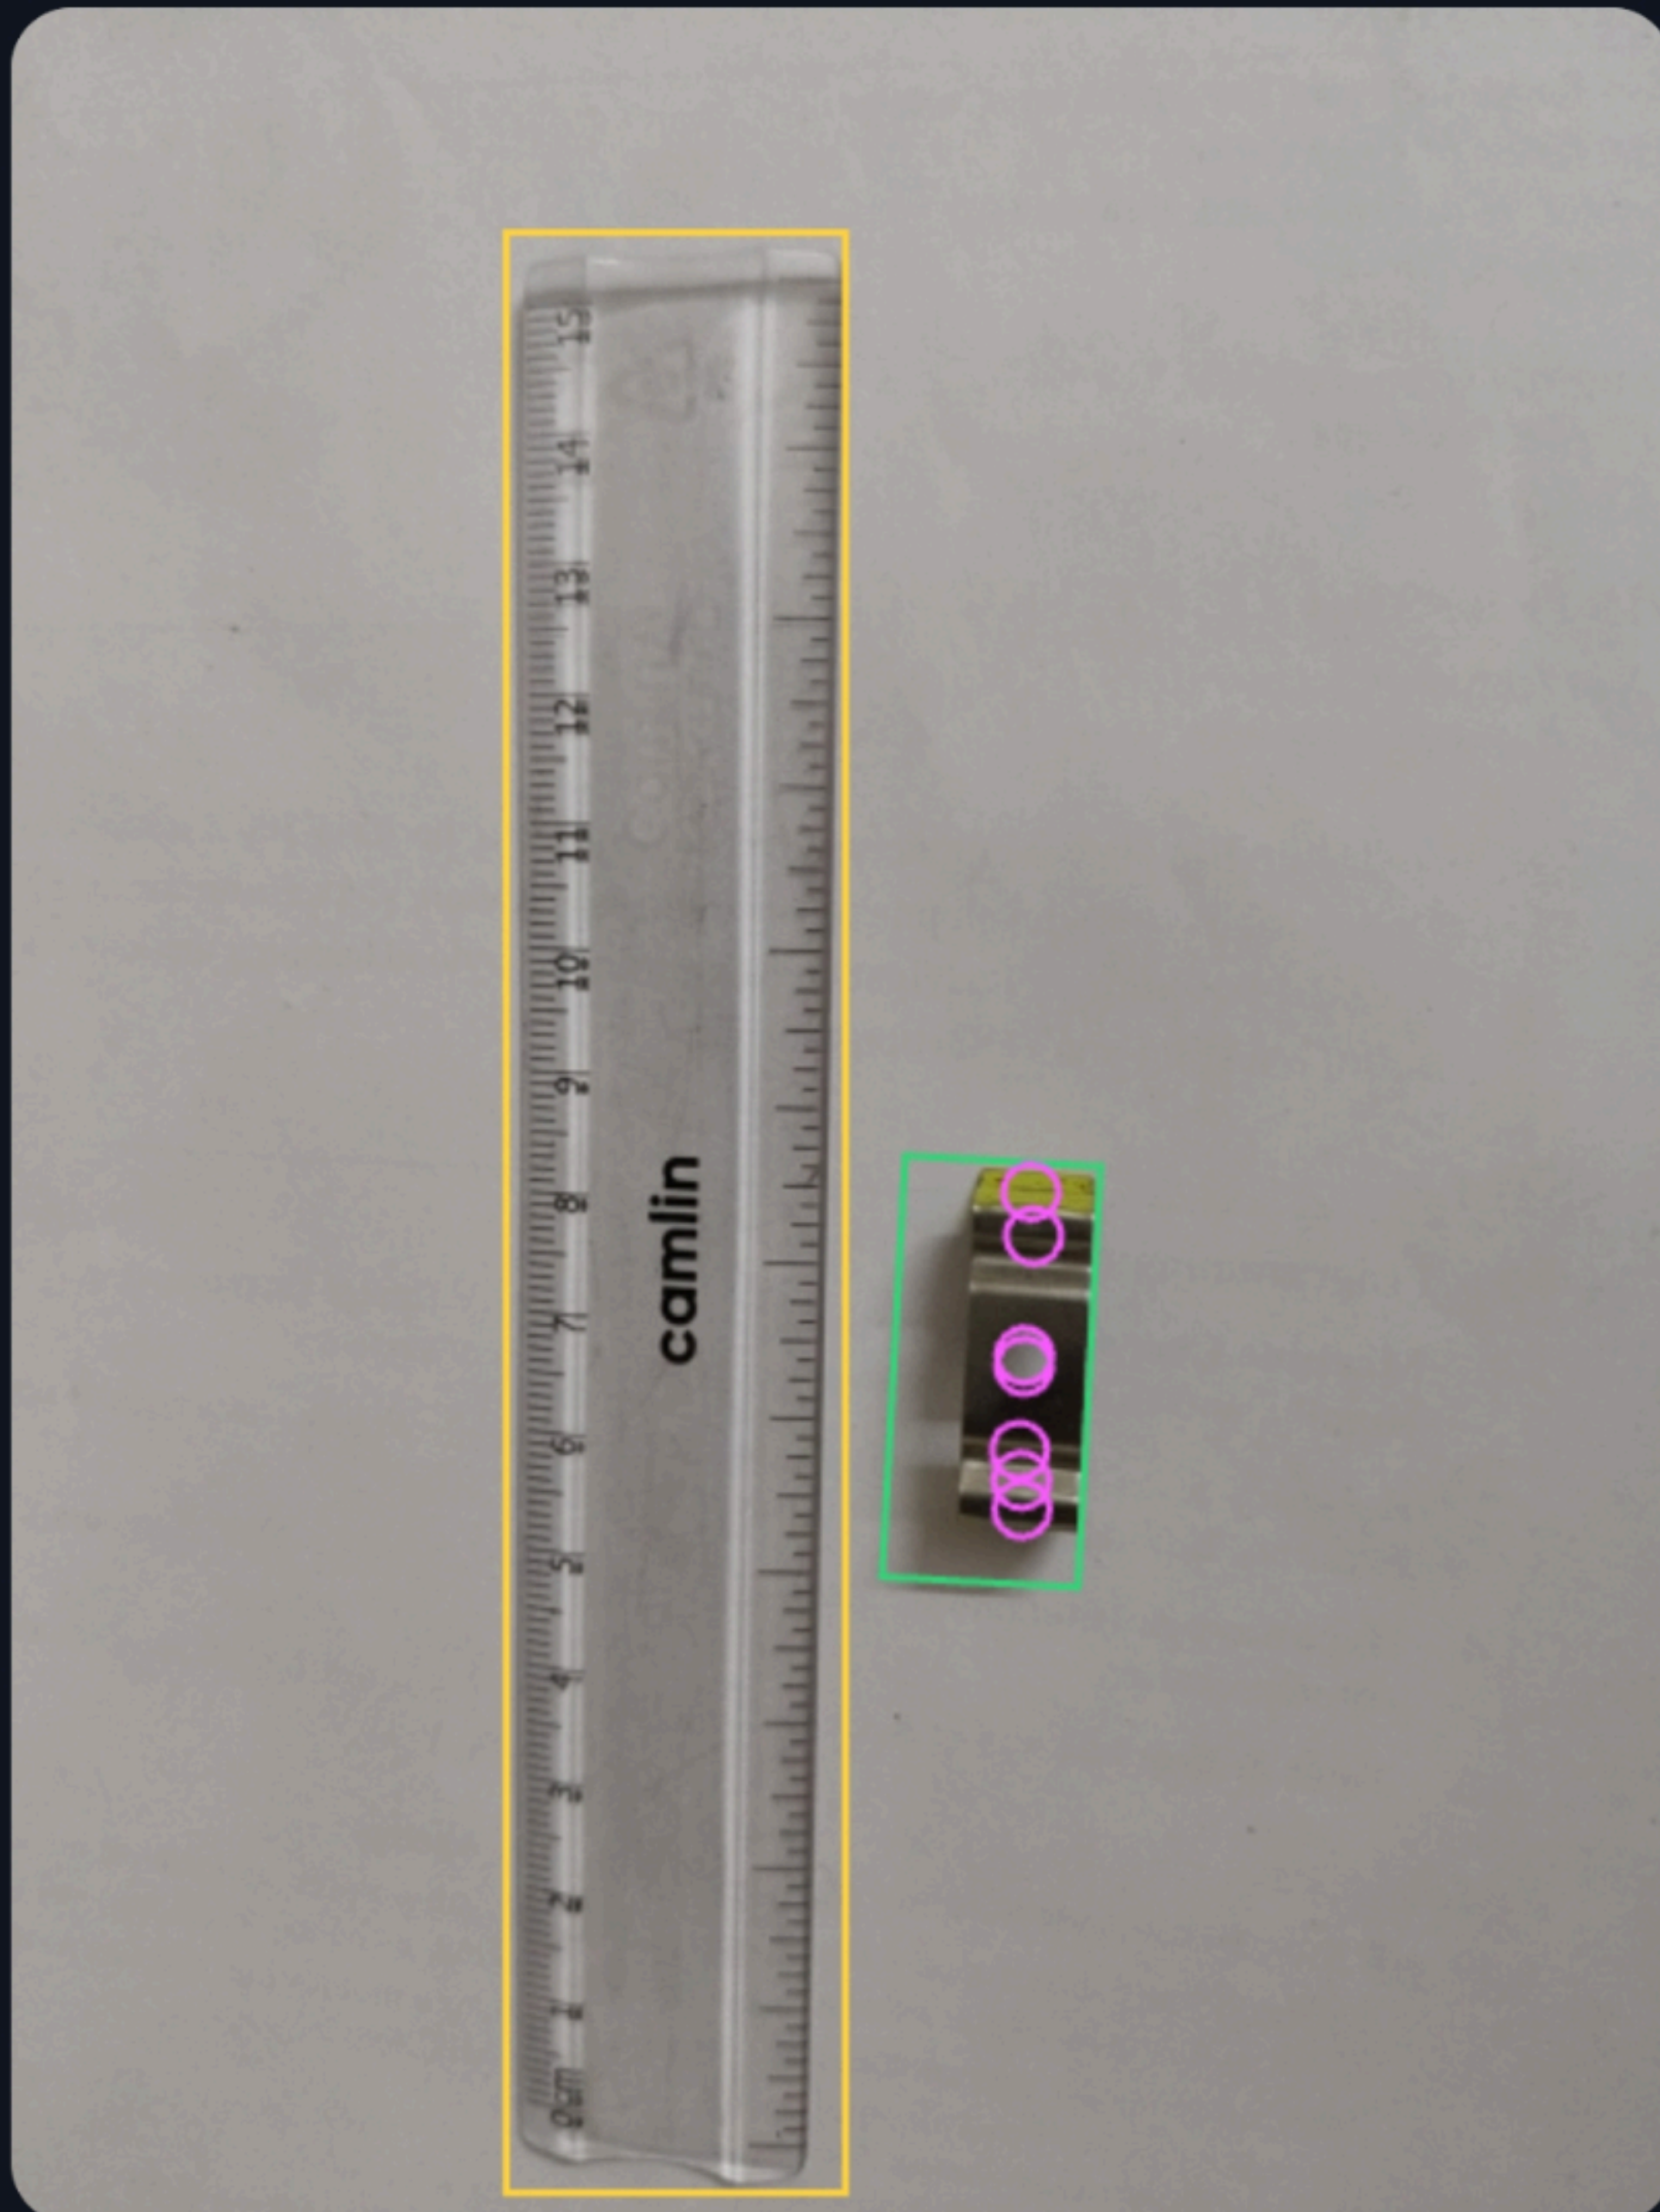
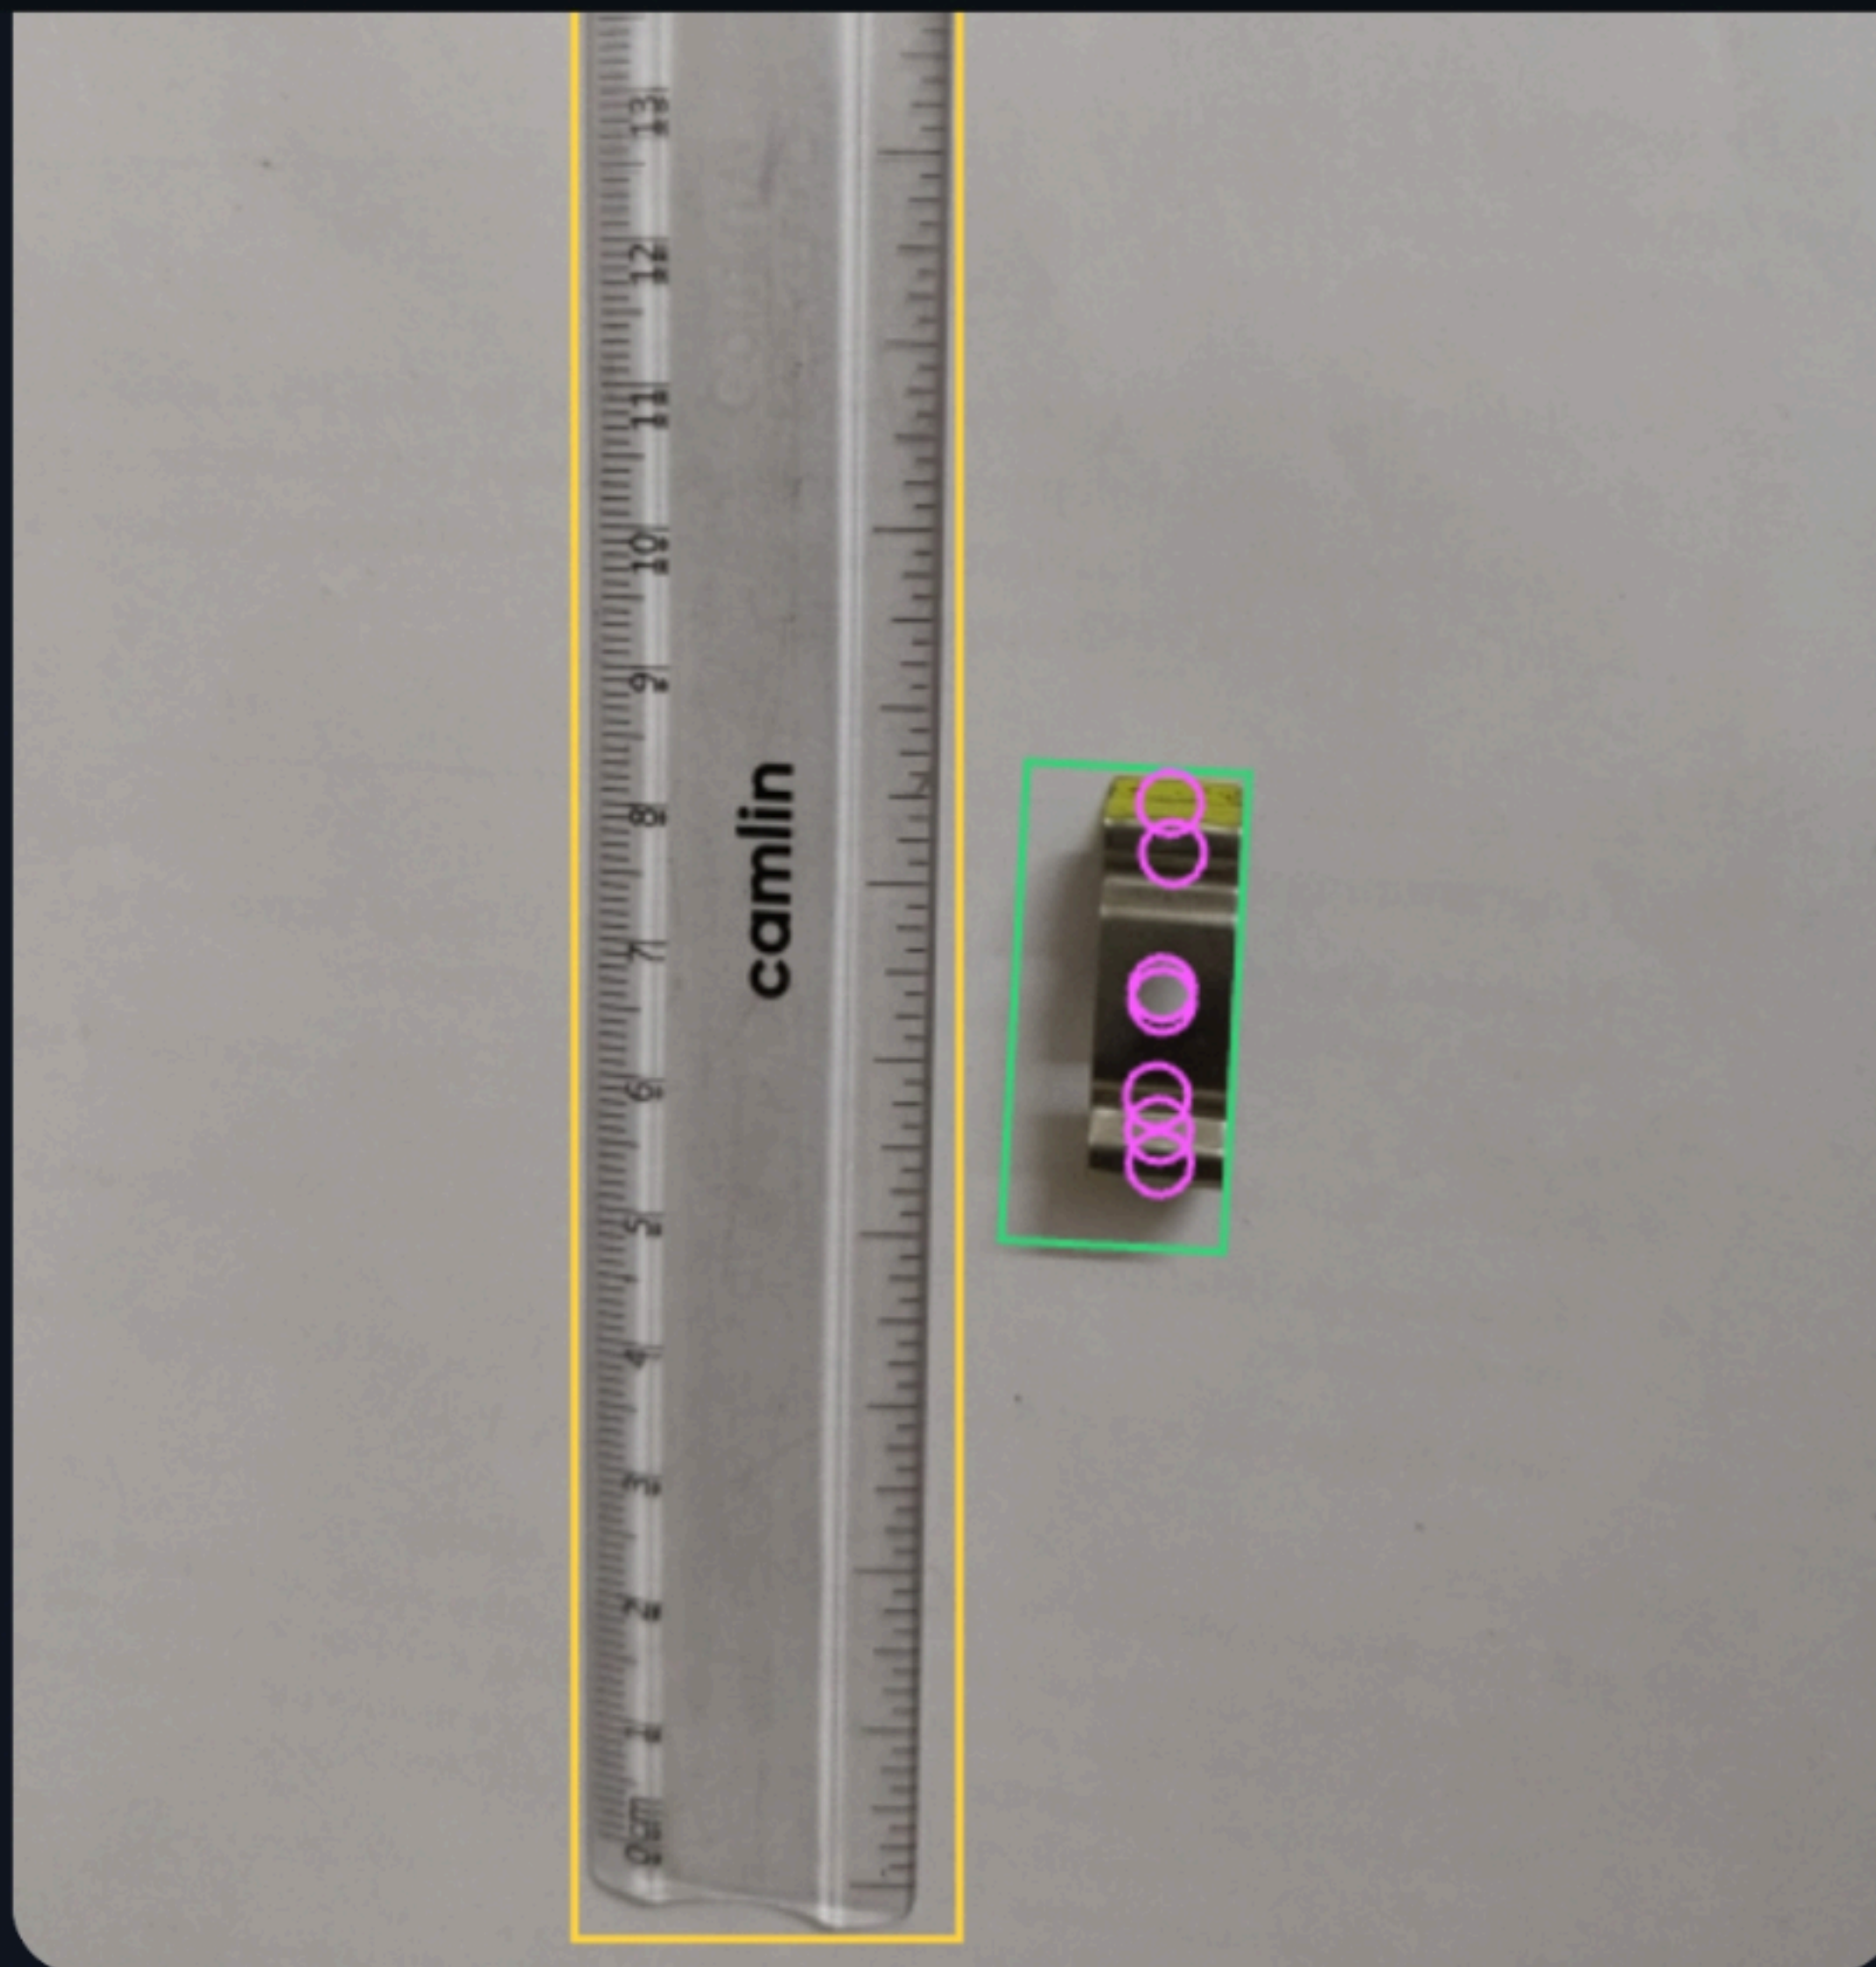
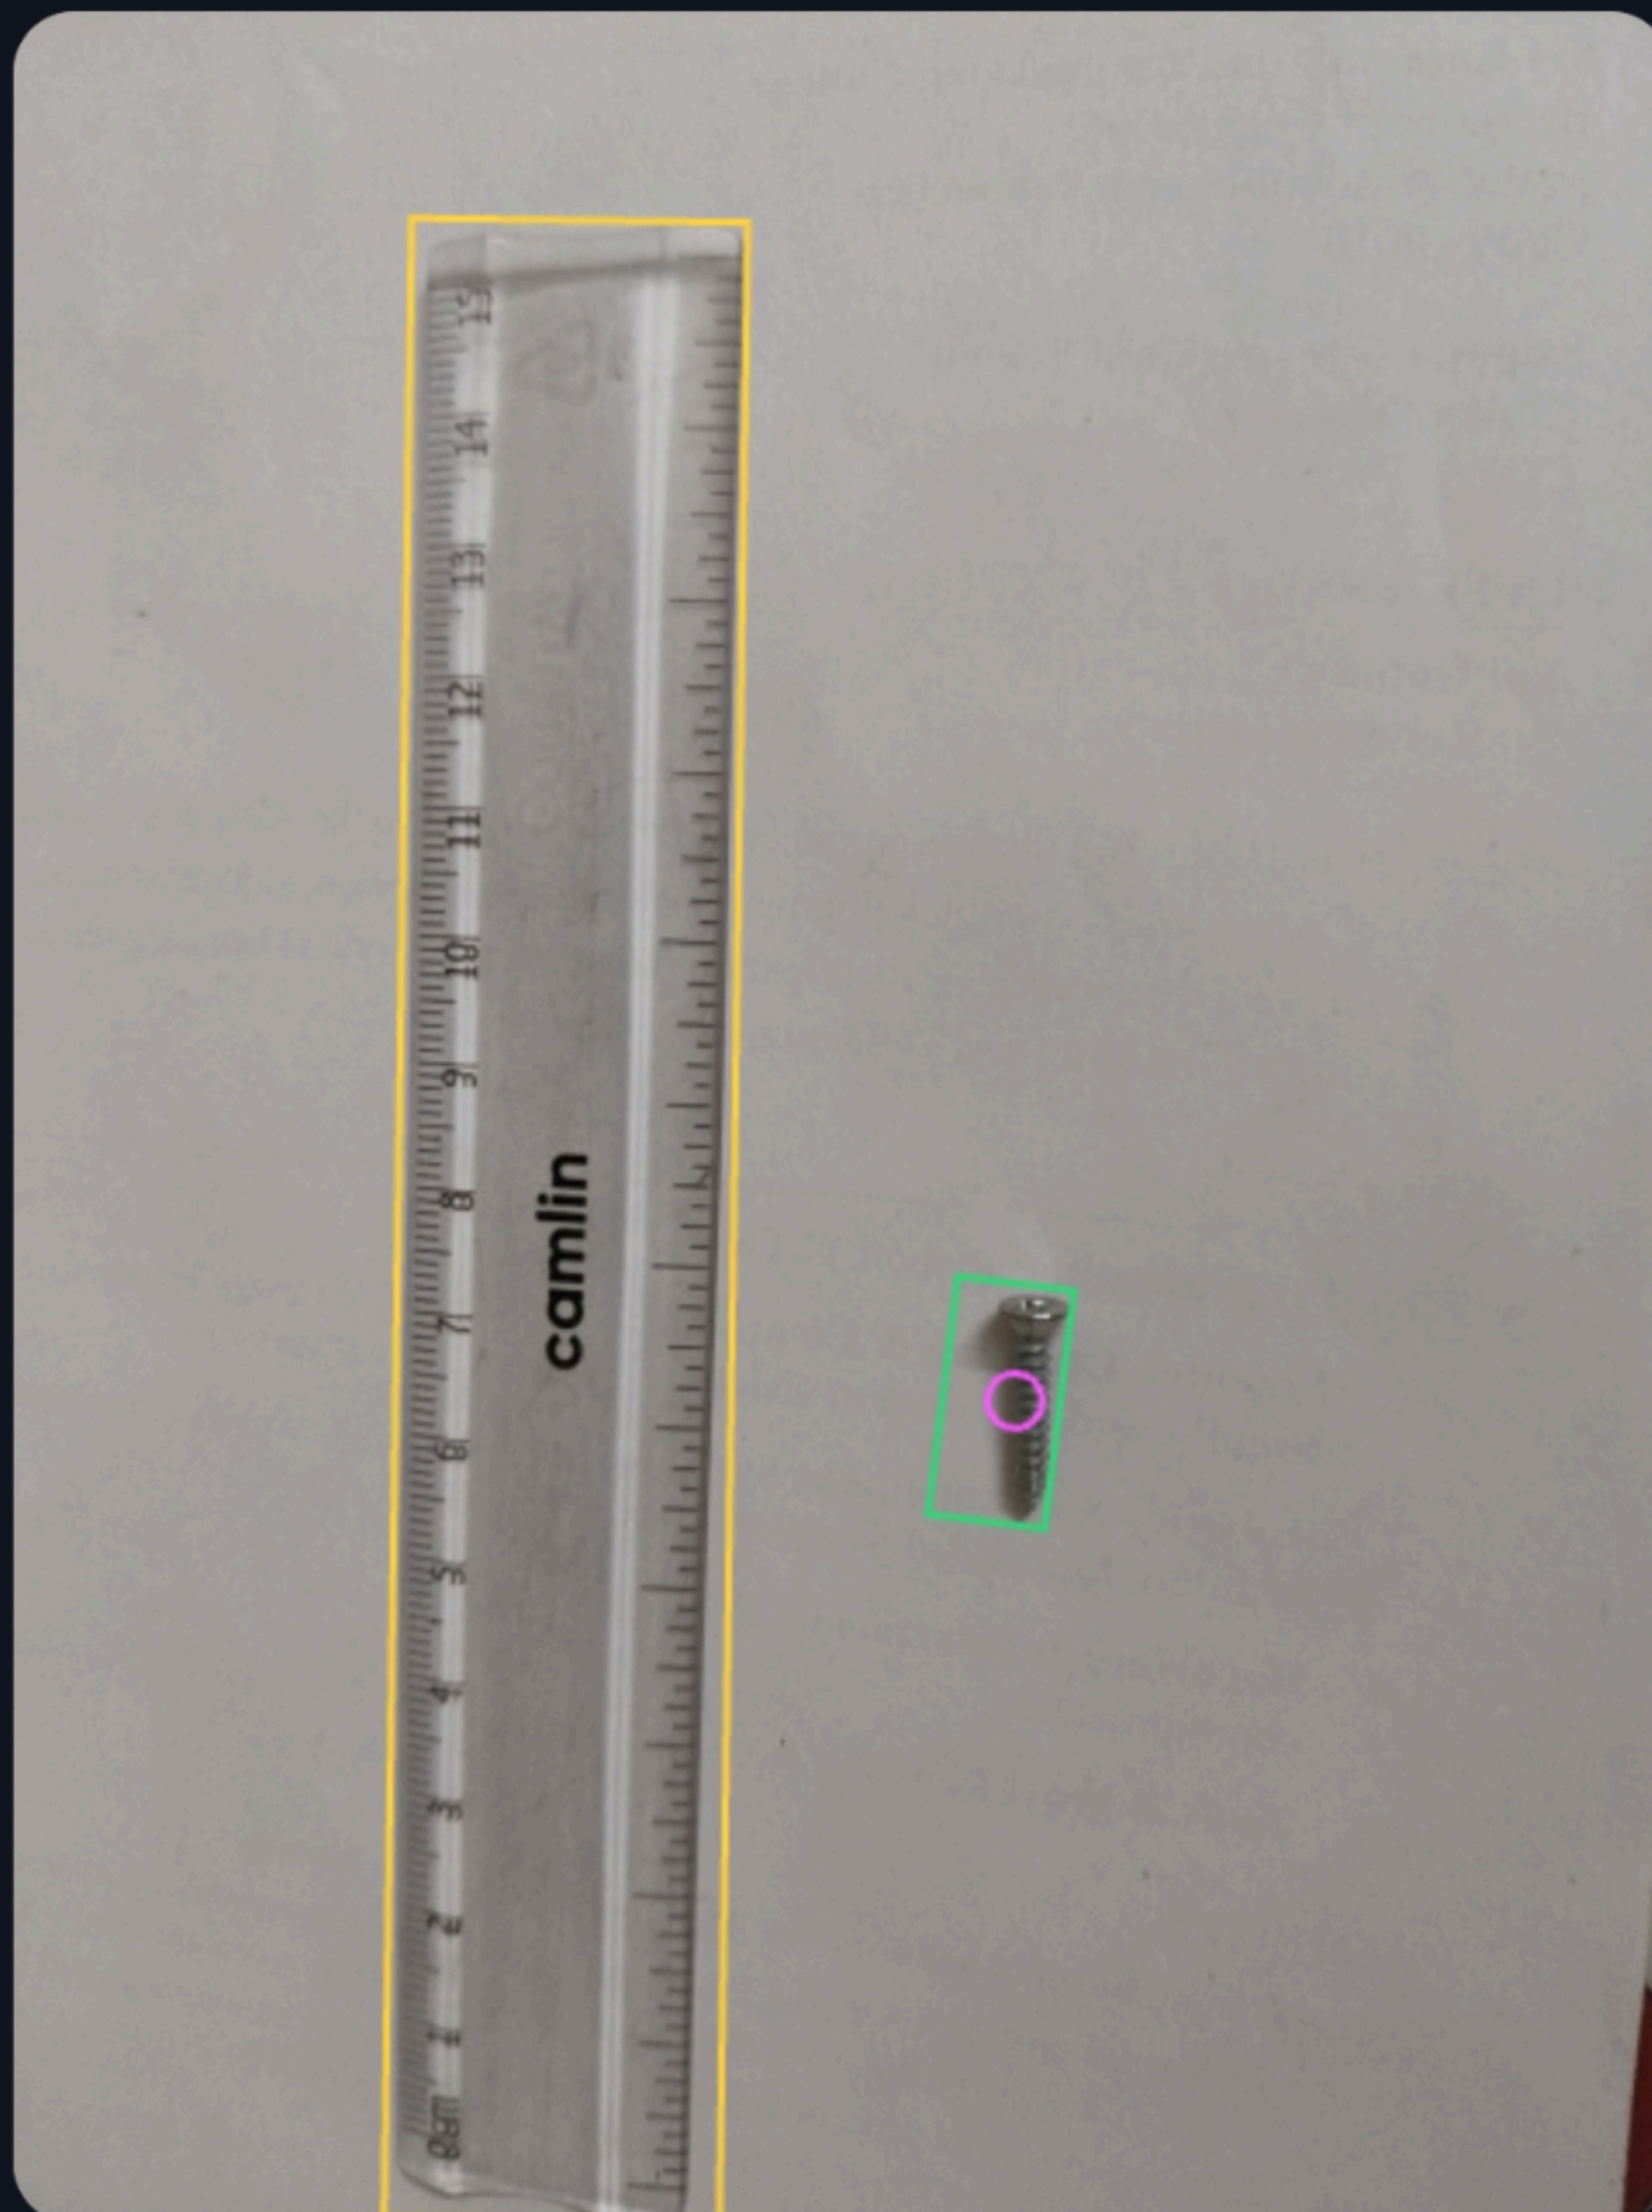
Component: mounting bracket (AI confidence 0.9%)

Measured length x width: 32.27 x 14.99 mm

Hole-to-hole: 11.79 mm

Defects: none flagged

Verdict: REVIEW

No complete dimensional tolerance was supplied; automatic PASS is disabled.

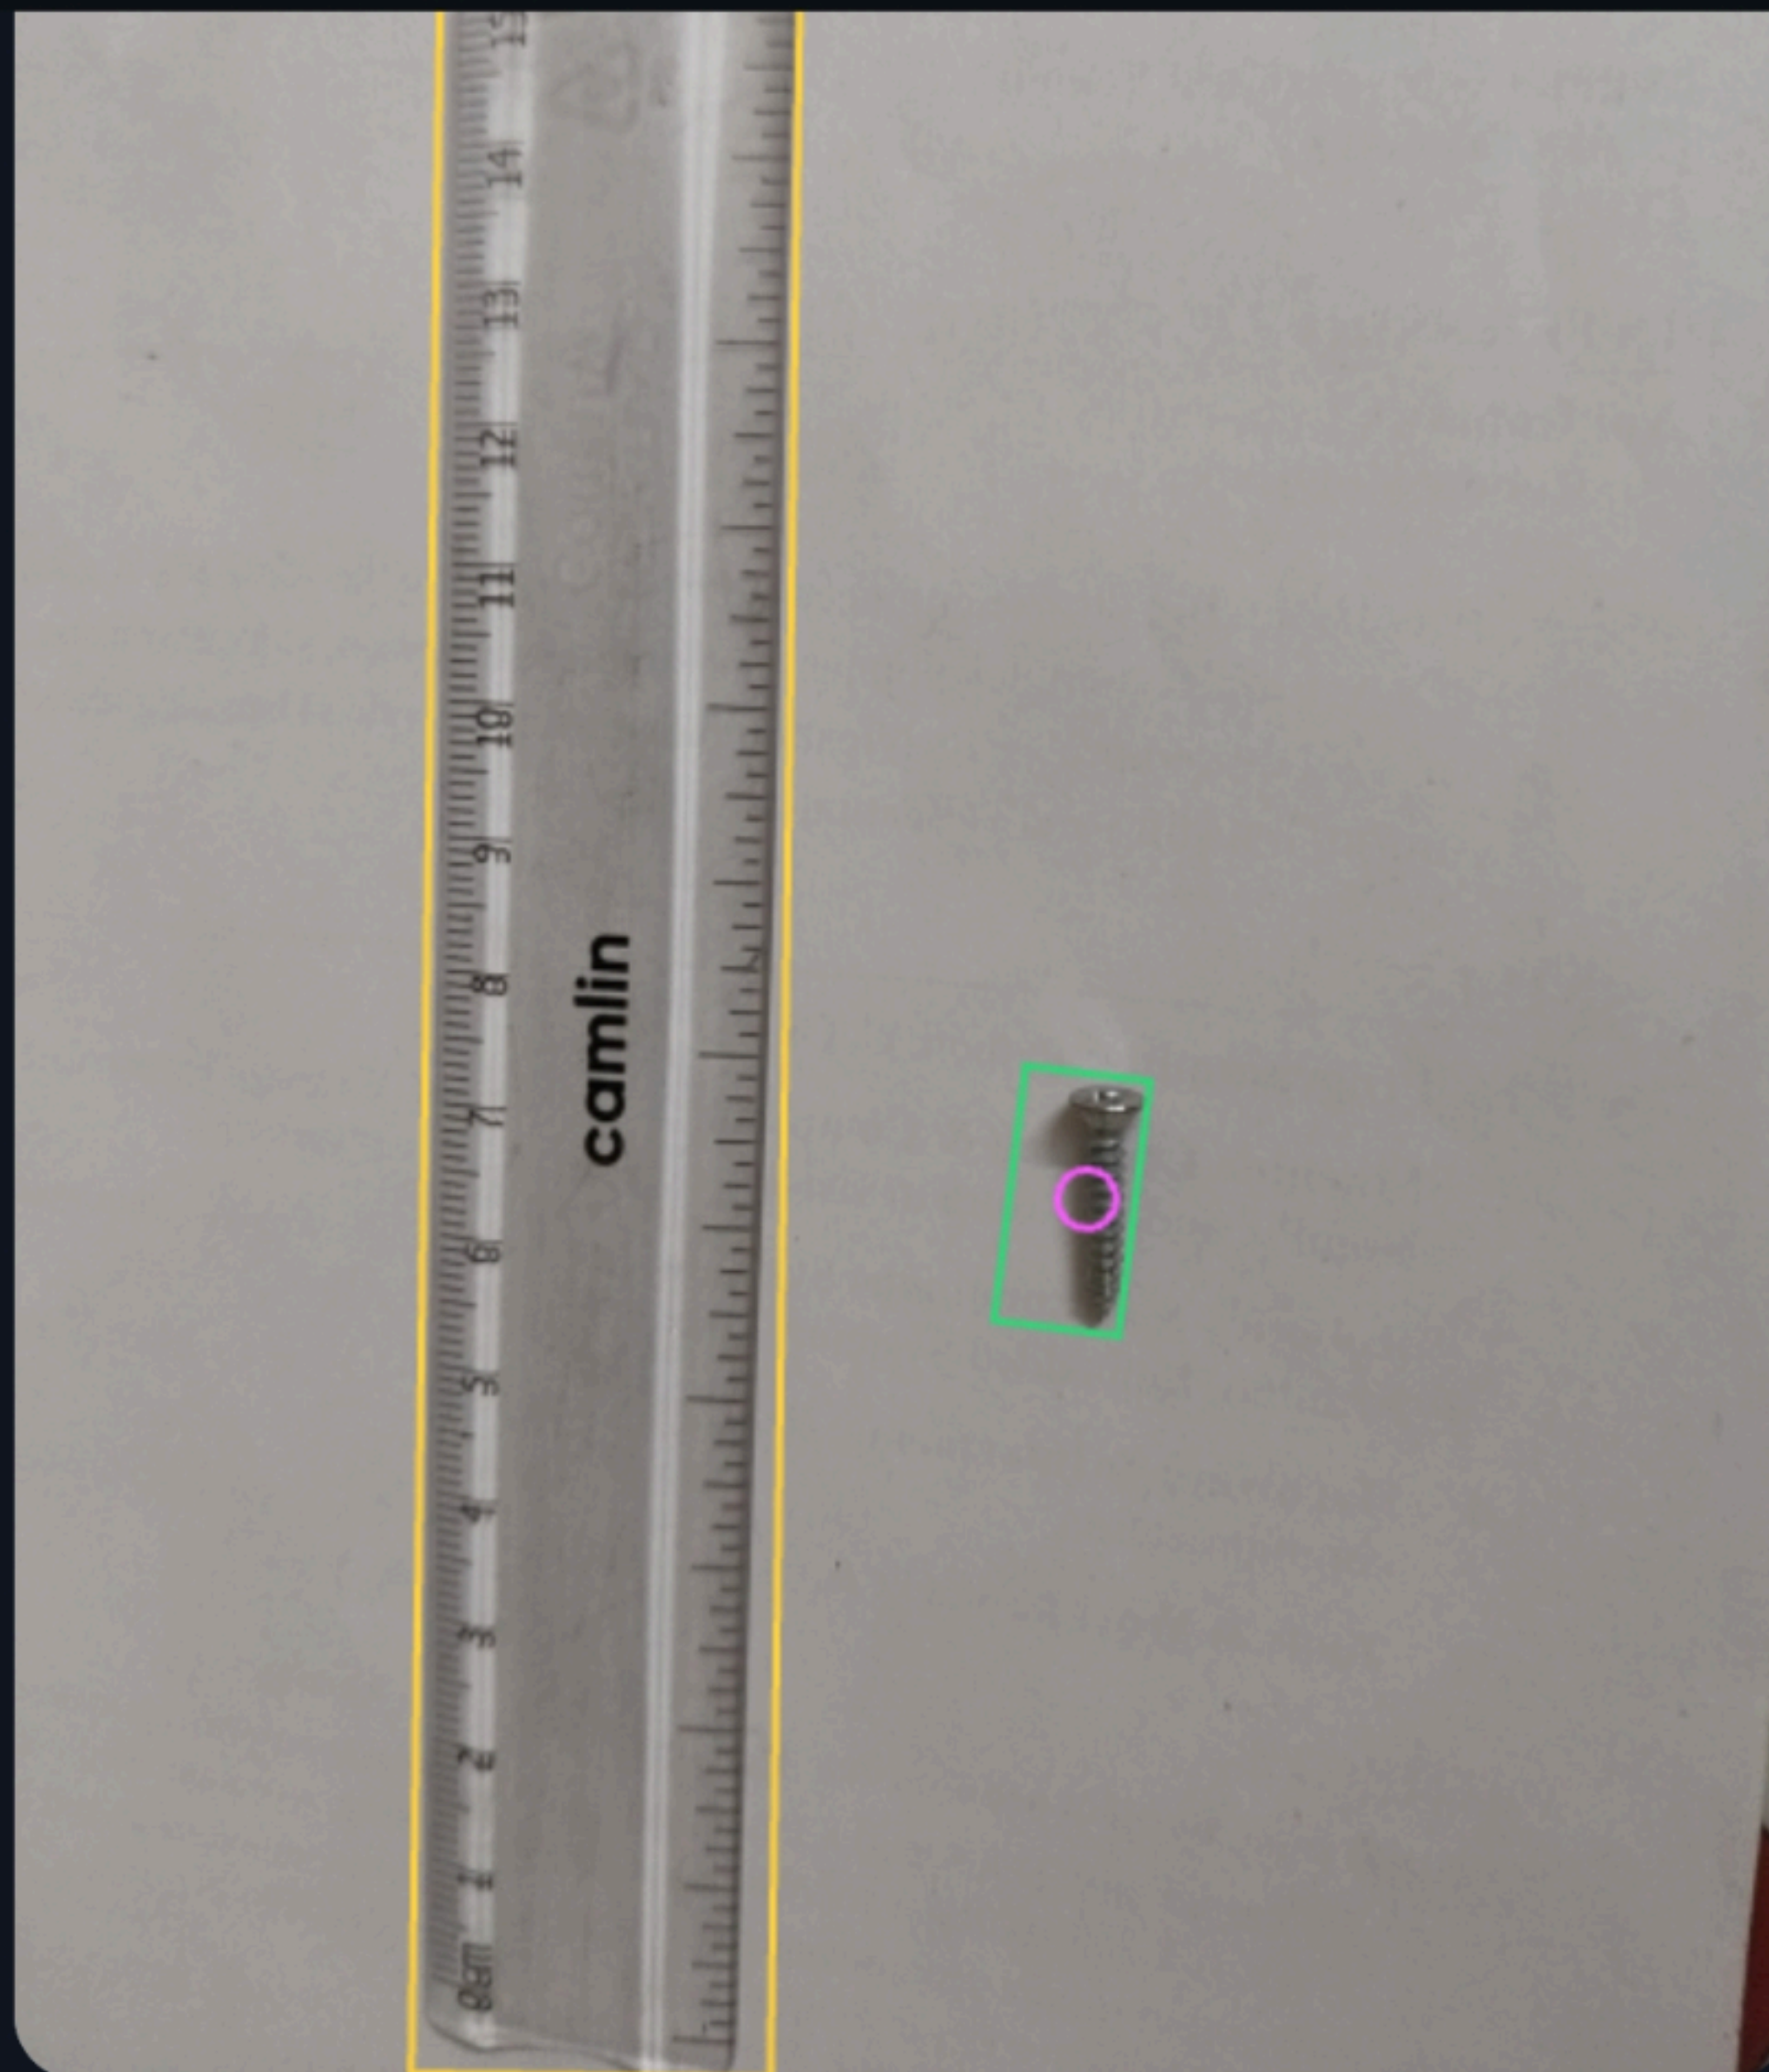
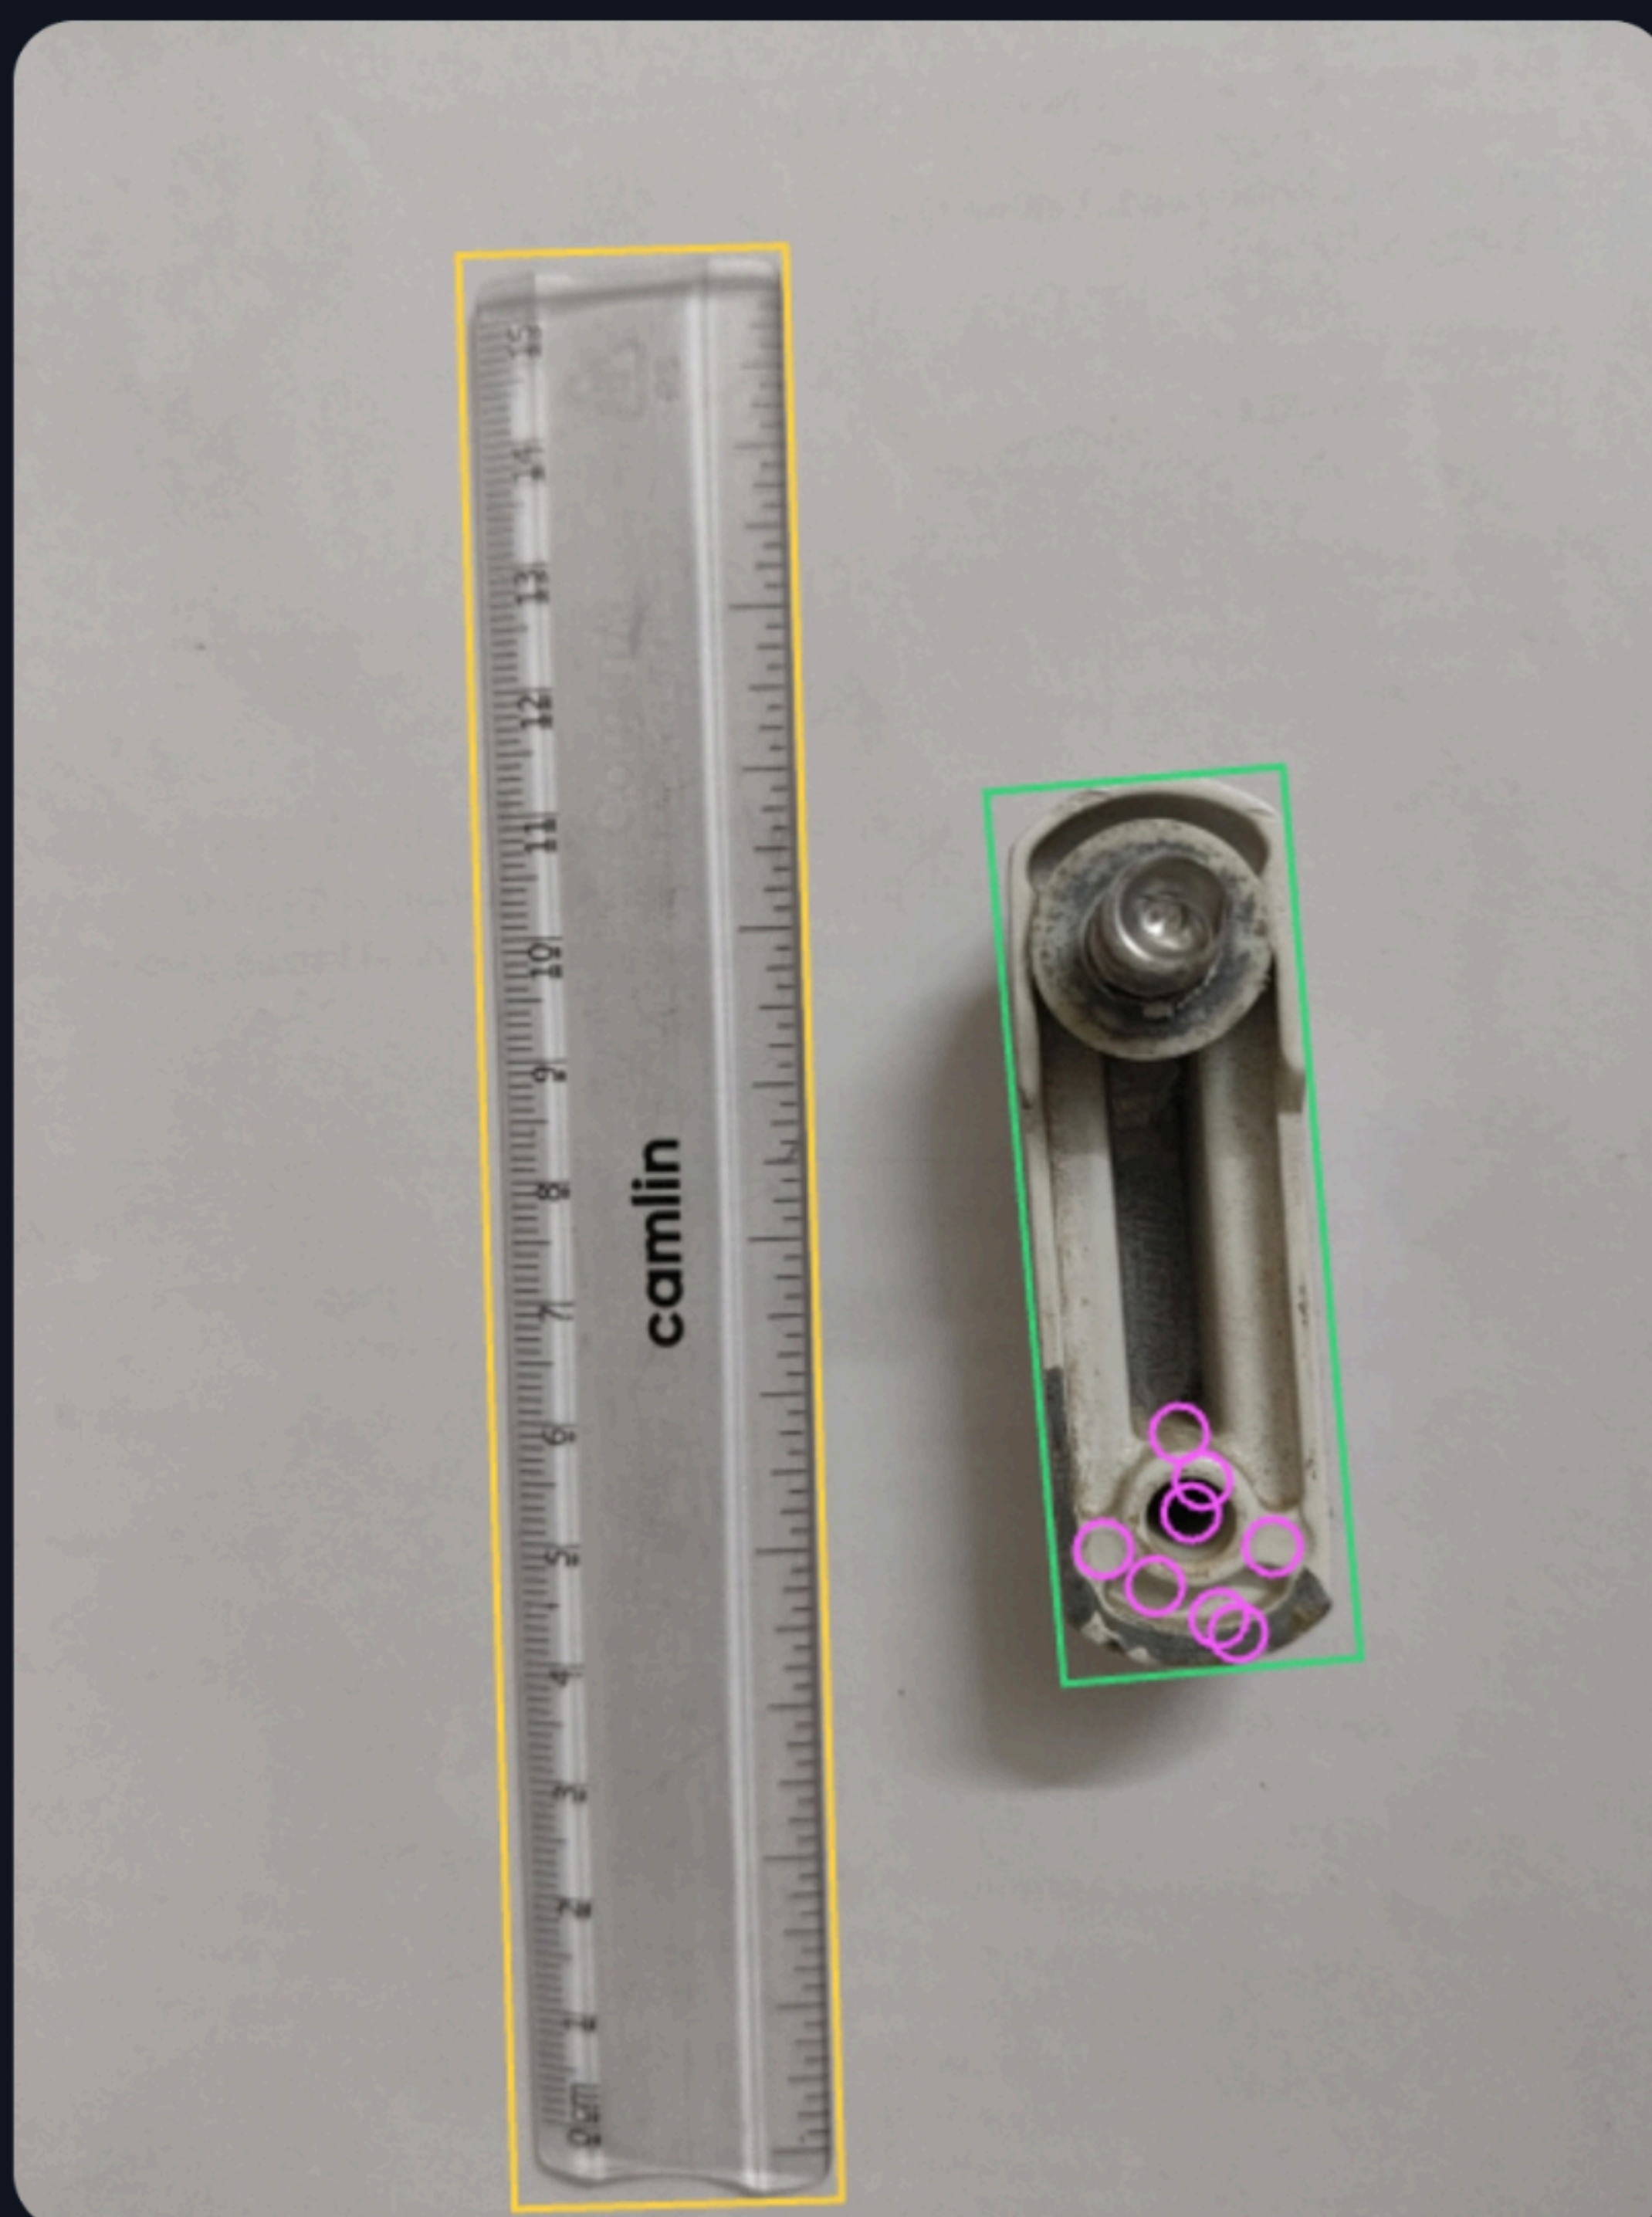
Component: screw (AI confidence 0.95%)

Measured length x width: 17.98 x 8.78 mm

Defects: none flagged

Verdict: REVIEW

No complete dimensional tolerance was
supplied; automatic PASS is disabled.
