Element evidence and reconciliation packet

Northbank Research Center · Level 02 · Ductwork · East wing · supply air

RFI: Confirm terminal clearance and inspection requirements

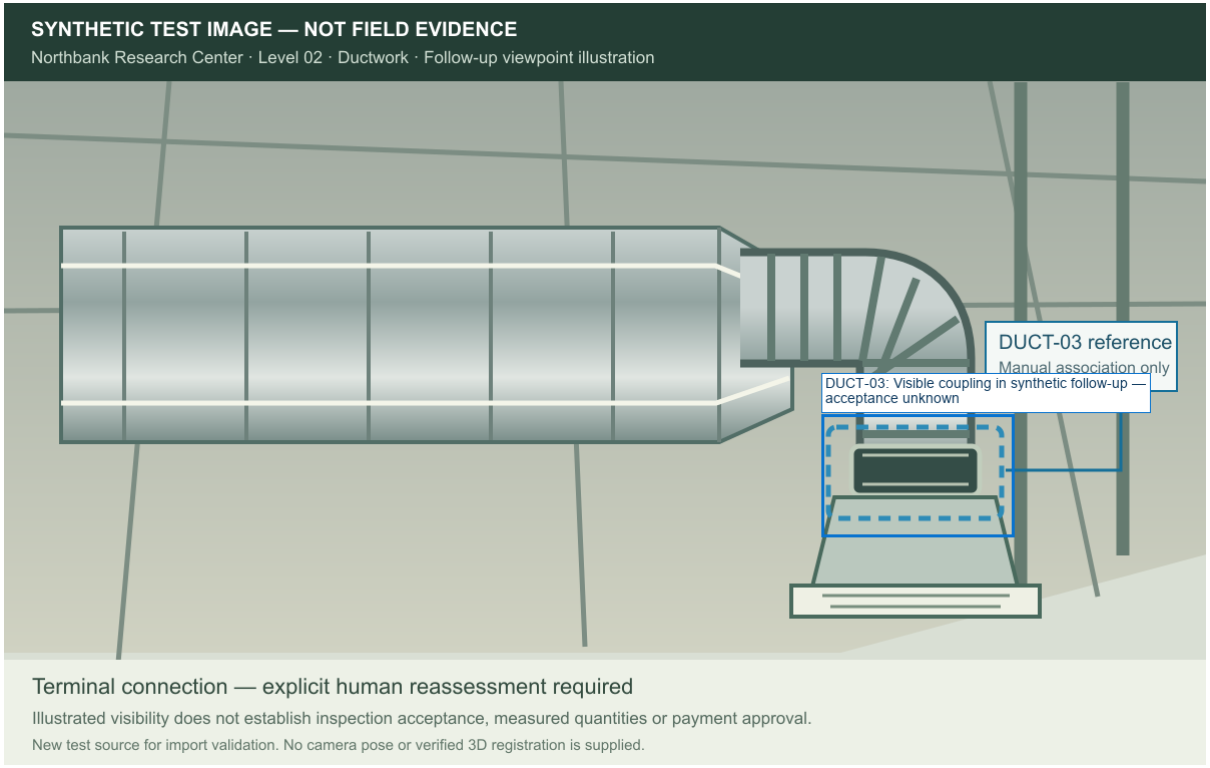
Synthetic acceptance example: the October 8 connection was obscured. The October 18 imported test view now shows the coupling, but clearance criteria, hidden fixings and inspection acceptance remain unverified. Selected original and follow-up findings are retained below.

Location Level 02 · East wing · DUCT-03 terminal · Requested action Confirm the required clearance, accepting inspector and inspection criteria before ceiling closure. Identify any additional evidence required; visible installation alone is not acceptance. · Proposed assignee MEP design coordinator — synthetic pilot

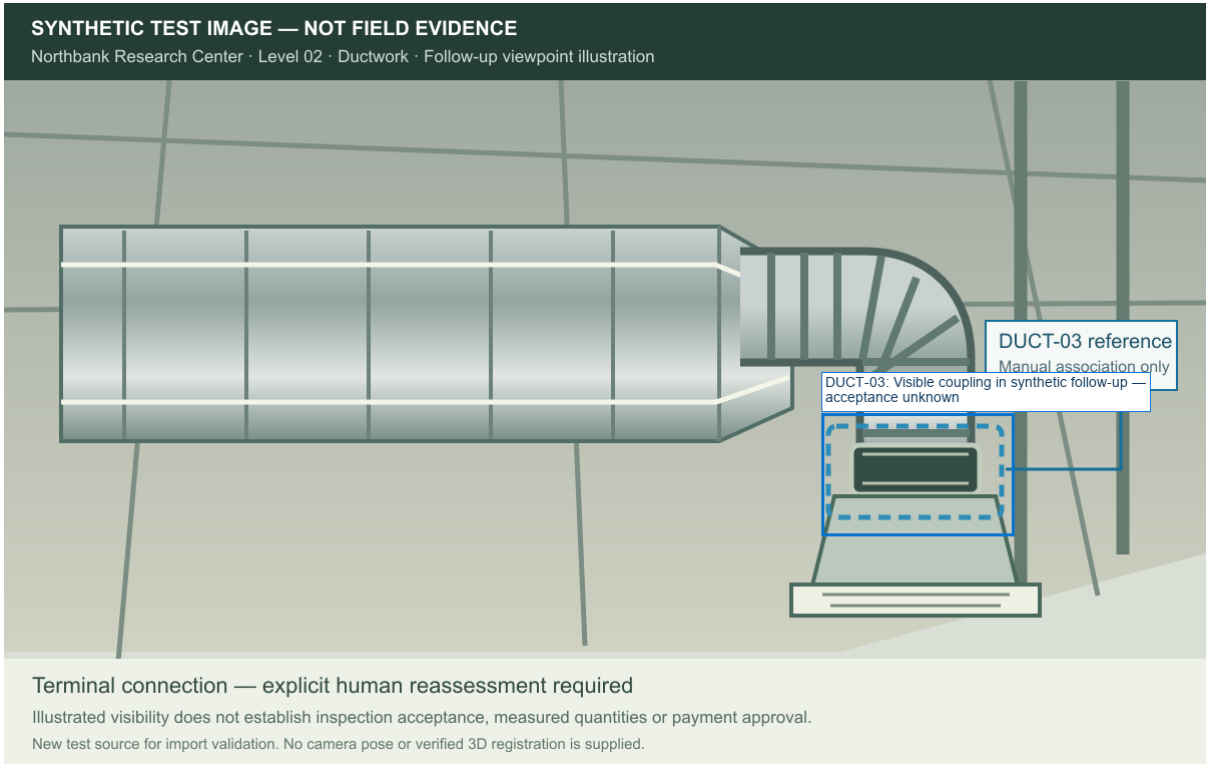
Synthetic test recapture · Terminal close-up · October 18

Acceptance example: the synthetic follow-up shows the terminal coupling and neck. This reviewer records observed installed for the illustrated element only; no inspection or quantity approval is inferred.
Uncertainty: Hidden fasteners, seal integrity and inspection acceptance are not established by this view. · Evidence quality: usable

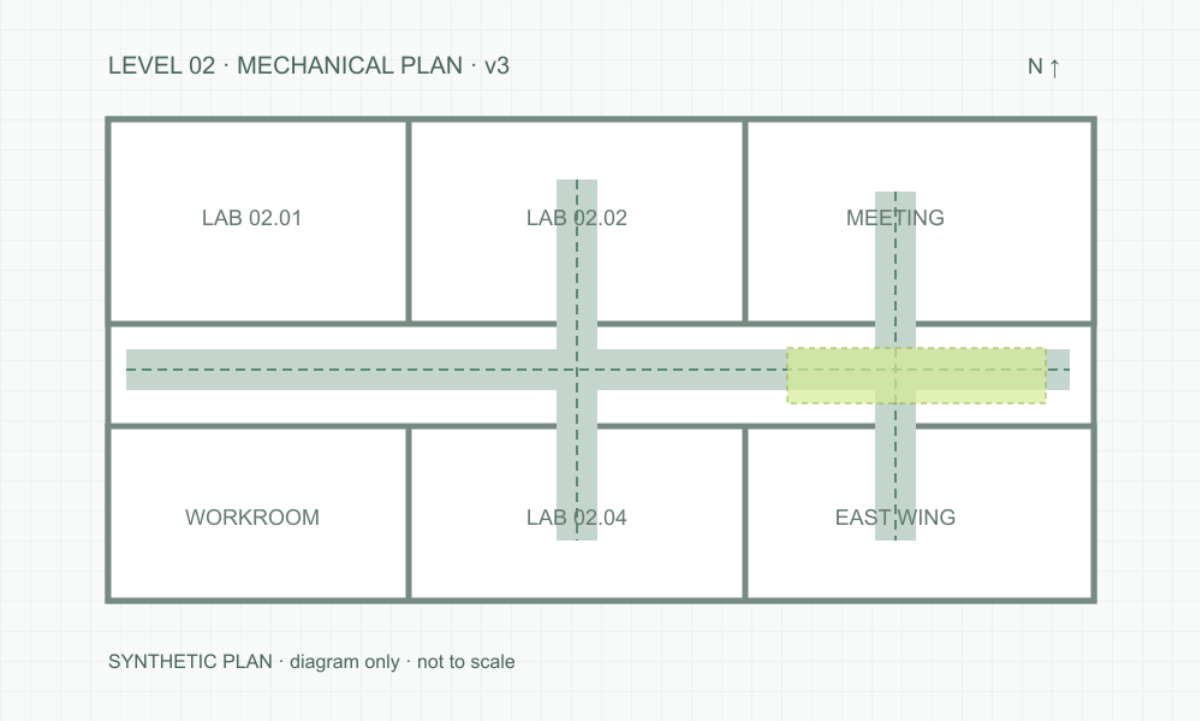
DUCT-03 · revision 1 · Observed installed

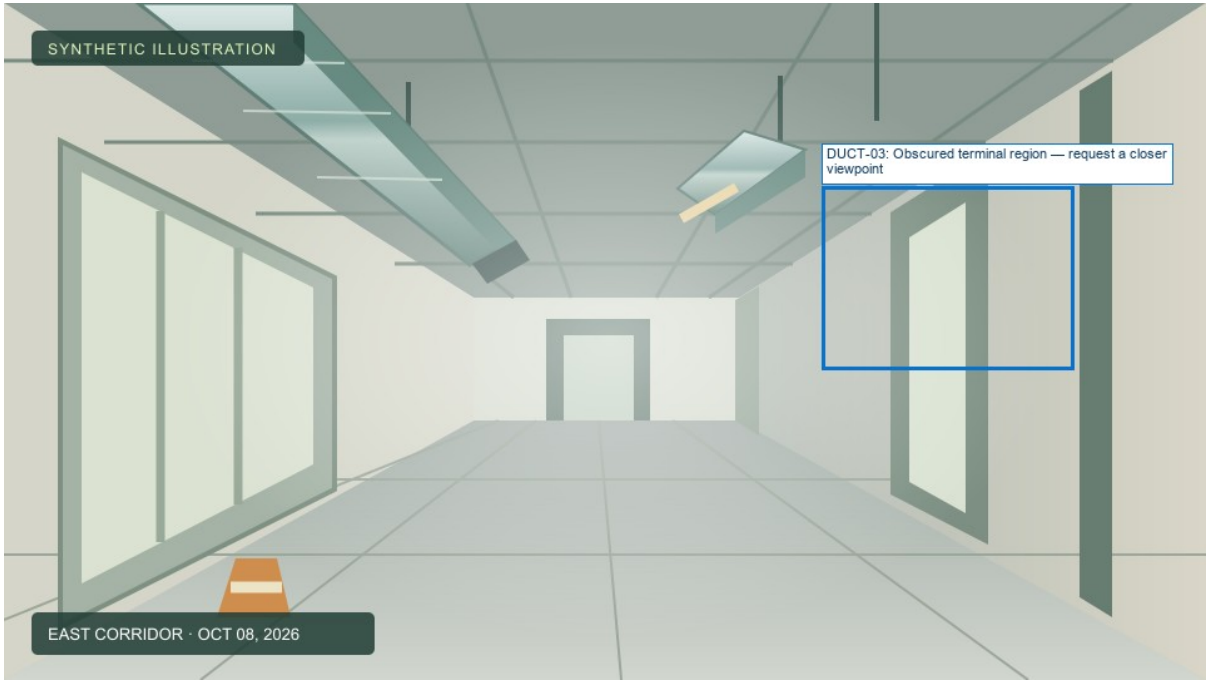
DUCT-01 · revision 1 · Observed installed

Acceptance example: the main supply duct is visible in the synthetic October 8 illustration. This bounded human observation does not measure quantity or establish

acceptance.
Uncertainty: None recorded · Evidence quality: usable
