HINDUSTAN PETROLEUM CORPORATION

COMPREHENSIVE JOURNEY RISK MANAGEMENT ANALYSIS REPORT

ROUTE ANALYSIS DETAILS

Analysis Date: June 09, 2025

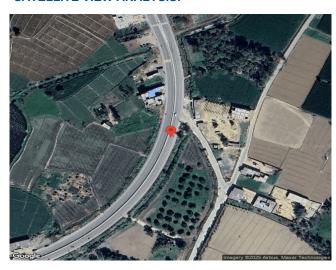
VISUAL EVIDENCE FOR TURN #7:

CRITICAL TURN #7: 75.7 deg - BLIND SPOT - HIGH RISK		
GPS Coordinates	29.625320, 77.439180	
Turn Angle	75.7 deg (Deviation from straight path)	
Risk Classification	BLIND SPOT - HIGH Risk Level	
Recommended Maximum Speed	25 km/h	
Safety Distance Required	Minimum 50m approach visibility	
Driver Action Required	Reduce speed, check mirrors, signal early	
Street View Images	1 images available	
Satellite Images	1 images available	
Total Visual Evidence	2 images for analysis

File: streetview_a3c3ec01-48e5-4165-afd4-942977ae3e5b_turn_7_h0.jpg

ROAD ANALYSIS:

* Turn angle: 75.7 degrees

* Visibility: Limited due to sharp curve

* Hazard level: HIGH * Max speed: 25 km/h
