JSTAN PETROLEUM CORPORATION LIM

COMPREHENSIVE JOURNEY RISK MANAGEMENT ANALYSIS REPORT

ROUTE ANALYSIS DETAILS

Analysis Date: June 09, 2025

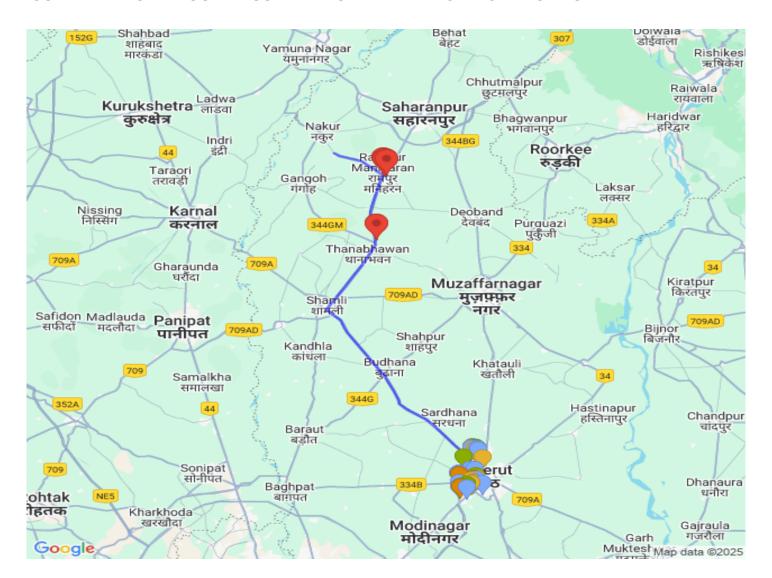
COMPREHENSIVE ROUTE VISUALIZATION WITH ALL CRITICAL POINTS
