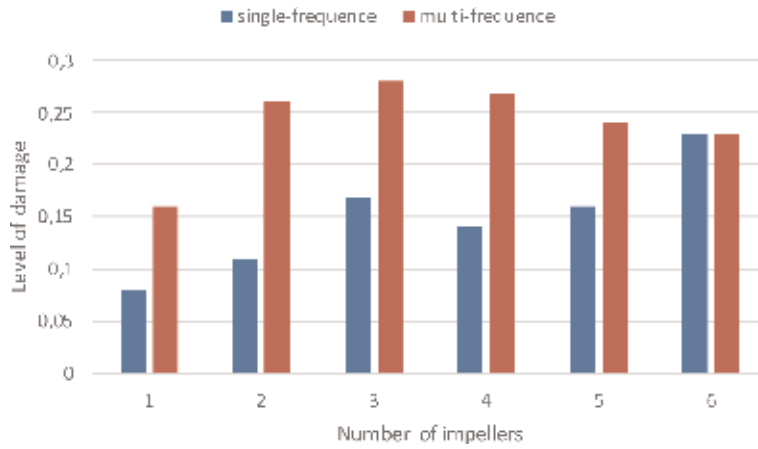
Figure 7.
Estimated cumulative damage for impeller blades.

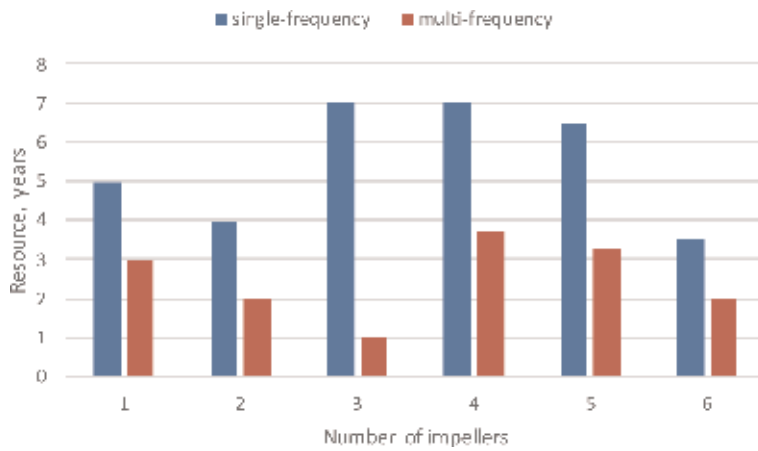
Figure 8.
Estimated residual life of impeller blades by the criterion of cracking.

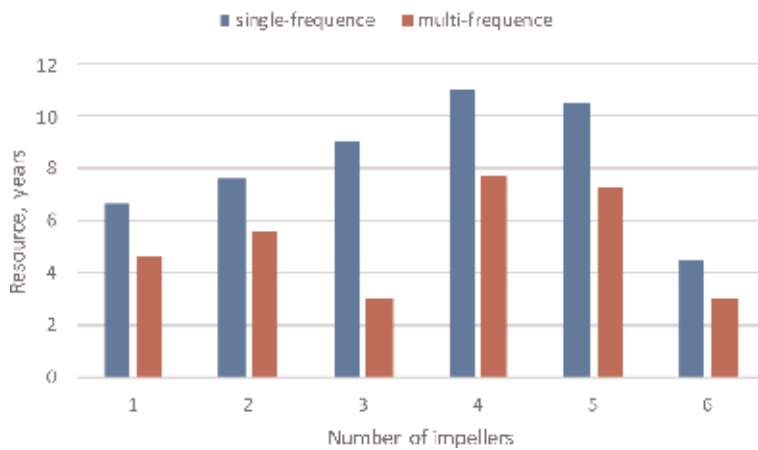
Figure 9.
Estimated residual life of impeller blades at the stage of crack development.
