VEHICLE INSPECTION REPORT

AI-Powered Body + Engine Sound Analysis · June 06, 2026 at 15:09
Physical Defect Detection (7-class YOLO + Severity Model) + Engine Knock Audio Classification

VIN / Registration	JTHBK1GG7R1234567	Mileage	45000
Make / Model	LEXUS LEXUS-SUV-TEST	Year	2024

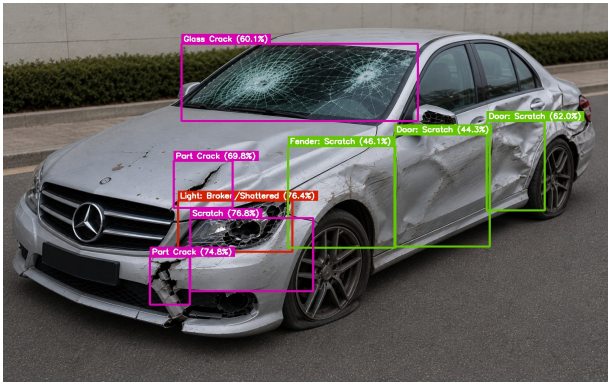
Annotated Images — Dual Model Detections

The inspection detected: Light — Lamp Crack, Door — Scratch, Fender — Scratch, Scratch, Part Crack, Glass Crack. Safety-critical damage identified on Light — Lamp Crack, Glass Crack requires immediate attention.

Light — Lamp Crack ■ Safety-Critical (Severe, 80.2% confidence)
Damaged lights reduce road legality — replace before driving at night.

Door — Scratch (Moderate, 65.1% confidence)
Inspect door seals and hinges — repair to prevent water ingress.

Fender — Scratch (Severe, 88.7% confidence)
Exposed metal will oxidise — treat and repair at nearest opportunity.

Door — Scratch (Minor, 48.7% confidence)
Inspect door seals and hinges — repair to prevent water ingress.

Scratch (Moderate, 76.8% confidence)
Scratches expose bare metal — treat with touch-up paint to prevent rust.

Part Crack (Moderate, 74.8% confidence)
Consult a qualified technician for assessment and repair.

Part Crack (Moderate, 69.8% confidence)
Consult a qualified technician for assessment and repair.

Glass Crack ■ Safety-Critical (Moderate, 60.1% confidence)
Glass cracks compromise structural integrity and visibility — replace immediately.

- 1. Damaged lights reduce road legality — replace before driving at night.
- 2. Inspect door seals and hinges — repair to prevent water ingress.
- 3. Exposed metal will oxidise — treat and repair at nearest opportunity.
- 4. Scratches expose bare metal — treat with touch-up paint to prevent rust.
- 5. Cracked component detected — assess structural impact and repair.
