MATERIAL TESTING WORKS

Manggahan High school - Bobby C. Eusebio Building
Magsaysay Ave. Manggahan, Pasig City

NOVEMBER 2025

A. INTRODUCTION

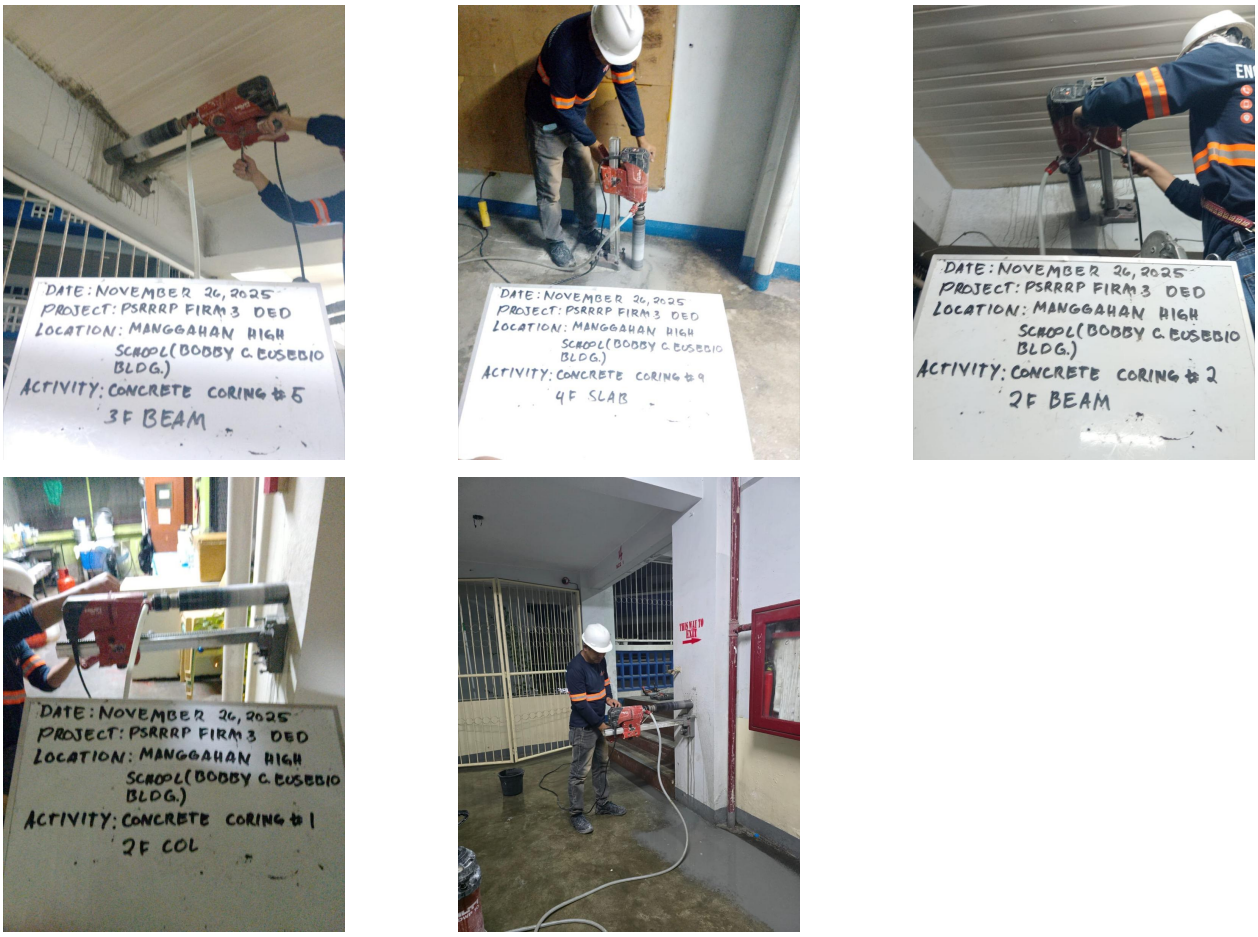
Figure B.3.1 Concrete Core Extraction

Concrete core extraction was conducted on selected structural members to obtain representative samples of the building's in-situ concrete. A total of **fifteen (15) cores** were extracted. The specimens were used to assess concrete quality, including compressive strength and overall material condition. Compressive strength testing was performed in accordance with ASTM C42/C42M, and the corresponding results are presented in **Annex III**.
