What height is safe? An analysis of building destruction along the 207-km path of Nepal's 2026 flood

Nusrat Zahan Jarin[1], Obaidur Rahman[2], Rezwan Ahmed[3]

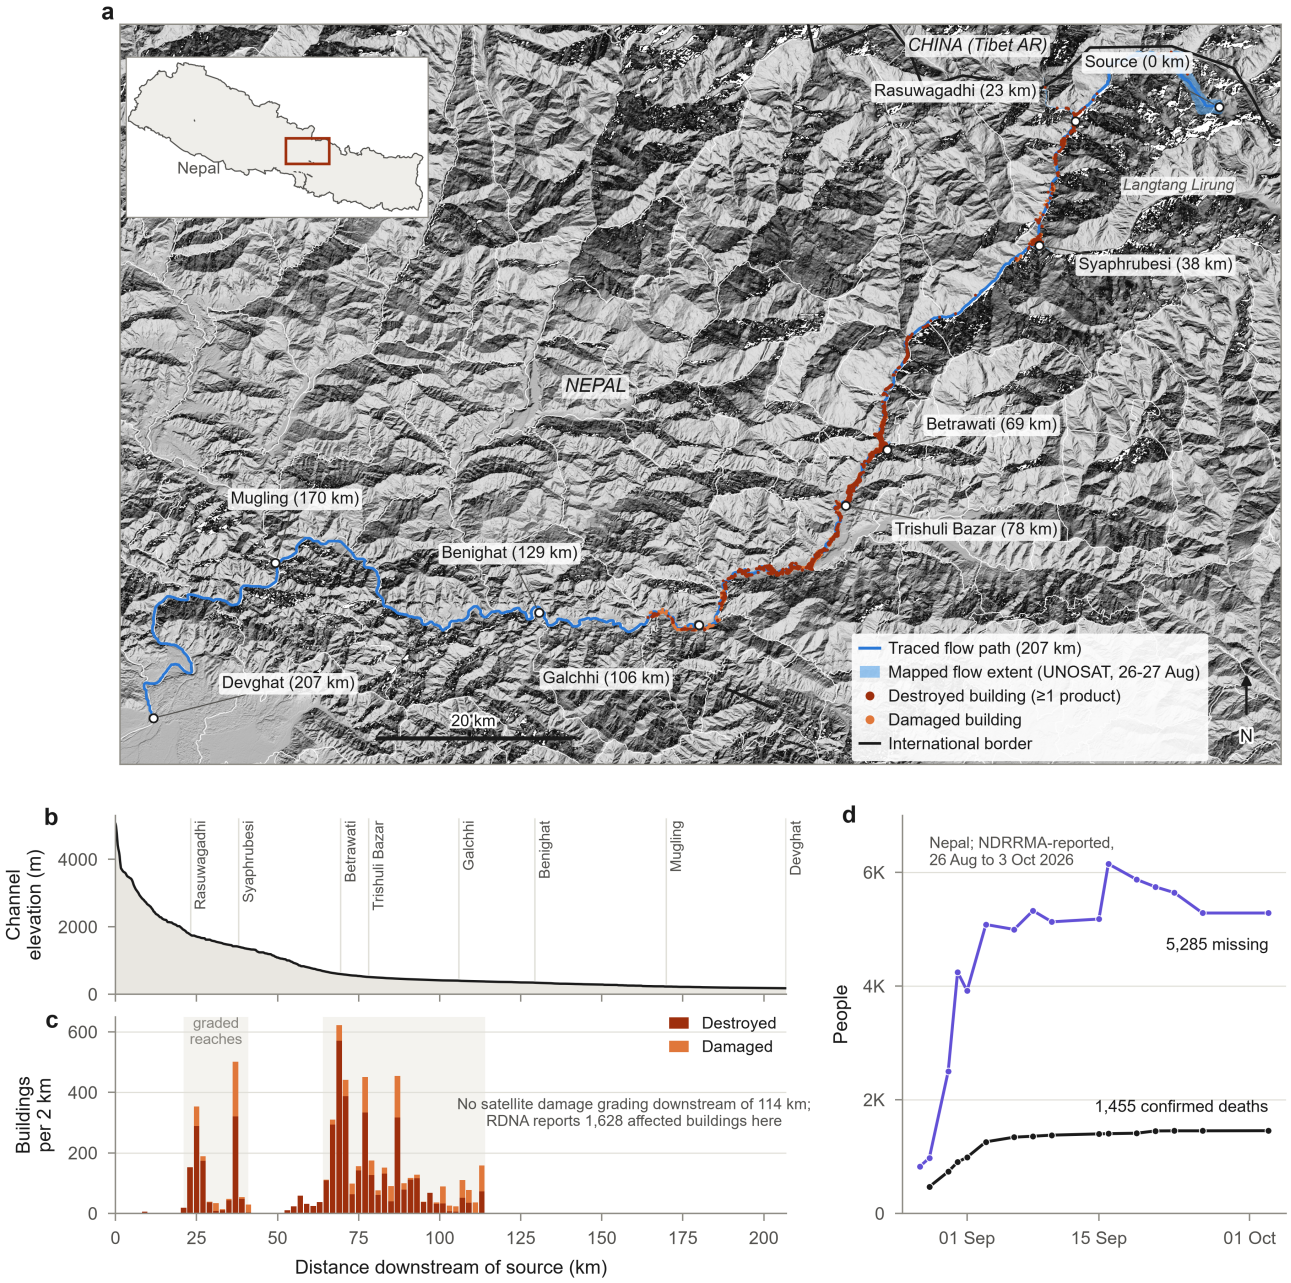
The flood wave decelerated sharply as it travelled down the corridor (Fig. 1a,b). Using the failure time recorded seismically (08:37:10 NPT) [18], the reported arrival at Rasuwagadhi and the times at which river gauges stopped transmitting or crossed warning levels [19], the front averaged 57 m s^{-1} over the first 23 km, 36 m s^{-1} to Syaphrubesi and 19 m s^{-1} to Betrawati, before slowing to 6–9 m s^{-1} along the Trishuli and 4 m s^{-1} above Devghat (Supplementary Table 2). Peak discharge was reconstructed at about 17,000 m^3 s^{-1} at Galchhi [17] and measured at 5,850 m^3 s^{-1} at Devghat [19]. Damaged buildings were concentrated in two reaches: the confined gorge between Rasuwagadhi and Syaphrubesi (21–41 km from the source), and the wider Trishuli valley between Betrawati and Galchhi (64–114 km) (Fig. 1c).

Fig. 1 | The 26 August 2026 cascade and its 207-km impact corridor. a, Shaded-relief map of the corridor from the failure on the north face of Langtang Lirung to the Trishuli–Kali Gandaki confluence at Devghat, showing the D8 flow path traced from the reported source, the UNOSAT flow extent mapped from imagery of 26–27 August, and buildings recorded as destroyed or damaged by at least one product. Distances are along the traced path. **b**, Elevation of the channel along the path. **c**, Damaged and destroyed buildings per 2 km of path; shading marks reaches graded by satellite products. **d**, Deaths and missing people in Nepal reported by NDRRMA between 26 August and 3 October 2026. Map projection: WGS 84 / UTM zone 45N. Data: Copernicus DEM; UNOSAT; HOT; CEMS EMSR927; UNDP RAPIDA; NDRRMA.

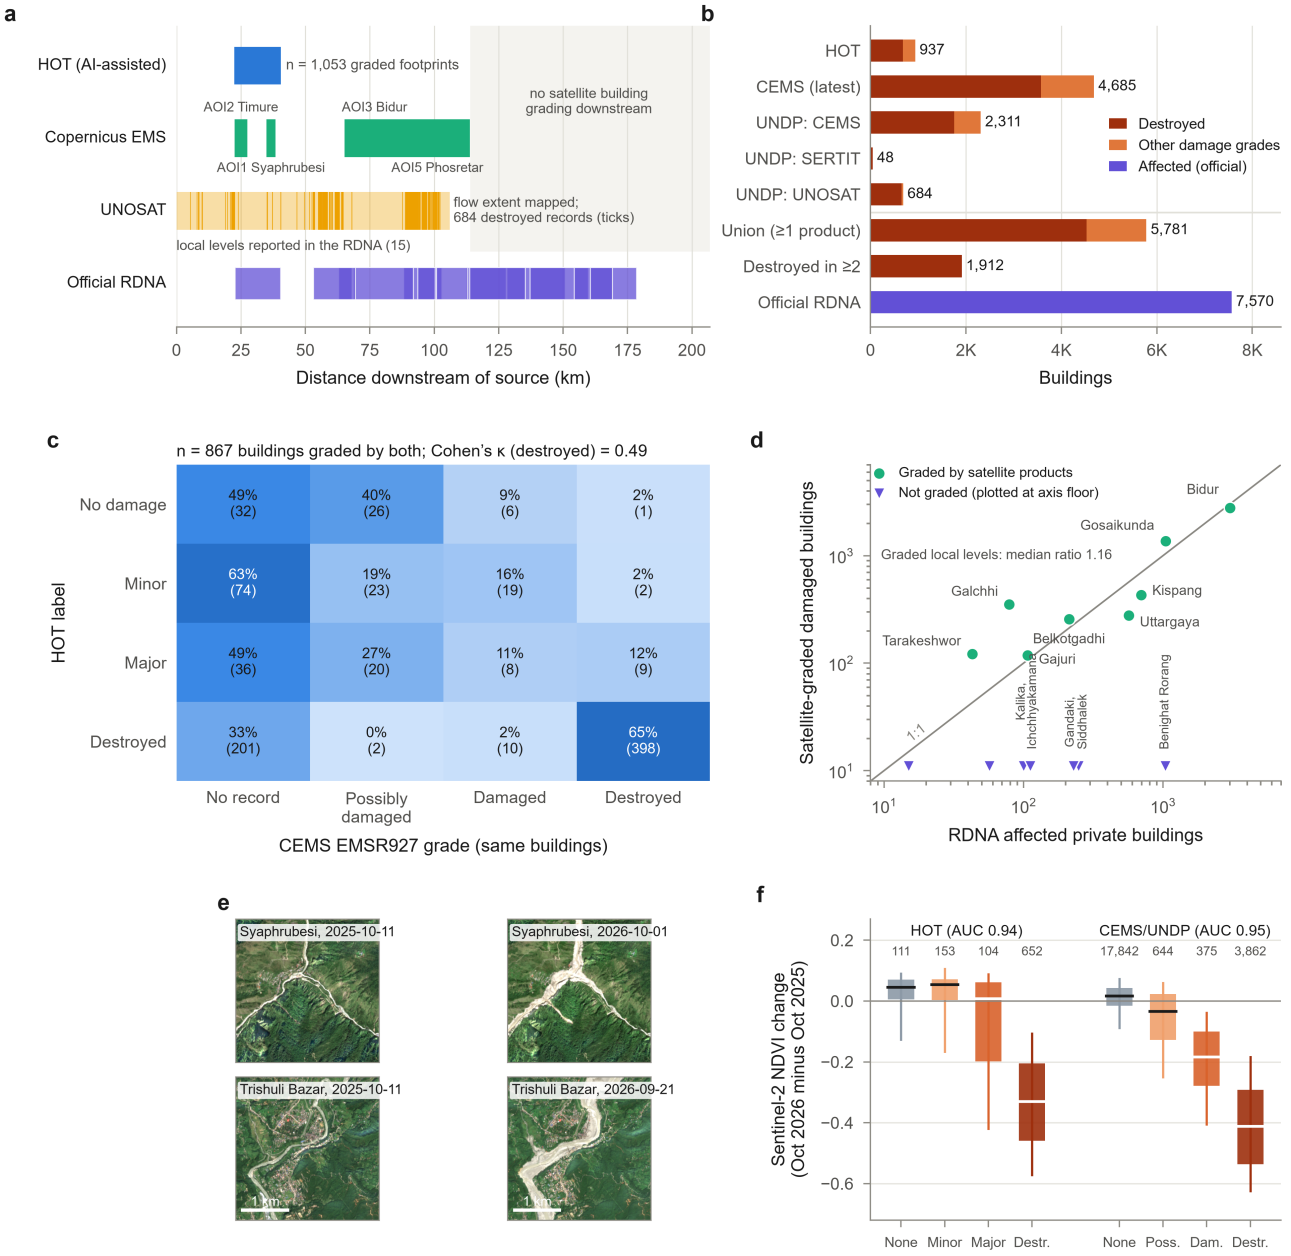
The products that recorded this damage overlapped only partly (Fig. 2a). The CEMS photo-interpreted 17,299 buildings in four areas of interest using 0.3–1 m imagery acquired between 27 August and 5 September and graded 4,685 of them as affected (3,571 destroyed) [25]. The HOT inventory graded 1,053 buildings in the upper corridor with an artificial-intelligence-assisted workflow [27], and the UNDP RAPIDA service re-published 3,043 damaged footprints attributed to CEMS, SERTIT and UNOSAT [28]. After one-to-one matching of points and footprints to a common stock of 115,048 buildings (Methods), the products together recorded **5,781 damaged buildings, of which 4,530 were destroyed**; 1,912 buildings were classed as destroyed by at least two products (Fig. 2b). This harmonized total is 2.5 times the 2,359 records available to the first UNDP assessment, because later CEMS monitoring products extended grading to Kispang, Belkotgadhi and Galchhi (Supplementary Table 3).

Where two products graded the same buildings, they agreed on destruction but not on lesser damage. Among 867 buildings graded by both HOT and CEMS, 97% of buildings that CEMS classed as destroyed were also destroyed in HOT, and 65% of HOT-destroyed buildings were destroyed in CEMS (Cohen's $\kappa = 0.49$) [35], whereas the two products disagreed on most minor and major damage (Fig. 2c and Supplementary Table 4). Only 34% of the 367 UNOSAT-attributed 'destroyed' records that fell inside CEMS areas were also destroyed in CEMS, indicating that records of unknown provenance should not be merged without checking. Sentinel-2 composites from the same season before and after the event, which no product used for building grading, independently corroborated the destruction labels. The loss of vegetation signal at building locations, consistent with sediment covering roofs, gardens and fields, separated destroyed from undamaged buildings with an area under the receiver-operating-characteristic curve (AUC) of 0.95 across all graded areas and 0.94 against HOT's labels (normalized difference vegetation index, NDVI; visible brightness gave 0.94). In the CEMS grading, the median NDVI change was +0.02 for buildings without damage, −0.03 for possibly damaged, −0.18 for damaged and −0.41 for destroyed buildings (Fig. 2e,f, Supplementary Fig. 2 and Supplementary Table 5).

The satellite-graded counts matched the government's RDNA in the graded reaches (median ratio 1.16; Fig. 2d), but not elsewhere. In local levels without satellite grading, most of them below Galchhi, the RDNA reported 1,797 affected buildings, including 1,037 in Benighat Rorang [21]. Yet only 33 buildings in Benighat Rorang lie within 10 m of the channel's elevation, and stage rises of about 9 m were recorded or reconstructed in this reach [17,19]. The

Fig. 2 | Reconciling the damage record. a, Reaches graded by each product along the corridor and the local levels reported in the RDNA; ticks show individual UNOSAT-attributed records. **b**, Buildings recorded as damaged by each product, by the harmonized union and by the RDNA. **c**, Agreement between HOT and CEMS for the 867 buildings graded by both, as row percentages with counts. **d**, Satellite-graded damaged buildings against RDNA-affected buildings by local level; local levels without satellite grading are plotted at the axis floor. **e**, Sentinel-2 true-colour images from the clearest pre-event (October 2025) and post-event (September–October 2026) scenes at Syaphrubesi (top) and Trishuli Bazar (bottom), with acquisition dates and the same reflectance stretch for all images. **f**, Post-minus-pre change in NDVI at building locations by HOT grade and by CEMS/UNDP grade (boxes, interquartile range; whiskers, 10th–90th percentiles; numbers, buildings), with the AUC for separating destroyed from undamaged buildings within each set. Contains modified Copernicus Sentinel data (2025, 2026).

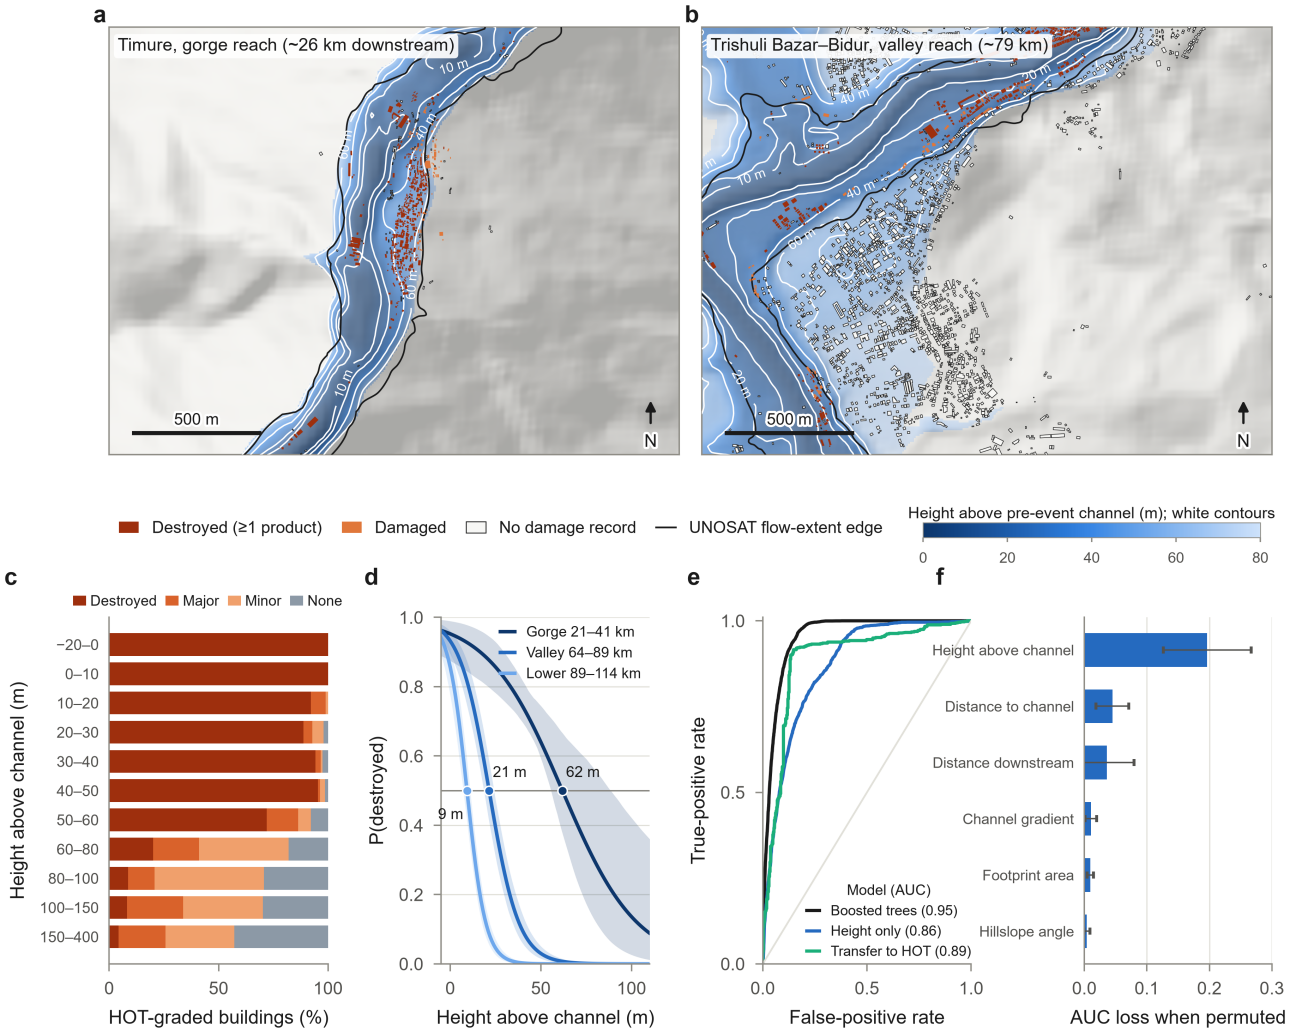
Within the HOT inventory, the share of destroyed buildings fell from 95% for buildings less than 20 m above the channel to 7% for buildings more than 80 m above it, while the shares of minor damage and no damage rose (Fig. 3c). Height above the pre-event channel — the relative elevation of each building above the traced flow path, similar to height above nearest drainage [36,37] — discriminated destroyed from surviving buildings with an AUC of 0.92; each additional 10 m of height halved the odds of destruction (odds ratio 0.50). Distance from the channel was a weaker discriminator (AUC 0.83). In an ordinal model of the four HOT damage classes with errors clustered by 1-km reach, height (odds ratio 0.85 per 10 m), distance, distance downstream and hillslope gradient were all associated with less severe damage, and buildings on the outer banks of bends had 1.5 times the odds of more severe damage (odds ratio 1.53, 95% confidence interval 1.07–2.17; Supplementary Table 6) — consistent with superelevation and erosion where flows impinge on the outside of bends.

Across the 23,453 buildings in all graded areas, a gradient-boosted classifier [38,39] trained on terrain and building attributes predicted destruction with an AUC of 0.95 under spatial block cross-validation [40,41] (precision–recall AUC 0.76 at a prevalence of 18%; Fig. 3e and Supplementary Table 7). Height above the channel was by far the most important predictor: permuting it reduced the AUC by 0.20, against 0.045 for distance from the channel and 0.036 for distance downstream (Fig. 3f and Supplementary Fig. 3) [42]. The result did not depend on which product supplied the labels: a model using CEMS labels alone achieved an AUC of 0.95, and a model trained outside the HOT reach predicted HOT's independent labels with an AUC of 0.89. Height alone retained an AUC of 0.86, but its effect differed strongly between reaches (Fig. 3d), which motivated a reach-specific analysis.

The two zoomed maps in Fig. 3 illustrate the contrast. At Timure, in the gorge, buildings were destroyed up to the upper limit of the valley floor, tens of metres above the river. At Trishuli Bazar–Bidur, destroyed buildings were confined to the lower river terraces, below about 20 m, while the town on the higher terrace survived almost intact (Fig. 3a,b).

Fig. 3 | Height above the channel governed destruction. a,**b**, Height above the pre-event channel (shading and white contours), the UNOSAT flow-extent edge and building footprints coloured by the most severe grade recorded, at Timure in the gorge (**a**) and Trishuli Bazar–Bidur in the valley (**b**). **c**, Composition of HOT damage classes by height above the channel; numbers at right give buildings per band (Supplementary Table 6). **d**, Probability of destruction against height above the channel for the three graded reach groups, with 95% block-bootstrap bands; dots mark the height at 50% probability. **e**, Receiver-operating-characteristic curves for gradient-boosted trees under spatial cross-validation, for height alone, and for the model transferred to HOT labels. **f**, Permutation importance (mean loss of AUC ± s.d. across folds).

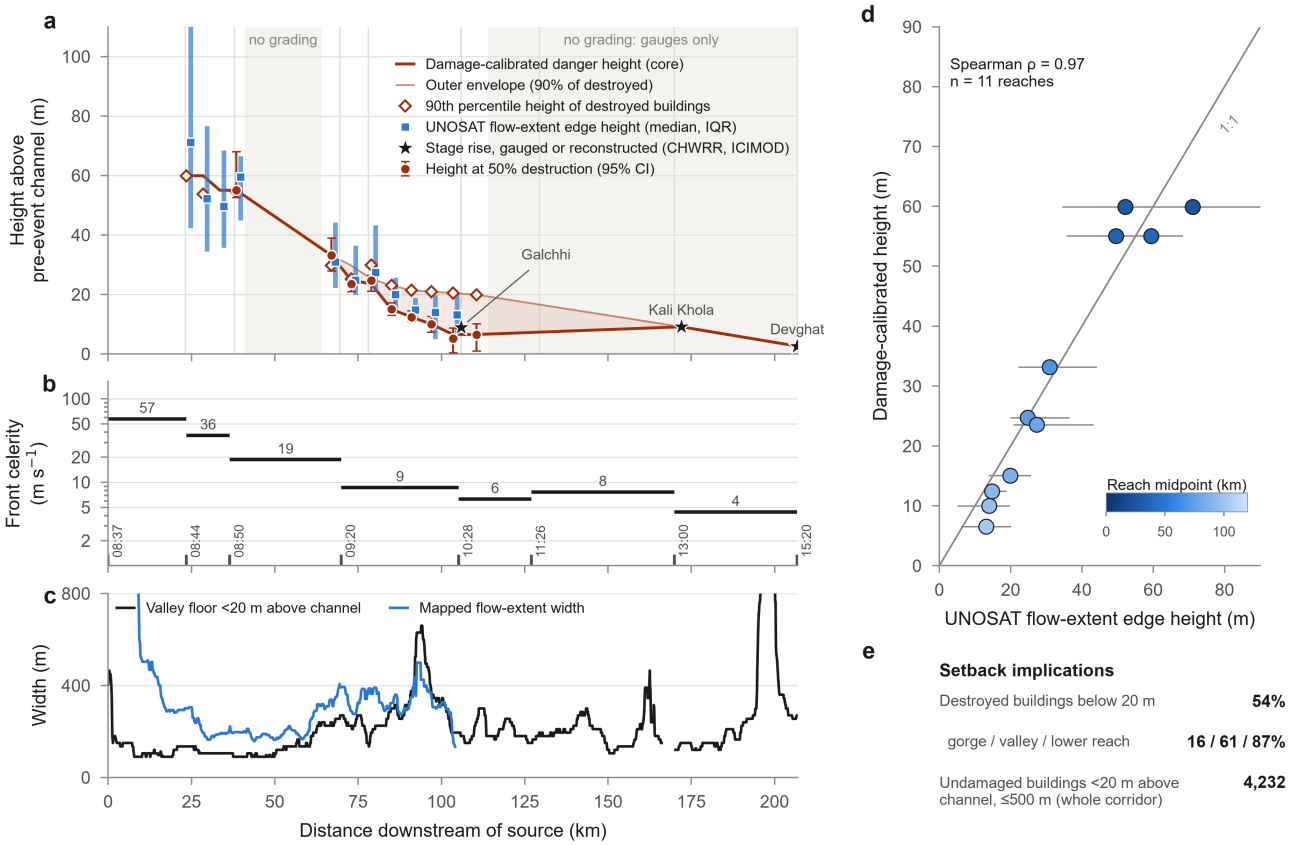
We estimated, for each graded reach, the height above the channel at which the probability of destruction reached 50% (Methods). This damage-calibrated height was 55–60 m in the gorge (all gorge buildings pooled: 62 (95% CI 56–88) m), declined from 33 to 15 m between Betrawati and Bidur (pooled: 21 (95% CI 19–24) m) and was 7–12 m below Bidur (pooled: 9 (95% CI 7–11) m) (Fig. 4a and Supplementary Table 8). It closely matched an independent measure — the height of the outer edge of the UNOSAT flow extent, mapped from imagery rather than from buildings — across all 11 reaches (Spearman $\rho = 0.97$; Fig. 4d). Downstream of the last graded reach, stage rises recorded or reconstructed at Galchhi (about 9 m), Kali Khola (about 9 m) and Devghat (about 2.6 m) [17,19] were consistent with the lowest damage-calibrated heights.

The downstream decline in destructive height paralleled the deceleration of the wave front from more than 50 m s^{-1} to less than 10 m s^{-1} and the widening of the valley floor from about 100 m in the gorge to more than 250 m below Betrawati (Fig. 4b,c and Supplementary Fig. 4). In the gorge, destruction extended well beyond plausible water depths: only 16% of destroyed buildings lay less than 20 m above the channel, compared with 61% in the middle valley and 87% in the lower reach (Fig. 4e). This pattern implicates the high momentum of a sediment-laden surge confined in a narrow valley, superelevation in bends and the collapse of undercut terraces, rather than inundation alone [43–45]. It also means that a single setback distance or flood-mark height cannot define safe ground along the whole corridor (Supplementary Table 9).

Fig. 4 | The destructive height attenuated downstream. a, Damage-calibrated destructive height (height at 50% probability of destruction, with 95% intervals), 90th-percentile height of destroyed buildings, height of the UNOSAT flow-extent edge (median and interquartile range) and stage rises gauged or reconstructed downstream, with the core and outer envelopes used for the danger zones. **b**, Mean celerity of the wave front between timed locations, with times (NPT). **c**, Width of the valley floor less than 20 m above the channel and width of the mapped flow extent (running medians). **d**, Damage-calibrated height against flow-extent edge height for the 11 graded reaches. **e**, Shares of destroyed buildings below 20 m and the number of undamaged buildings below 20 m.

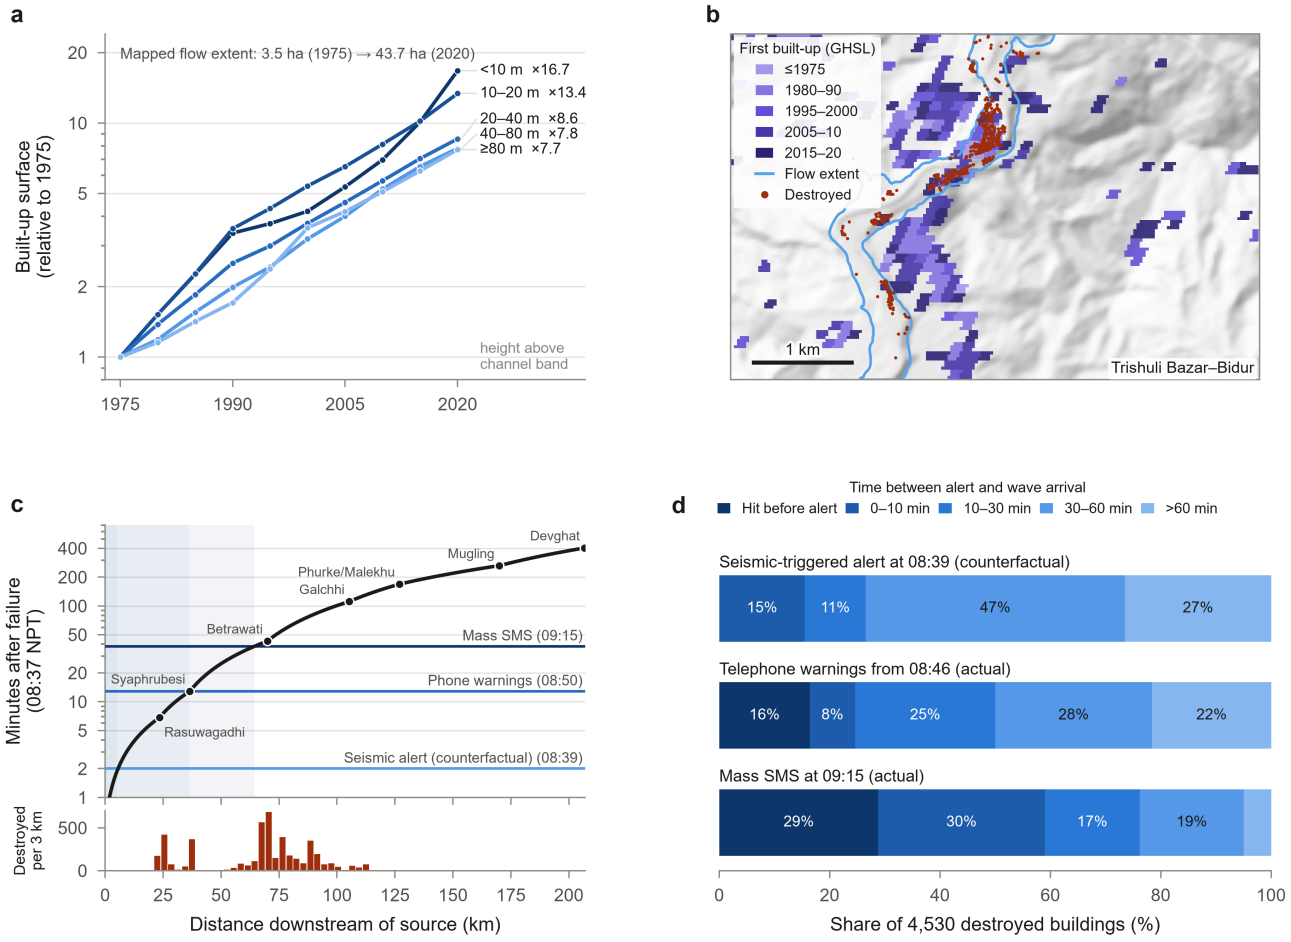
Built-up surface on the valley floor had expanded far faster than on higher ground (Fig. 5a). Within 1 km of the channel in the graded corridor, built-up area less than 10 m above the channel grew 17-fold between 1975 and 2020, and that 10–20 m above the channel 13-fold, compared with 7.7-fold for land more than 80 m above it (Supplementary Table 10) [46,47]. Inside the area later mapped as flow extent, built-up surface increased from 3.5 ha to 43.7 ha (consistent with an independent estimate [31]). At Trishuli Bazar–Bidur, much of the riverside building destroyed in 2026 had appeared since 2005 (Fig. 5b). The pattern mirrors the faster growth of settlements in flood zones observed worldwide [15,48] and in Nepal's road and hydropower corridors [13,49].

The propagation record shows that warning time was short only in the uppermost reach (Fig. 5c). The first official warnings were telephoned from Rasuwa between 08:46 and 08:54, requesting evacuation of residents up to 200 m above the riverbank, and the Department of Hydrology and Meteorology sent 679,295 SMS warnings at 09:15 [20]. By then the wave had passed Syaphrubesi and was approaching Betrawati. Interpolating arrival times along the channel, 29% of destroyed buildings were reached before the SMS was sent, and only 24% received it at least 30 minutes ahead of the flood (Fig. 5d). Had an alert been issued automatically two minutes after the seismic signal, which exceeded magnitude 5 [18,51], no destroyed building would have been reached before the alert, and 73% would have had at least 30 minutes (median 41 min). Even so, the median warning in Gosaikunda would have been only 6 min, compared with 54 min in Bidur (Supplementary Table 11).

Fig. 5 | Exposure growth into the destructive zone and warning time. a, Built-up surface within 1 km of the channel in the graded corridor, relative to 1975, by band of height above the channel (GHS-BUILT-S R2023A). **b**, Epoch in which each 30-m cell first exceeded 10% built-up surface at Trishuli Bazar–Bidur, with the flow extent and destroyed buildings. **c**, Arrival time of the wave front after the failure (log scale) along the corridor and the times of the counterfactual seismic-triggered alert, the first telephone warnings and the mass SMS; the lower panel shows destroyed buildings per 3 km. **d**, Time between alert and wave arrival for the 4,530 destroyed buildings under the three alert scenarios.

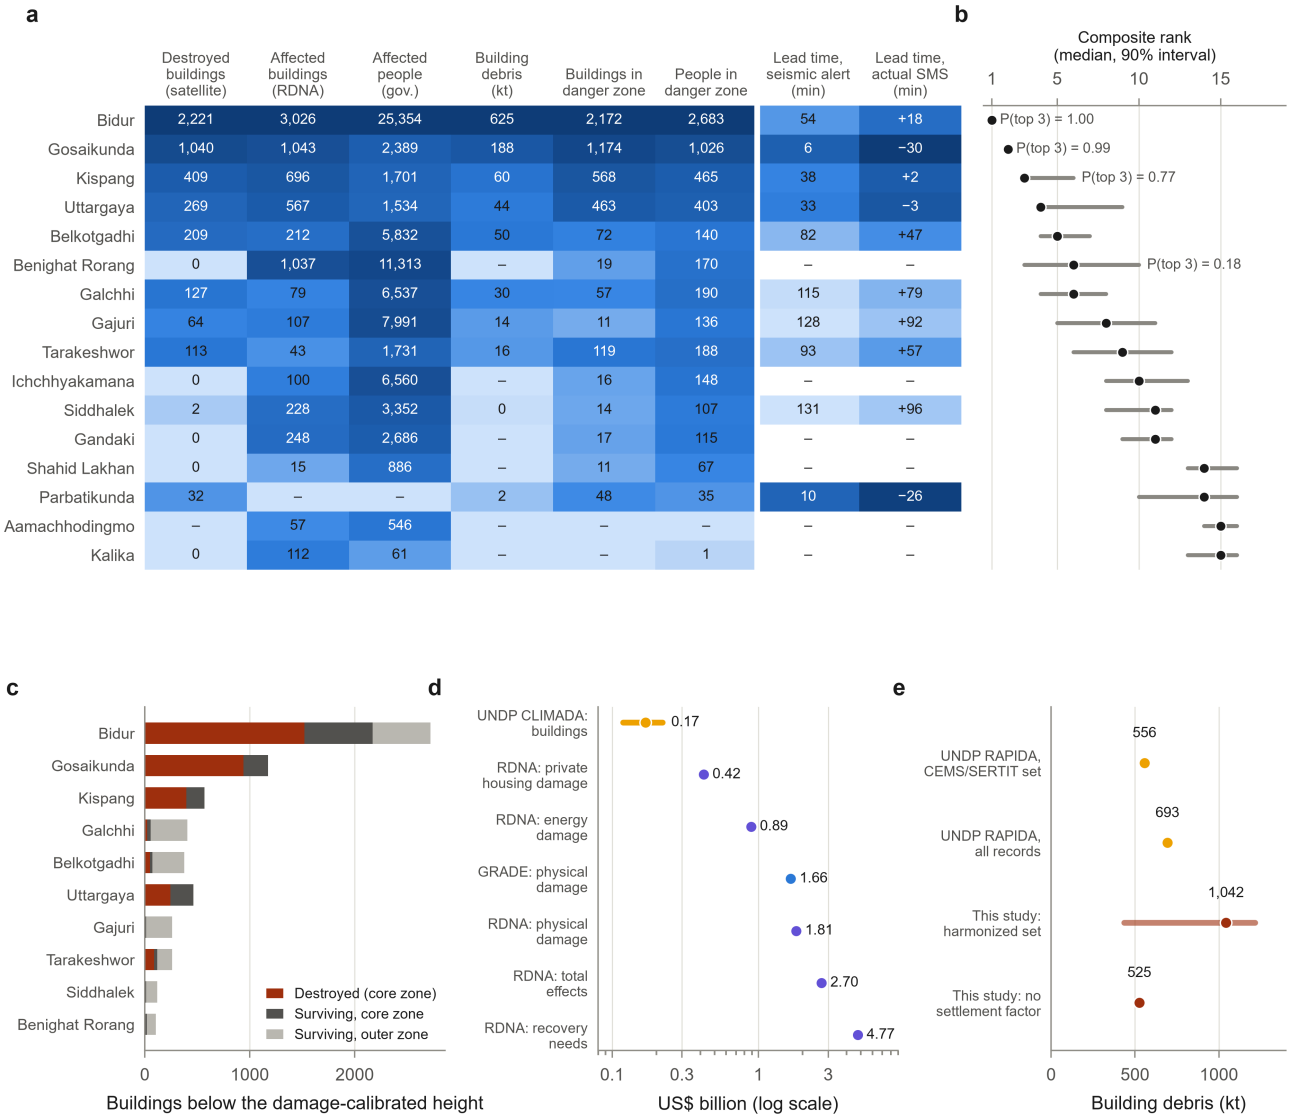
We combined satellite-recorded destruction, RDNA-affected buildings, government-reported affected people, modelled building debris and the buildings and population in the core danger zone into a composite index, and propagated uncertainty in weighting, normalization and aggregation by Monte Carlo simulation [52,53] (Methods). Bidur and Gosaikunda ranked first and second in almost every simulation (probability of a top-three rank 1.00 and 0.99), followed by Kispang (0.77) (Fig. 6a,b and Supplementary Fig. 5c). Benighat Rorang ranked sixth on average but with the widest interval, reflecting the absence of satellite grading and the large RDNA count (Table 2).

Fig. 6 | Recovery priorities. **a**, Indicators by local level, shaded by their log-scaled magnitude (lead-time columns are shaded so that shorter warning is darker). **b**, Median rank and 5–95% interval of the composite index over 20,000 Monte Carlo draws of weights, normalization and aggregation, with the probability of a top-three rank. **c**, Buildings below the damage-calibrated height within 500 m of the channel: destroyed and surviving in the core zone, and additional surviving buildings in the outer zone. **d**, Published monetary estimates by scope (log scale). **e**, Building debris estimated by UNDP and in this study (5–95% Monte Carlo range).

Three implications follow for recovery in the Bhote Koshi–Trishuli corridor. First, danger zones should be defined by reach-specific heights above the channel rather than by a uniform flood mark or setback distance: a criterion appropriate to the lower Trishuli, where the destructive height was 7–12 m, would leave out most of the gorge, where destruction reached about 60 m above the river. Second, 1,541 buildings that survived within the core zone, and 3,377 within the outer zone, require structural inspection and a decision on whether they can be safely reoccupied; reconstruction in these zones would recreate the exposure that grew fastest before 2026 (Fig. 5a). Third, the largest debris and housing burdens lie in Bidur and Gosaikunda, but the uncertain urban debris multiplier and the unexplained RDNA counts below Galchhi should be resolved by field survey before large clearance contracts or compensation are committed.
