# Hardware Case Study: Overcoming Magnetic Core Saturation at High Resolutions

**Date:** September 2026 **System:** Magnetic Field Scanner (RM3100, ESP32-S3, FreeRTOS)

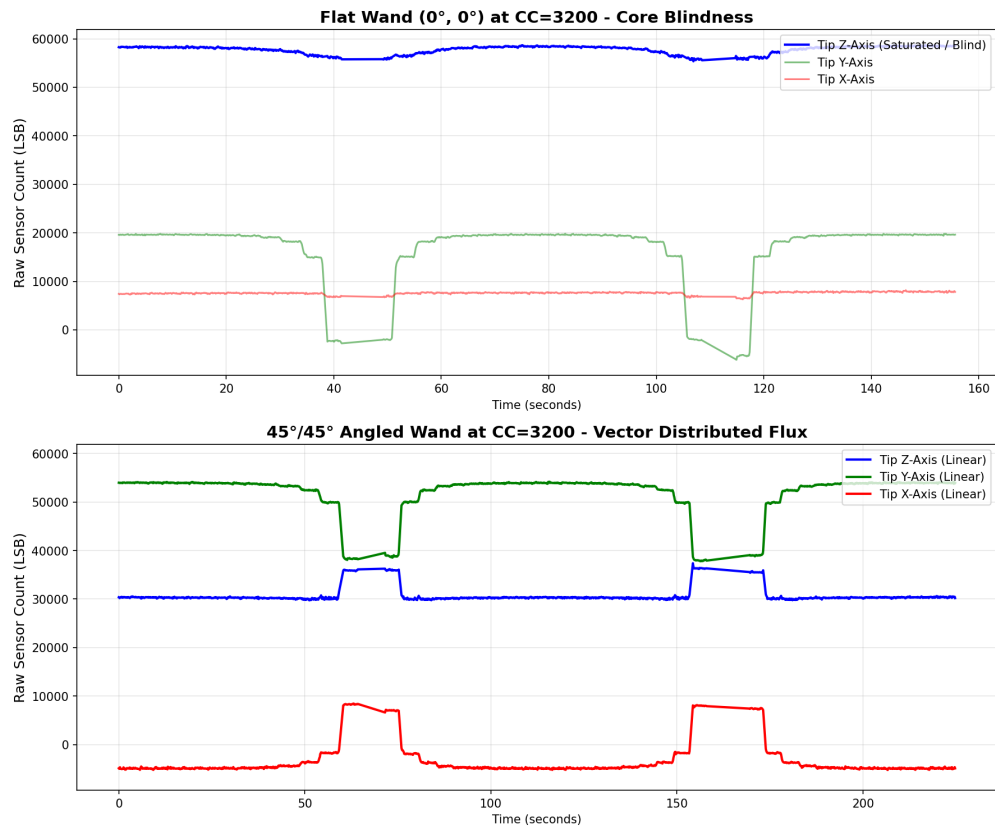
At CC=3200 (the sensor's maximum theoretical resolution), the output should have scaled linearly to over 300,000 LSB. Instead, the sensor locked up entirely, hovering in a dead-state around 55k-58k. The magnetic flux from the massive rebar, combined with the ultra-long integration time of CC=3200, forced the physical soft iron core into total saturation, stalling the LR oscillator.

The comparative plot below is the "smoking gun."

- Top Plot (Flat Wand at CC=3200):** You can clearly see all three axes completely flatline. The sensor has been entirely blinded by the physical load. It completely fails to detect the anomaly.
- Bottom Plot (45/45 Wand at CC=3200):** By distributing the flux, the sensor is restored. All three axes (X, Y, Z) stay alive and form smooth, unclipped curves as the anomaly approaches.

By physically angling the sensor array, we took the massive vertical magnetic vector and geometrically projected it across the X, Y, and Z inductors simultaneously. Because of vector math ( $\cos(45^\circ)$ ), the peak flux on any single axis was drastically reduced. The inductors "shared" the magnetic load, keeping them all within their healthy, linear oscillation range.

This test proves that when hunting massive iron anomalies (like deeply buried utility pipes) at ultra-high resolutions (CC=3200), gradiometers should not have their sensors mounted perfectly flat. By mechanically tilting the sensor array at 45 degrees inside the enclosure, we artificially restore the dynamic range of the ADCs, entirely prevent single-axis lockup, and maintain flawless sensitivity under extreme magnetic loads.
