Inspection report, Final: PO003007

KS105293-HAUTE RED: BINA BELT

1st inspection

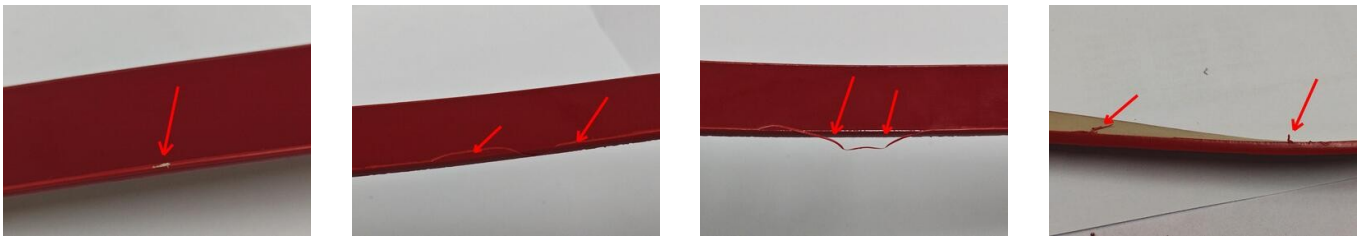
3	**F5 Coarse/thick Yarn. The edges are not smooth and there is peeling.** **(Automatic translation)**	MINOR Items affected: 10

3. Belts with rough edges or peeling need to be re-inspected and repaired.
