**PHASE I
ENVIRONMENTAL SITE ASSESSMENT**

**RICHARDS-GEBAUR MEMORIAL AIRPORT
3600 MARKEY ROAD, BUILDING 839
KANSAS CITY, MISSOURI**

PSI PROJECT NUMBER 5985E081

October 3, 1995

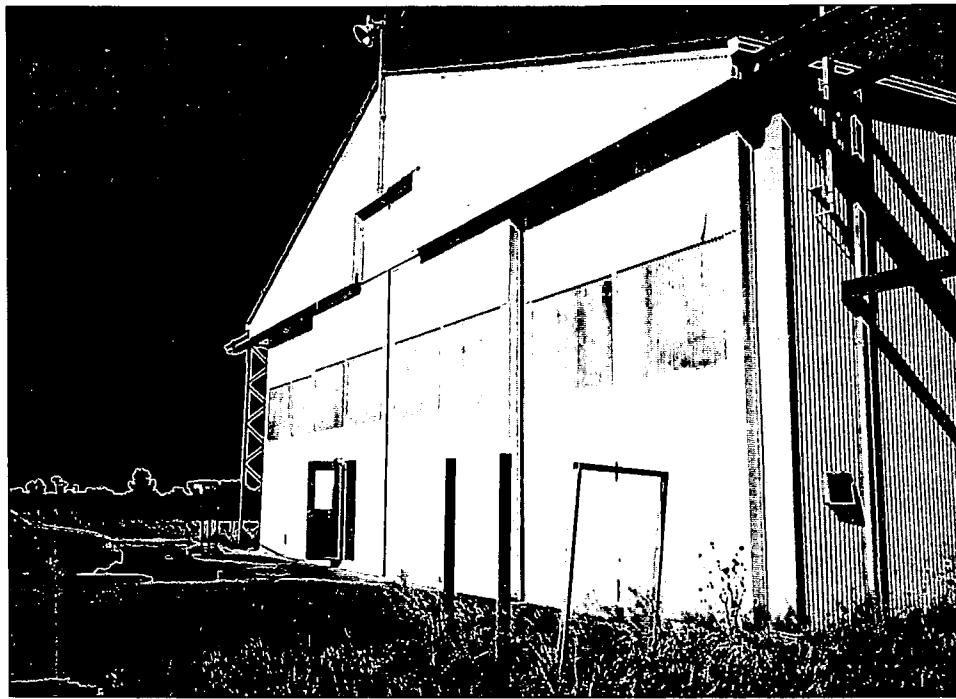
PHOTOGRAPH 1: Building 839 - west exterior.

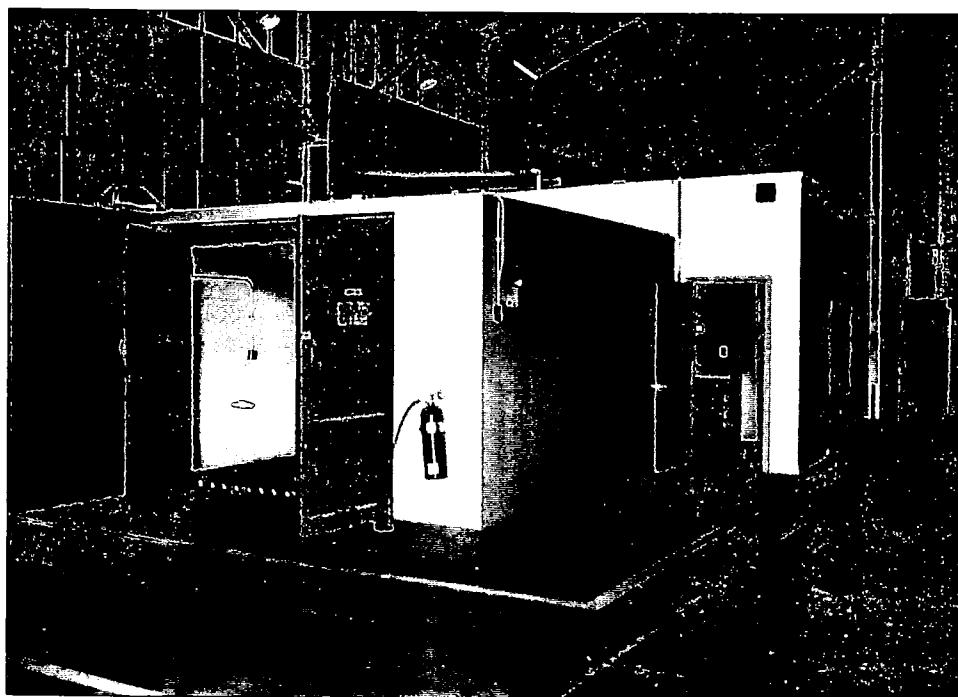
PHOTOGRAPH 3: Building interior.

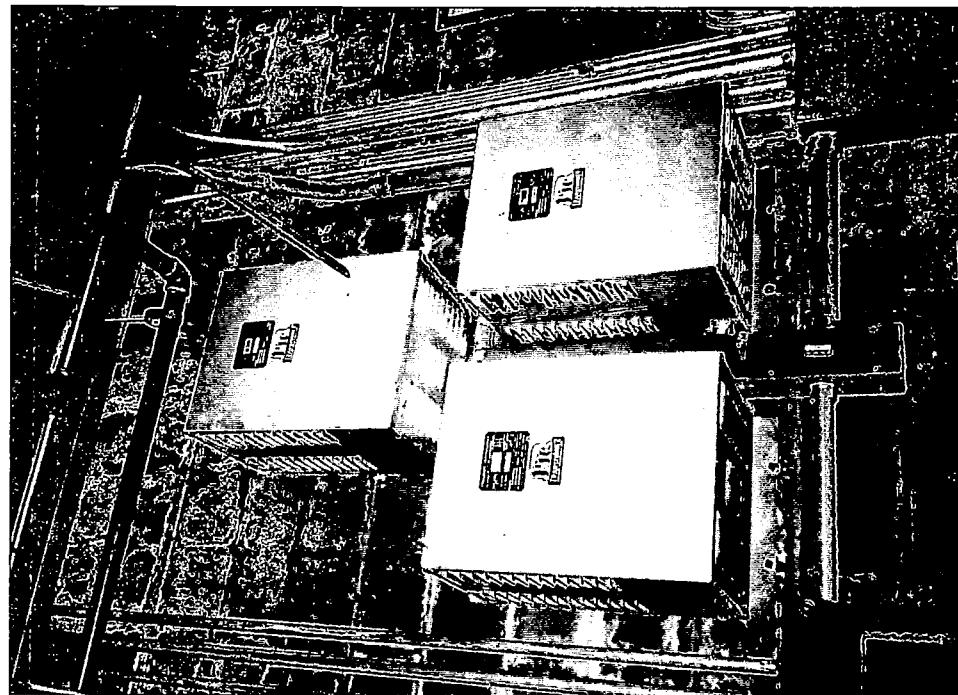
Located southeast of the building were three pole-mounted transformers (pole number 4610). No labels regarding PCB content were identified. No leakage or staining was observed associated with the transformers. According to Steve Yates with the Missouri Public Service (MPS), Belton District Office, the transformers are owned and maintained by MPS and have not been tested for PCB content.

PHOTOGRAPH 8: Three-phase transformer located in HVAC/electrical room.

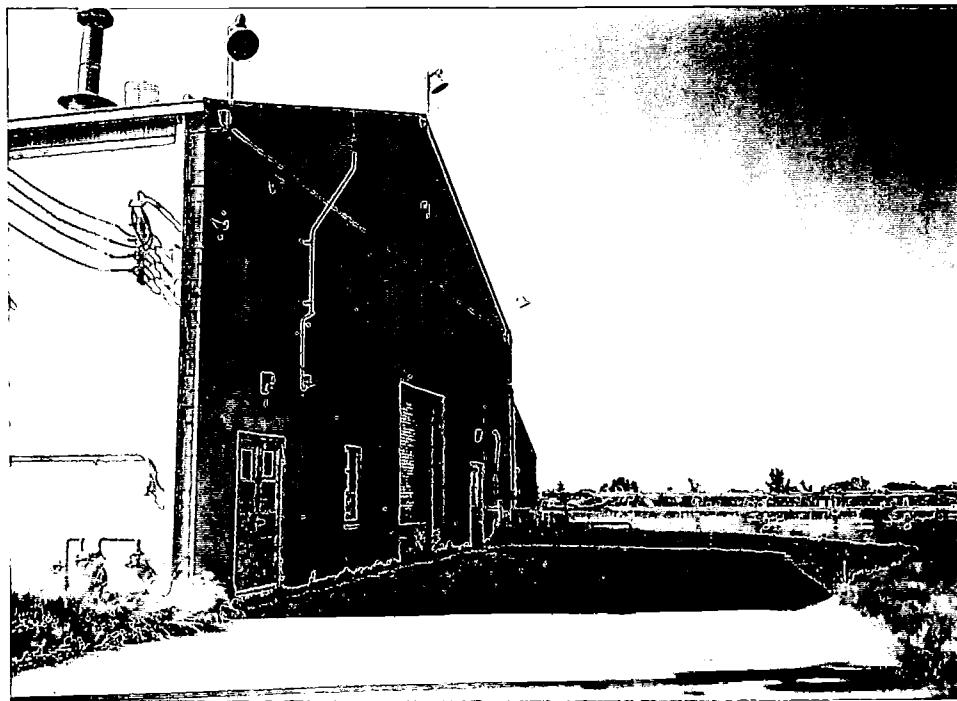
PHOTOGRAPH 9: East area of building.

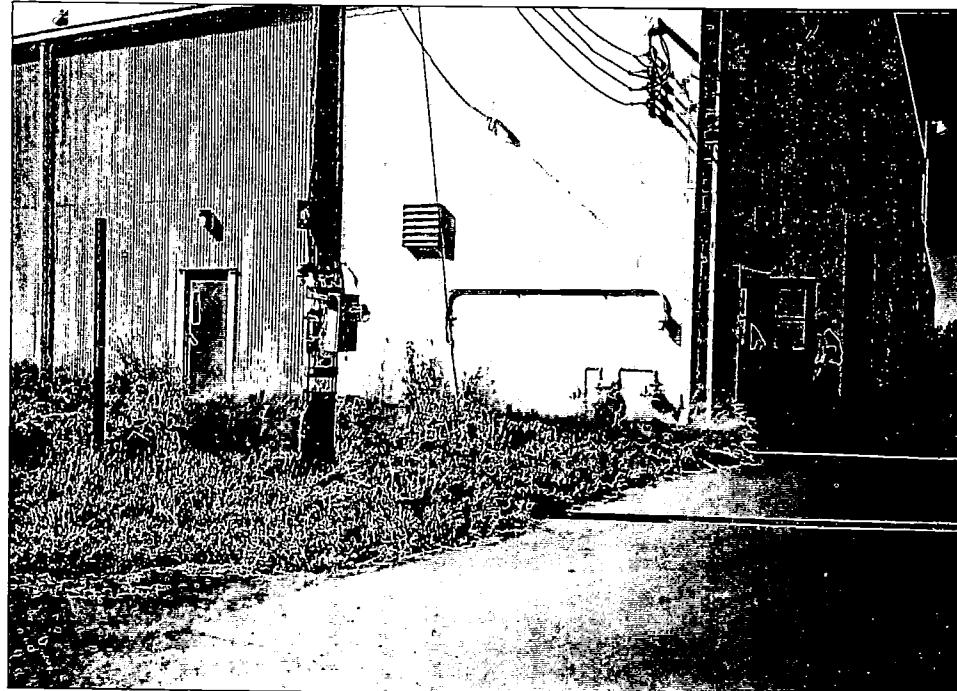
According to Mr. Wilmsmeyer, a 4,000-gallon, steel, underground storage tank previously containing #2 Fuel Oil was removed from an area south of the electrical room in March of 1992. According to information provided by Mr. Esch, the tank was in operation from 1961 until 1992. The location of the tank removal site is 12 feet south of the southeast corner of the building. Soil samples were collected and found to not exceed existing environmental standards.

PHOTOGRAPH 10: Former UST location on southeast area of building.

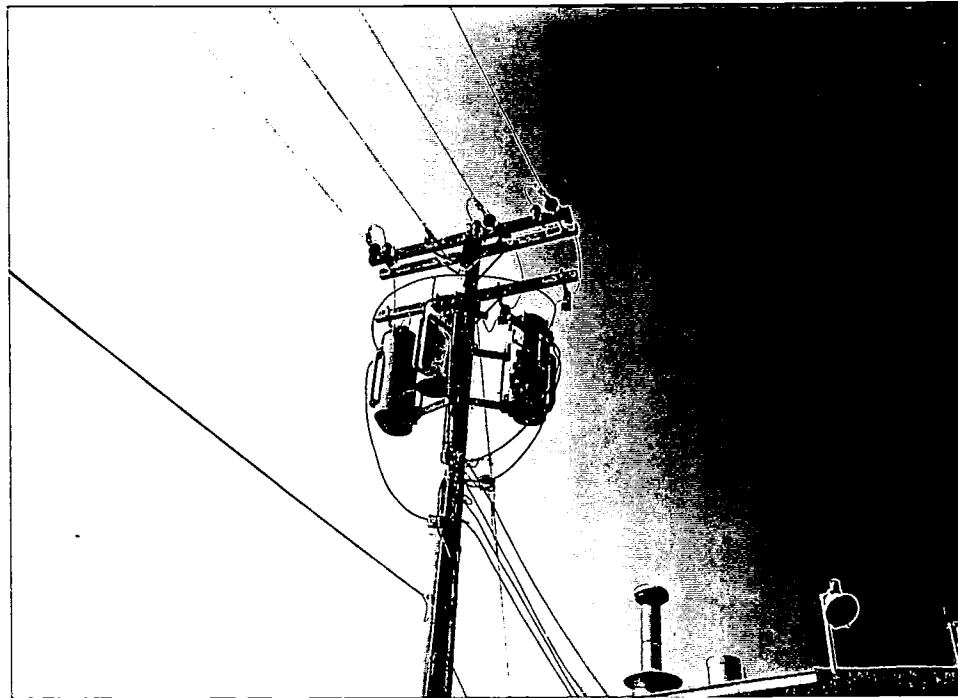
PHOTOGRAPH 11: Three pole-mounted transformers located southeast of the building.

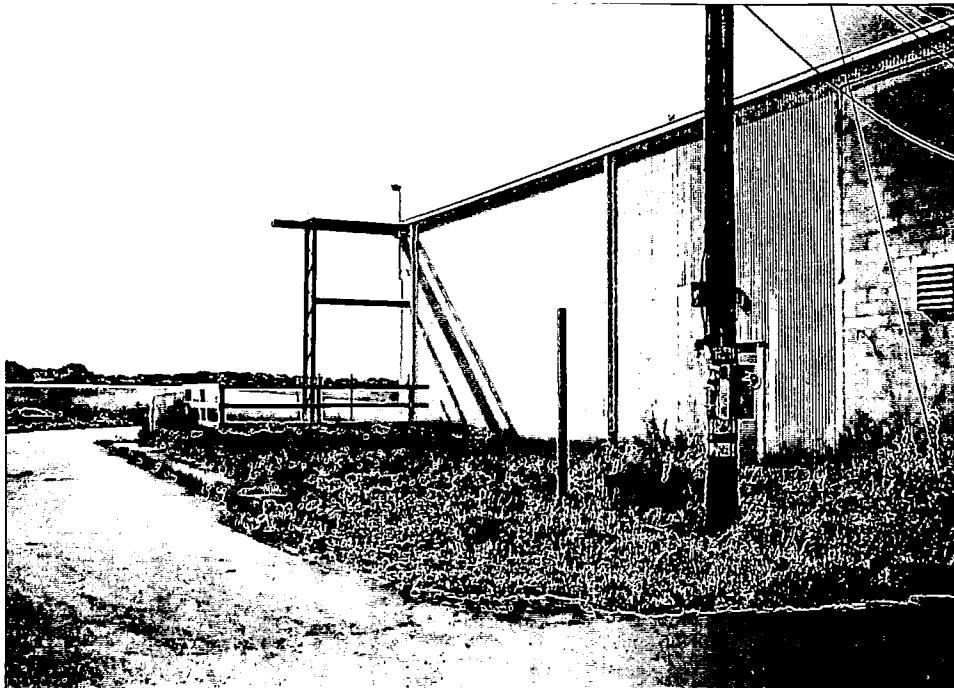
PHOTOGRAPH 12: South area of the building.

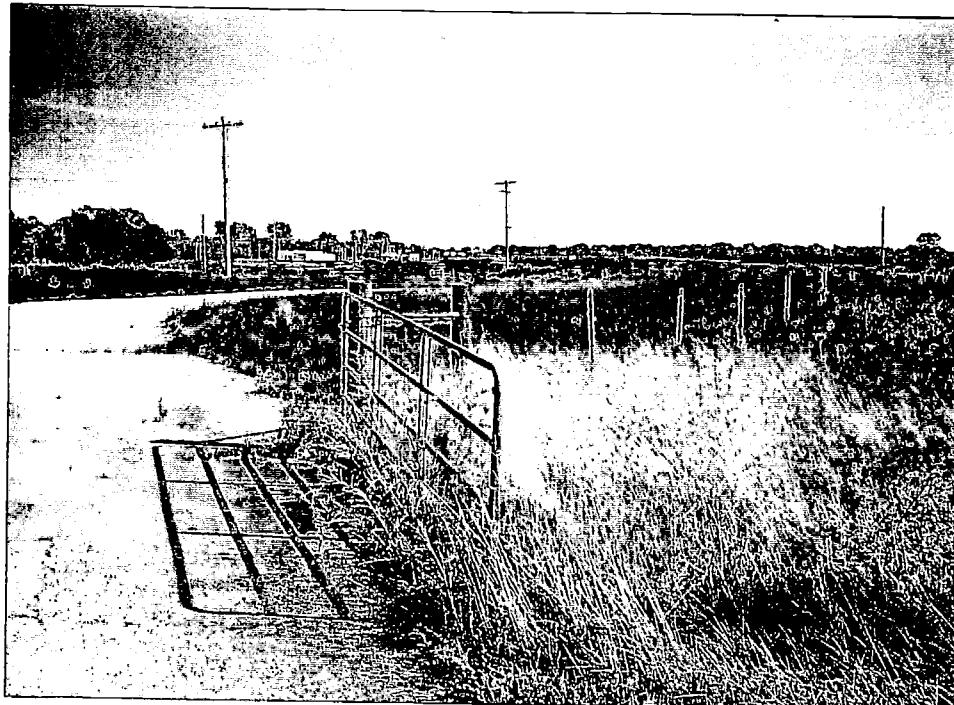
PHOTOGRAPH 16: East adjacent properties along Markey Road.
