SIO Shipyard Representative Bi-Weekly Progress Report		
Project: AGOR 28	Contract No.: N00014-12-C-0305	Shipyard: Dakota Creek Industries
Prepared by: Paul D. Bueren Scripps Institution of Oceanography (SIO) 297 Rosecrans St. San Diego, CA 98106	Date: 26 February 2015	Program Officer: Robert (Tim) Schnoor Office of Naval Research 875 Randolph St ONR 321 Arlington, VA 22203-1995
Distribution Statement A: Approved for public release; distribution unlimited.		Report No. A002.073

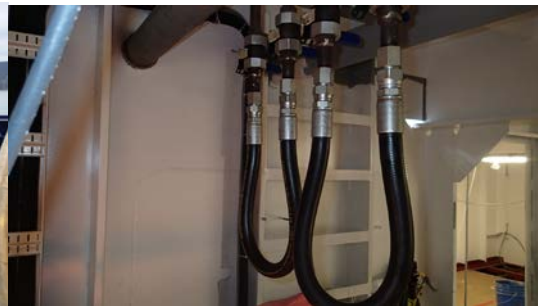
Port Storeroom Siemens Equipment

- Sally Ride Electrical – Cable is being feed to several of Siemen' s IO and Machinery Control cabinets throughout the vessel in preparation for termination.
