MISSING STRUTS

9x9x9 octet lattice · 58.18 μm/voxel · 350 μm nominal strut · registration correction applied
972 boundary caps and 777 plate-embedded struts excluded, not counted as healthy

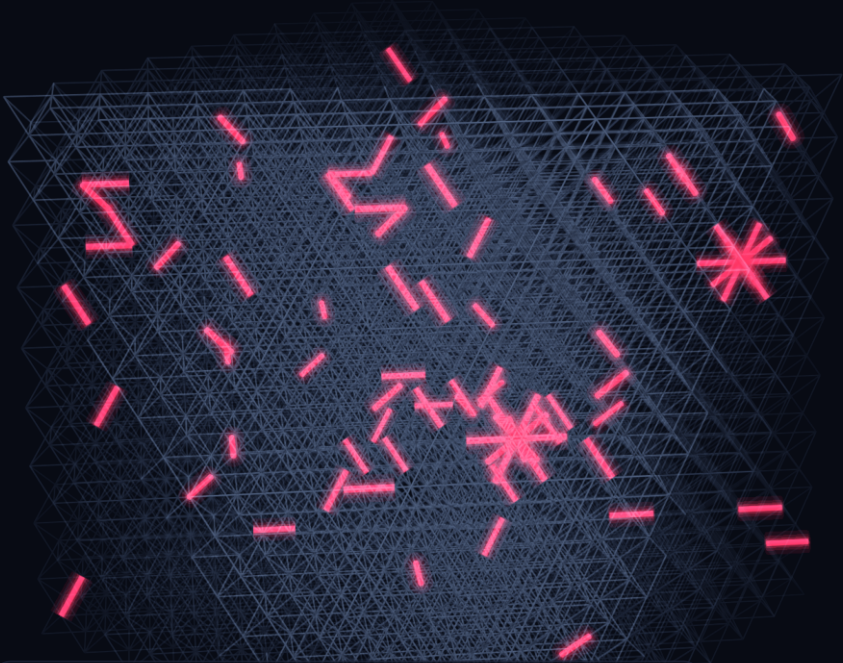
0.525%

no matched voxel on the nominal cylinder and every cross-section empty — a count of zero, so the call carries no threshold to tune

89 of 16,949 measurable struts

THE DEFECTS ARE NOT INDEPENDENT
40% share a junction with another missing strut
10% ± 5% if the same 89 were scattered at random
one junction has 12 of its struts gone
