90% SUBMITTAL (NOT FOR CONSTRUCTION)

GRADING
21ST AVE S BTWN S WALKER ST & S BAYVIEW ST

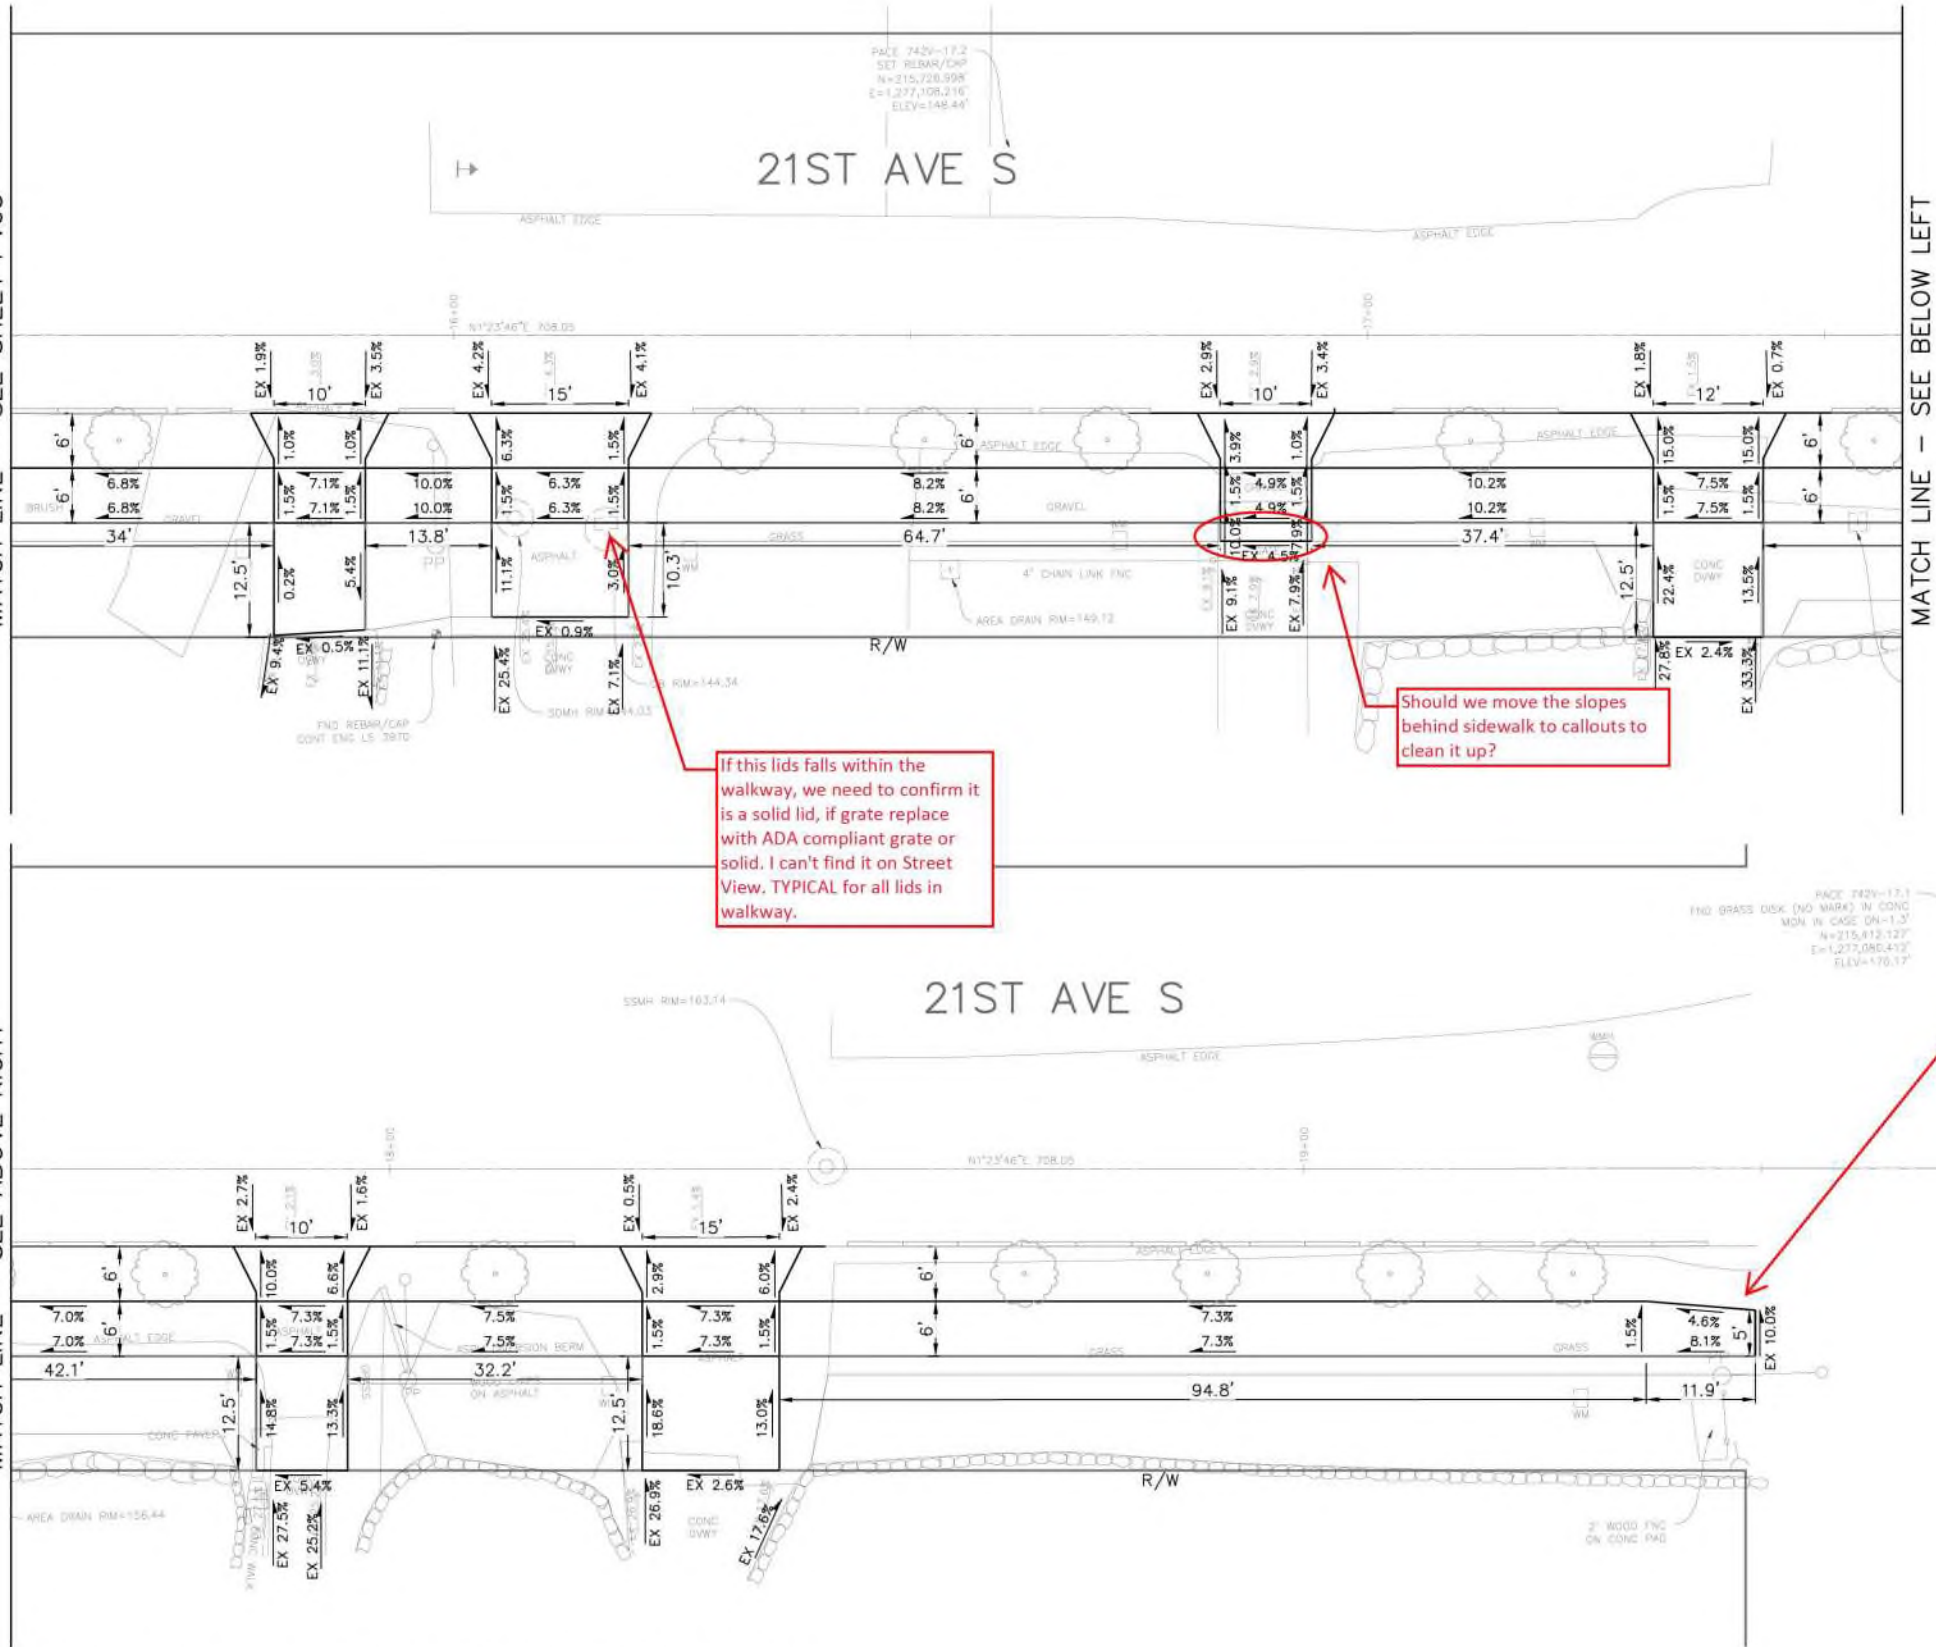
If this lids falls within the walkway, we need to confirm it is a solid lid, if grate replace with ADA compliant grate or solid. I can't find it on Street View. TYPICAL for all lids in walkway.

Should we move the slopes behind sidewalk to callouts to clean it up?

Would matching here preclude from building a compliant future curb ramp? Should we match into the landing of the new curb ramp instead? I would ask for an eastbound curb ramp here, but unless we allow a deviation, it will trigger a companion curb ramp, it is less than 36" wide and greater than 12.5% and eventually all the way around. This ramp was built by a utility (since at least 2021) and lost in the system and just inspected last week. Can the project please design a curb ramp matching into the existing new landing and one showing what the ramp would be if it will have to match the proposed walkway as shown to the right? I'm assuming we have survey, it can be CAD screenshots, it will help decide if we will push for one option or the other. We can discuss if necessary.
