Situation report — Trishuli / Bhote Koshi corridor, Nepal (26 Aug 2026 flood)

Flood date: 2026-08-25 22:00 UTC · analysed area 3,334 km² at 20 m · detector: AI flood-segmentation model (flood_unet.onnx) · radar tracks: RO85 (2026-08-16→2026-08-28), RO19 (2026-08-24→2026-09-05) · Sentinel-2 cloud-free overlap 7% of the area

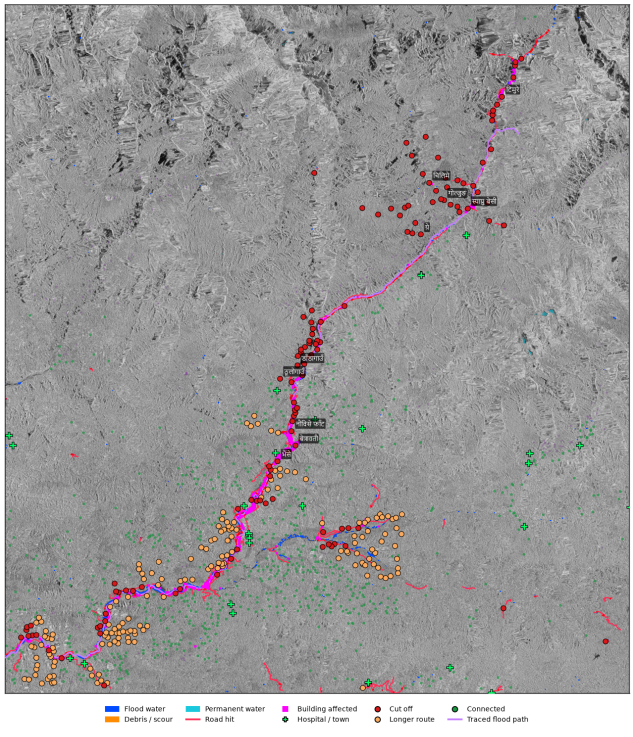
Who is cut off (road connection to nearest hospital/town lost)

Settlement	Buildings	Route before	Was served by
Unnamed settlement #664 (near नुवाकोट, 2.3 km)	391	1.23 km	Trishuli Hospital
गोल्जुङ	275	27.47 km	Rasuwa District Hospital
स्याप्रु बेसी	272	15.16 km	Rasuwa District Hospital
डाँडागाउँ	246	10.8 km	hospital (unnamed)
भैंसे	219	2.85 km	clinic (unnamed)
Unnamed settlement #663 (near बटार बजार, 2.9 km)	208	1.3 km	Trishuli Hospital
टिमुरे	197	26.4 km	Rasuwa District Hospital
Unnamed settlement #687 (near भैंसे, 0.8 km)	186	2.34 km	clinic (unnamed)

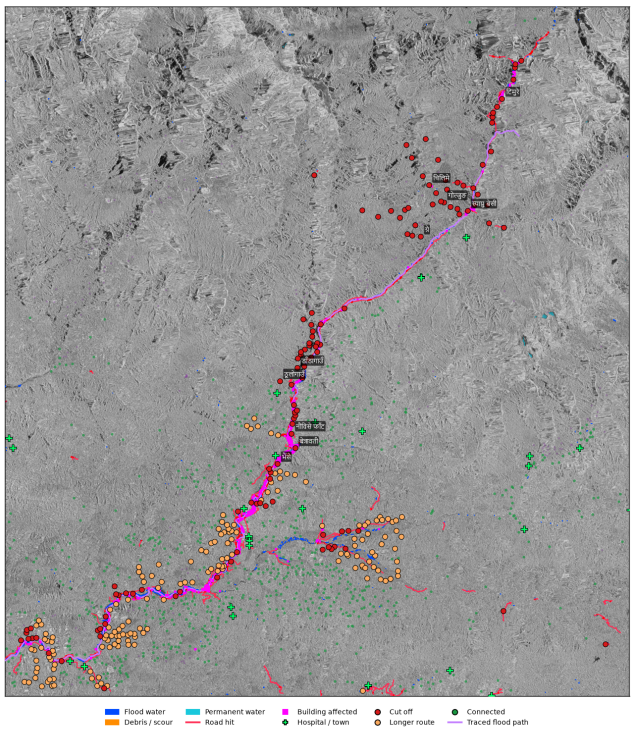
को को टाढा परेका छन् (नजिकको अस्पताल/सहरसँगको सडक सम्पर्क गुमेका)

बस्ती	भवन	पहिलेको दूरी	पहिले सेवा दिने ठाउँ
नाम नखुलेको बस्ती #६६४ (नुवाकोट नजिक, २.३ कि.मी.)	३९१	१.२३ कि.मी.	Trishuli Hospital
गोल्जुङ	२७५	२७.४७ कि.मी.	Rasuwa District Hospital
स्याप्रु बेसी	२७२	१५.१६ कि.मी.	Rasuwa District Hospital
डाँडागाउँ	२४६	१०.८ कि.मी.	अस्पताल (नाम नखुलेको)
भैंसे	२१९	२.८५ कि.मी.	क्लिनिक (नाम नखुलेको)
नाम नखुलेको बस्ती #६६३ (बटार बजार नजिक, २.९ कि.मी.)	२०८	१.३ कि.मी.	Trishuli Hospital
टिमुरे	१९७	२६.४ कि.मी.	Rasuwa District Hospital
नाम नखुलेको बस्ती #६८७ (भैंसे नजिक, ०.८ कि.मी.)	१८६	२.३४ कि.मी.	क्लिनिक (नाम नखुलेको)
