Situation report — Trishuli / Bhote Koshi corridor, Nepal (26 Aug 2026 flood)

Flood date: 2026-08-25 22:00 UTC · analysed area 3,334 km² at 20 m · detector: AI flood-segmentation model (flood_unet.onnx) · radar tracks: RO85 (2026-08-16→2026-08-28), RO19 (2026-08-24→2026-09-05) · Sentinel-2 cloud-free overlap 7% of the area

स्थिति प्रतिवेदन — Trishuli / Bhote Koshi corridor, Nepal (26 Aug 2026 flood)

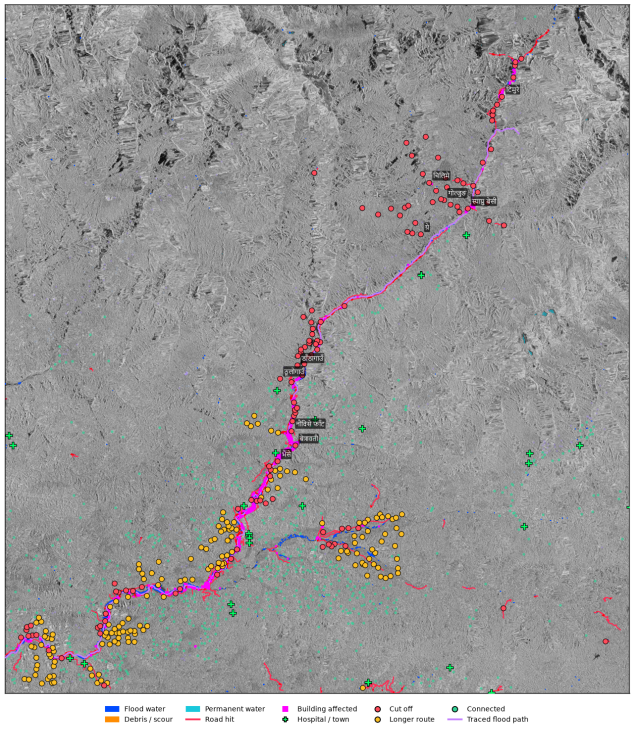
Who is cut off (road connection to nearest hospital/town lost)

Settlement	Buildings	Route before	Was served by
Unnamed settlement #664 (near नुवाकोट, 2.3 km)	391	1.23 km	Trishuli Hospital
गोल्जुङ	275	27.47 km	Rasuwa District Hospital
स्याप्रु बेसी	272	15.16 km	Rasuwa District Hospital
डाँडागाउँ	246	10.8 km	hospital (unnamed)
भैंसे	219	2.85 km	clinic (unnamed)
Unnamed settlement #663 (near बटार बजार, 2.9 km)	208	1.3 km	Trishuli Hospital
टिमुरे	197	26.4 km	Rasuwa District Hospital
Unnamed settlement #687 (near भैंसे, 0.8 km)	186	2.34 km	clinic (unnamed)

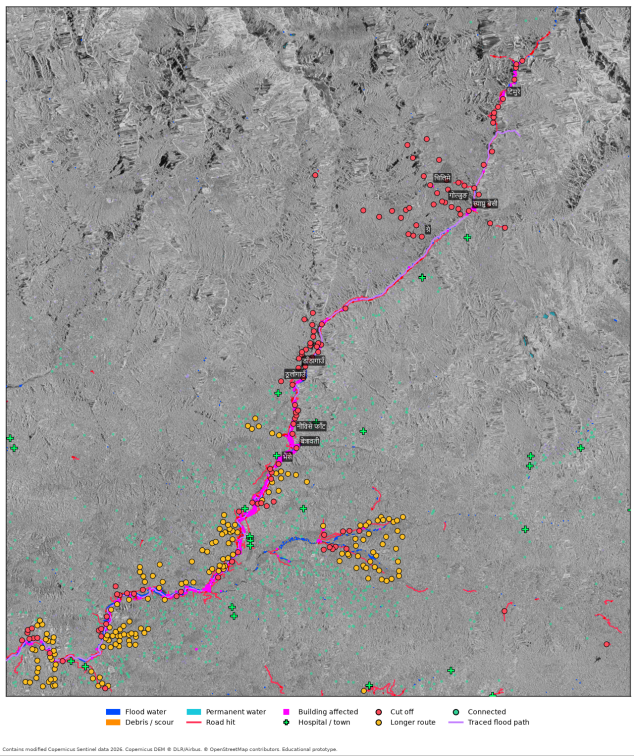
को को टाढा परेका छन् (नजिकको अस्पताल/सहरसँगको सडक सम्पर्क गुमेका)

बस्ती	भवन	पहिलेको दूरी	पहिले सेवा दिने ठाउँ
नाम नखुलेको बस्ती #६६४ (नुवाकोट नजिक, २.३ कि.मी.)	३९१	१.२३ कि.मी.	Trishuli Hospital
गोल्जुङ	२७५	२७.४७ कि.मी.	Rasuwa District Hospital
स्याप्रु बेसी	२७२	१५.१६ कि.मी.	Rasuwa District Hospital
डाँडागाउँ	२४६	१०.८ कि.मी.	अस्पताल (नाम नखुलेको)
भैंसे	२१९	२.८५ कि.मी.	क्लिनिक (नाम नखुलेको)
नाम नखुलेको बस्ती #६६३ (बटार बजार नजिक, २.९ कि.मी.)	२०८	१.३ कि.मी.	Trishuli Hospital
टिमुरे	१९७	२६.४ कि.मी.	Rasuwa District Hospital
नाम नखुलेको बस्ती #६८७ (भैंसे नजिक, ०.८ कि.मी.)	१८६	२.३४ कि.मी.	क्लिनिक (नाम नखुलेको)
