Situation report — Trishuli / Bhote Koshi corridor, Nepal (26 Aug 2026 flood)

Flood date: 2026-08-25 22:00 UTC · analysed area 3,334 km² at 20 m · detector: AI flood-segmentation model (flood_unet.onnx) · radar tracks: RO85 (2026-08-16→2026-08-28), RO19 (2026-08-24→2026-09-05) · Sentinel-2 cloud-free overlap 7% of the area

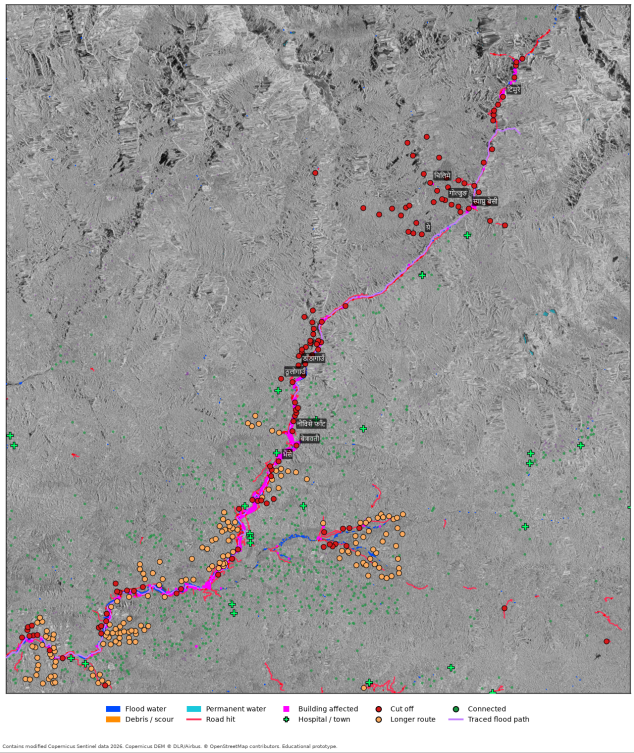
Who is cut off (road connection to nearest hospital/town lost)

Settlement	Buildings	Route before	Was served by
Unnamed settlement #664 (near नुवाकोट, 2.3 km)	391	1.23 km	Trishuli Hospital
गोल्जुङ	275	27.47 km	Rasuwa District Hospital
स्याप्रु बेसी	272	15.16 km	Rasuwa District Hospital
डाँडागाउँ	246	10.8 km	hospital (unnamed)
भैंसे	219	2.85 km	clinic (unnamed)
Unnamed settlement #663 (near बटार बजार, 2.9 km)	208	1.3 km	Trishuli Hospital
टिमुरे	197	26.4 km	Rasuwa District Hospital
Unnamed settlement #687 (near भैंसे, 0.8 km)	186	2.34 km	clinic (unnamed)
