PROPERTY INSPECTION DXB
RUKAN ALAEZ PROPERTY OBSERVER

PROPERTY INSPECTION REPORT CARD

Apt: 1904 Sobha Crest Grande

Property Address: Apt 1904 Sobha Crest Grande
Inspection Date: 25 Mar 2026
Inspected for: Apt 1904 Sobha Crest Grande

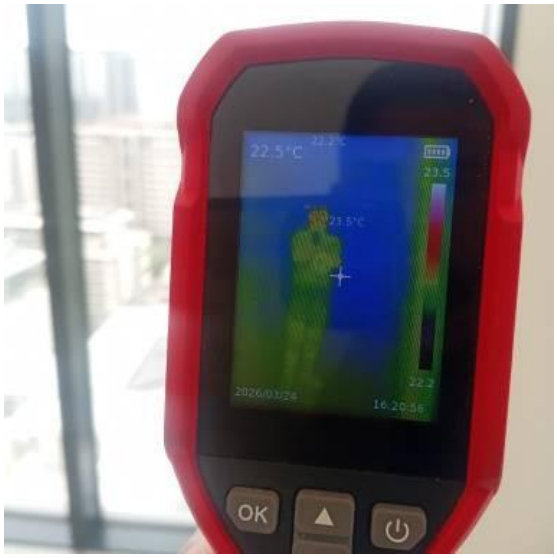
(2)

Location: Master bedroom
Status: PASS
Comments:

WINDOW INSULATION TESTING

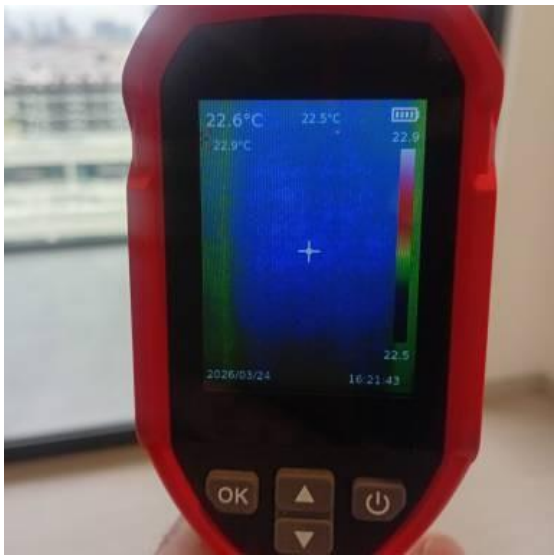
(4)

Location: Bedroom 2
Status: PASS
Comments:

WINDOW INSULATION TESTING

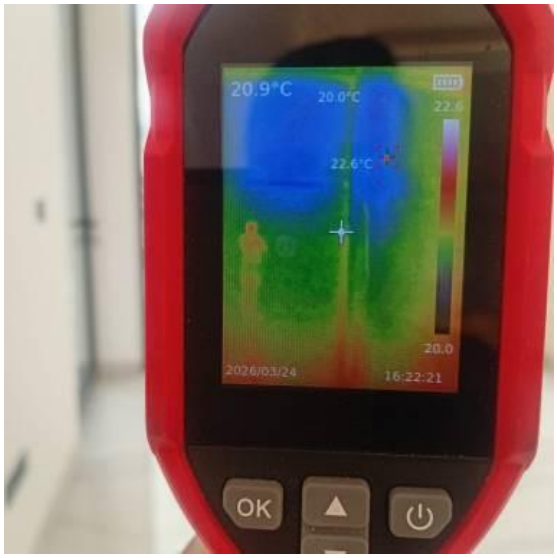
(8)

Location: Living
Status: Open
Comments:

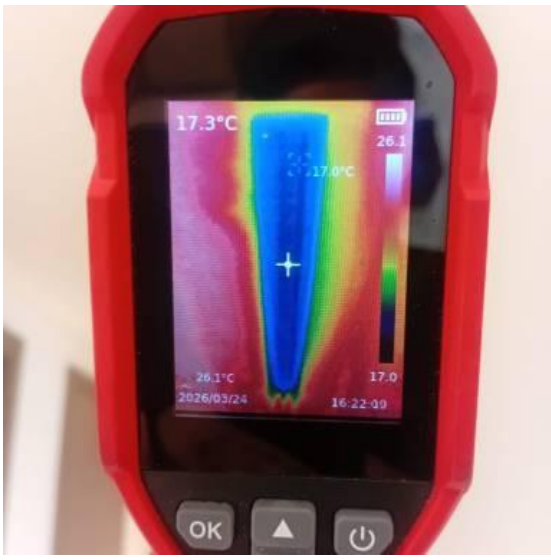
(10)

Location: Hallway
Status: PASS
Comments:

AC WORKING PROPERLY

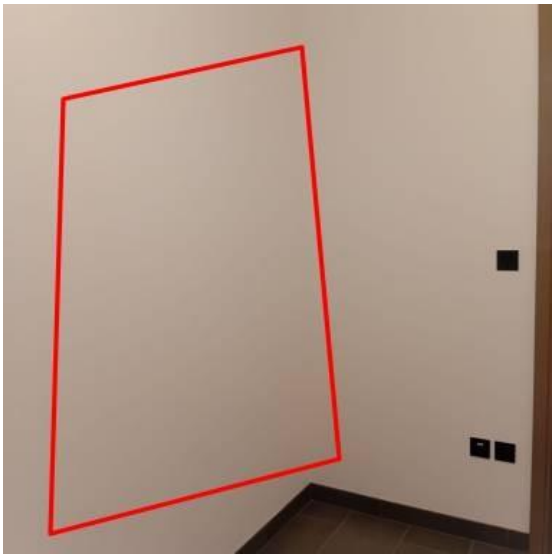
(29)

Location: Maid room
Status: Open
Comments:

Stains mark observed on the wall

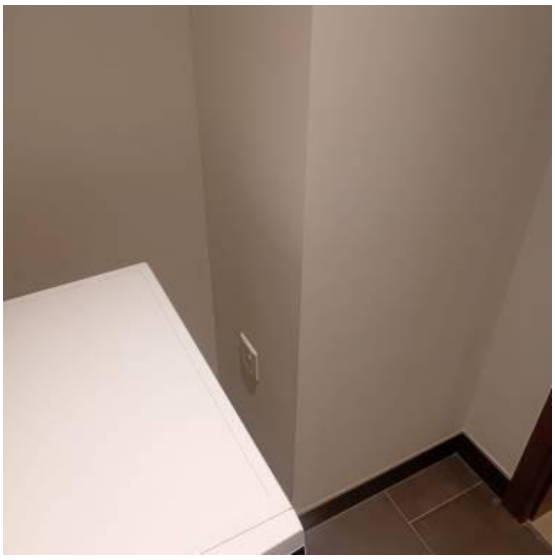
(79)

Location: Laundry
Status: Open
Comments:

Uneven painting observed on the wall
