AI Vision Inspection Report

7/9/2026, 10:33:38 pm

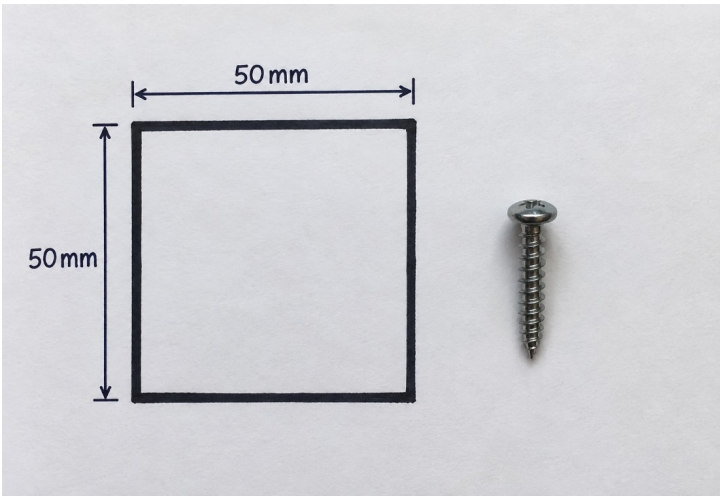
Component:	Shaft / elongated part
AI confidence:	86%
Calibration:	Auto square reference (50 mm)
Scale:	0.1157 mm/pixel
Overall length:	27.8 mm
Width / diameter:	8.6 mm
Uncertainty:	±0.23 mm*
Inspection:	PASS
Defect check:	No obvious gross geometric abnormality detected in the 2D silhouette.
Standards:	No fastener standard match applied.
