Barcelona Gardens Condominium

Typical elevations by building · Concrete and stucco repair locations

Project
Barcelona Gardens Condominium
101 E McNab Rd,
Pompano Beach, FL 33060

Sheet title
Cover and index
Typical elevations by building
Concrete and stucco repairs per NV5

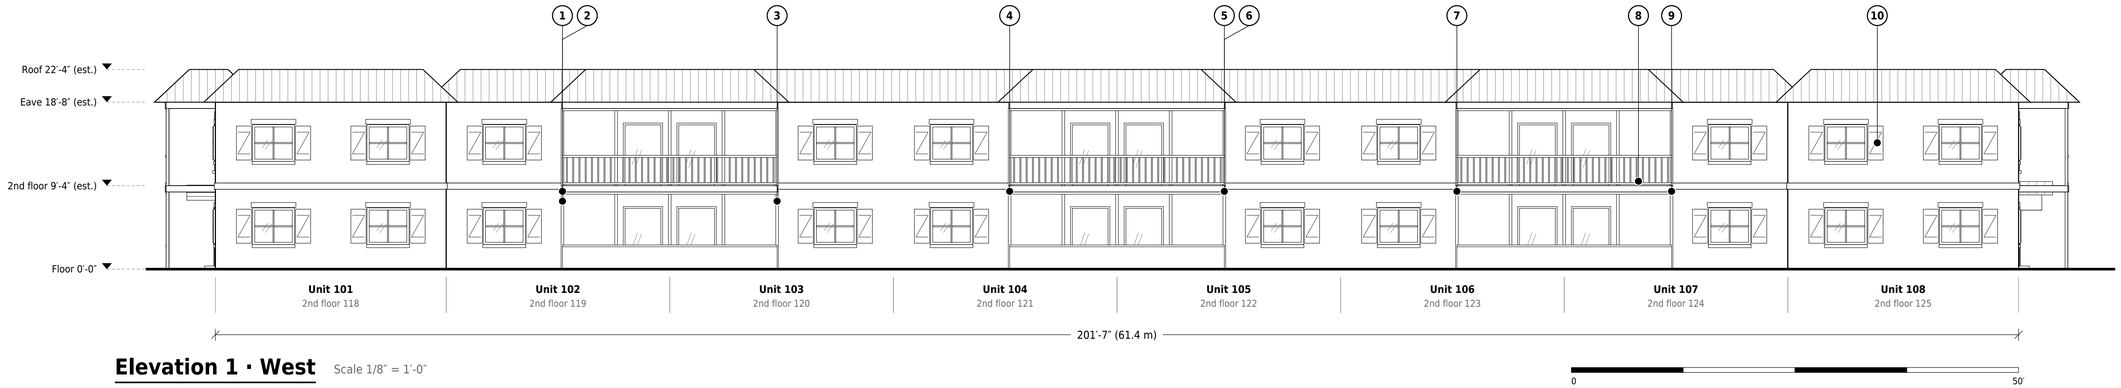
Sheet
E-000

No.	Code	Location and description	Floor	To exit
1	**B**	Beam crack. Right column, balconies 103/102	Ground	54′-10″
2	**RS**	Rust, balcony 102	Ground	51′-0″
3	**RS**	Rust, balcony 103	Ground	71′-11″
4	**B**	Beam crack. Right column, balconies 105/104	Ground	96′-10″
5	**B**	Beam crack. Left column, balconies 105/104	Ground	96′-10″
6	**E**	Edge. Side edge, balcony 105	Ground	95′-5″
7	**B**	Beam crack. Right column, balconies 107/106	Ground	73′-9″
8	**FL**	Balcony 124 floor, waterproofing required	2nd	55′-2″
9	**B**	Beam crack. Left column, balconies 107/106	Ground	54′-10″
10	**ST**	Stucco, corner of unit 125	2nd	41′-10″
11	**B**	Beam crack. Left column, balconies 110/111	Ground	55′-5″
12	**BL**	Block crack between balconies 110/111	Ground	64′-5″
13	**B/E**	Beam edge, balcony 111	Ground	71′-11″
14	**B/E**	Beam edge, balcony 112	Ground	95′-5″
15	**B/E**	Beam edge, balcony 114	Ground	95′-5″
16	**B**	Beam crack. Right column, balconies 112/114	Ground	97′-3″

17	**B**	Beam crack. Left column, balconies 115/116	Ground	74′-3″
18	**B**	Beam crack. Right column, balconies 115/116	Ground	55′-5″
19	**B/E**	Beam edge, balcony 116	Ground	52′-9″
20	**BR/ST**	Cracked brick and stucco, wall of unit 116	Ground	47′-3″
21	**BR**	Cracked brick, wall of unit 117	Ground	40′-7″

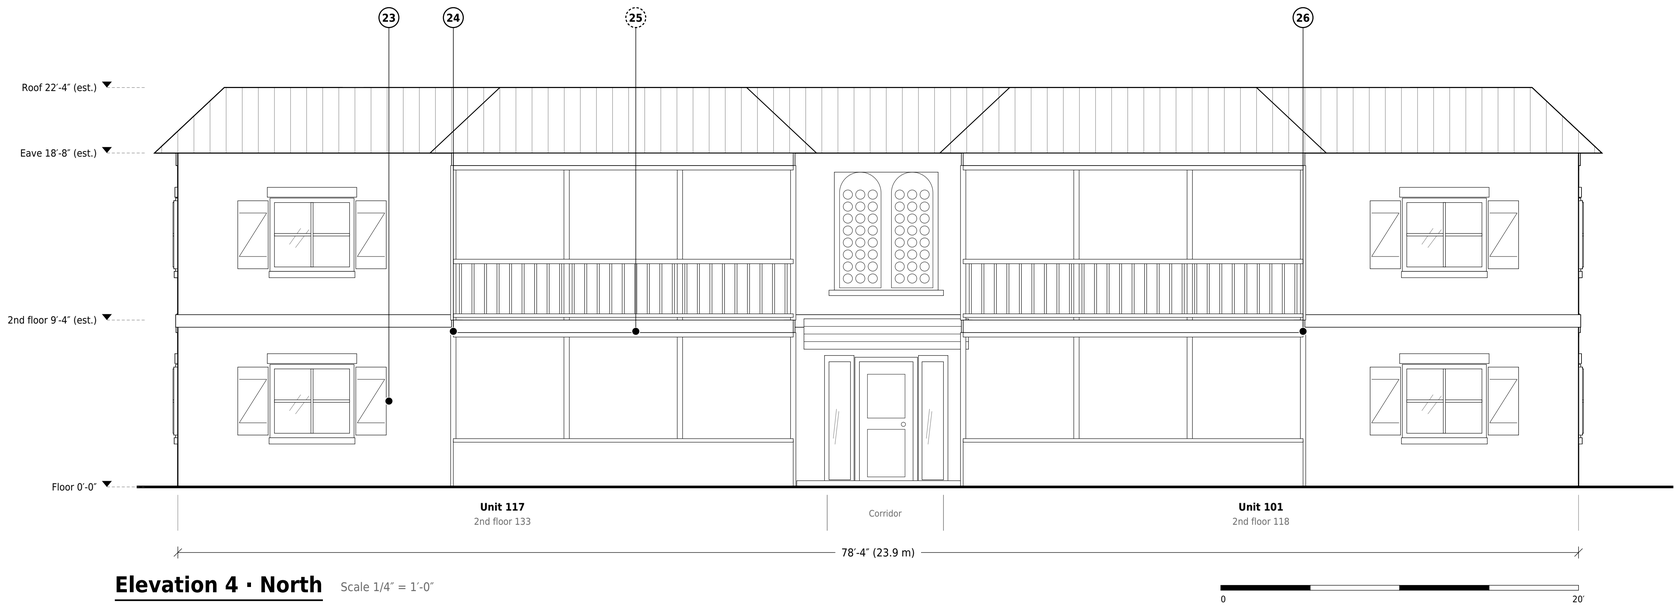
Sheet
E-101

No.	Code	Location and description	Floor	To exit
22	**B**	Beam crack. Corner of balcony 108	Ground	23′-11″
23	**ST/W**	Stucco at end wall of unit 117	Ground	27′-10″
24	**B**	Beam crack. Corner of balcony 117	Ground	24′-10″
25	**E/OH**	Overhead edge, balcony 117	Ground	15′-0″
26	**B**	Beam crack. Corner of balcony 101	Ground	23′-11″

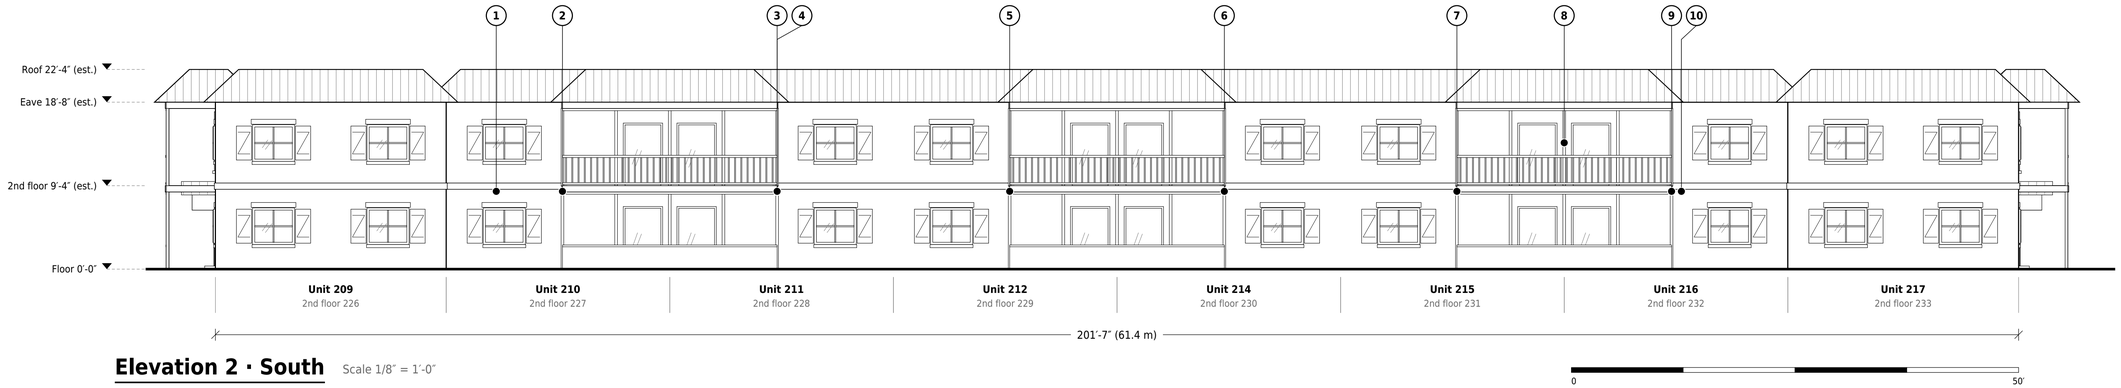
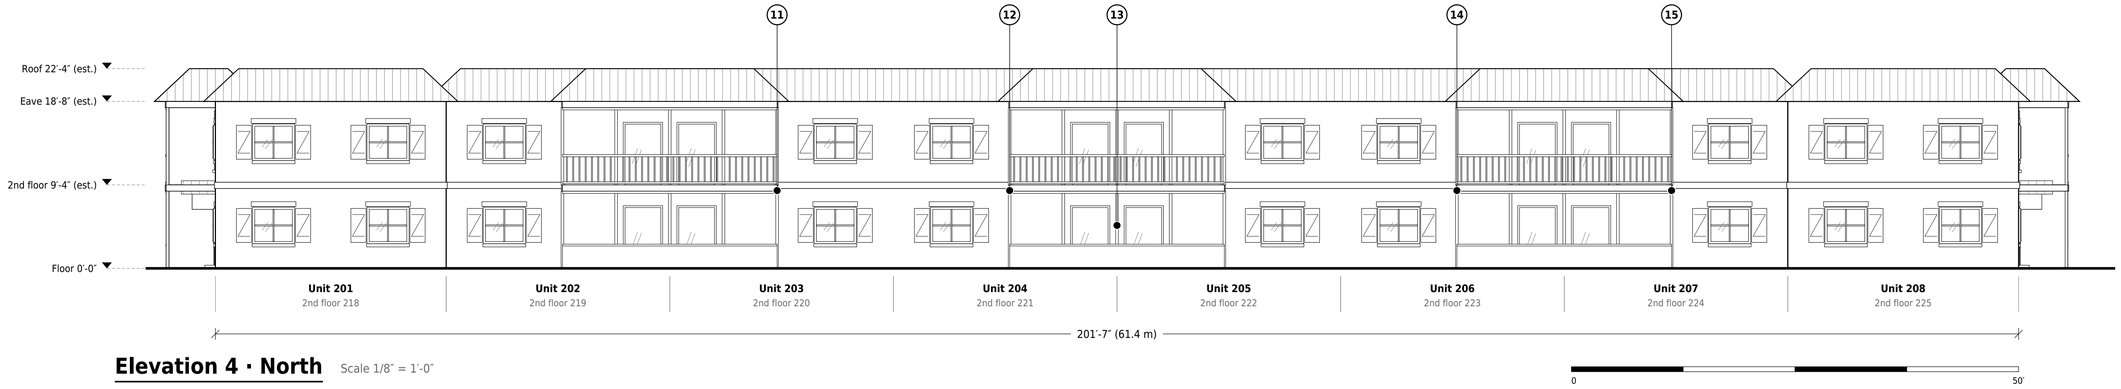
Sheet
E-102

No.	Code	Location and description	Floor	To exit
1	B/E	Beam edge, wall of unit 210	Ground	44′-8″
2	B	Beam crack. Left column, balconies 210/211	Ground	55′-5″
3	B	Beam crack. Right column, balconies 210/211	Ground	74′-3″
4	B/E	Beam edge, balcony 211	Ground	71′-11″
5	B	Beam crack. Left column, balconies 212/214	Ground	97′-3″
6	B	Beam crack. Right column, balconies 212/214	Ground	97′-3″
7	B	Beam crack. Left column, balconies 215/216	Ground	74′-3″
8	ST	Stucco, column between balconies 231/232	2nd	64′-5″
9	B	Beam crack. Right column, balconies 215/216	Ground	55′-5″
10	B/E	Beam edge, balcony 216	Ground	50′-2″
11	B	Beam crack. Left column, balconies 203/202	Ground	73′-9″
12	B	Beam crack. Right column, balconies 205/204	Ground	96′-10″
13	ST	Stucco, center column of balconies 205/204	Ground	108′-0″
14	B	Beam crack. Right column, balconies 207/206	Ground	73′-9″
15	B	Beam crack. Left column, balconies 207/206	Ground	54′-10″

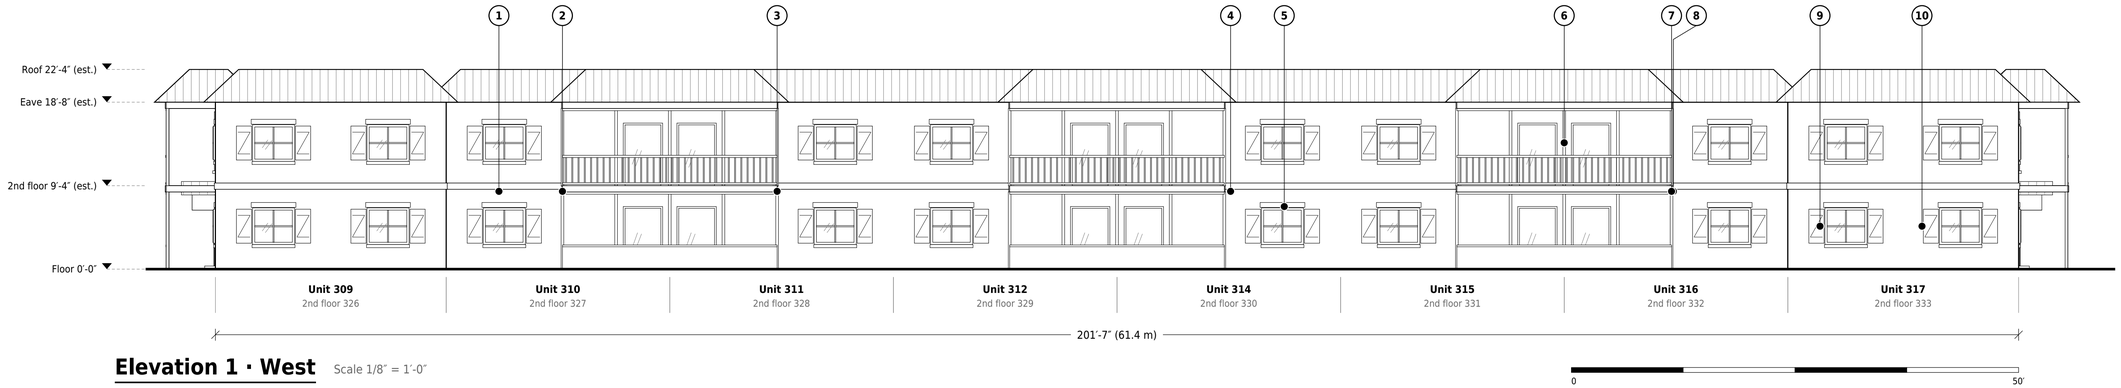
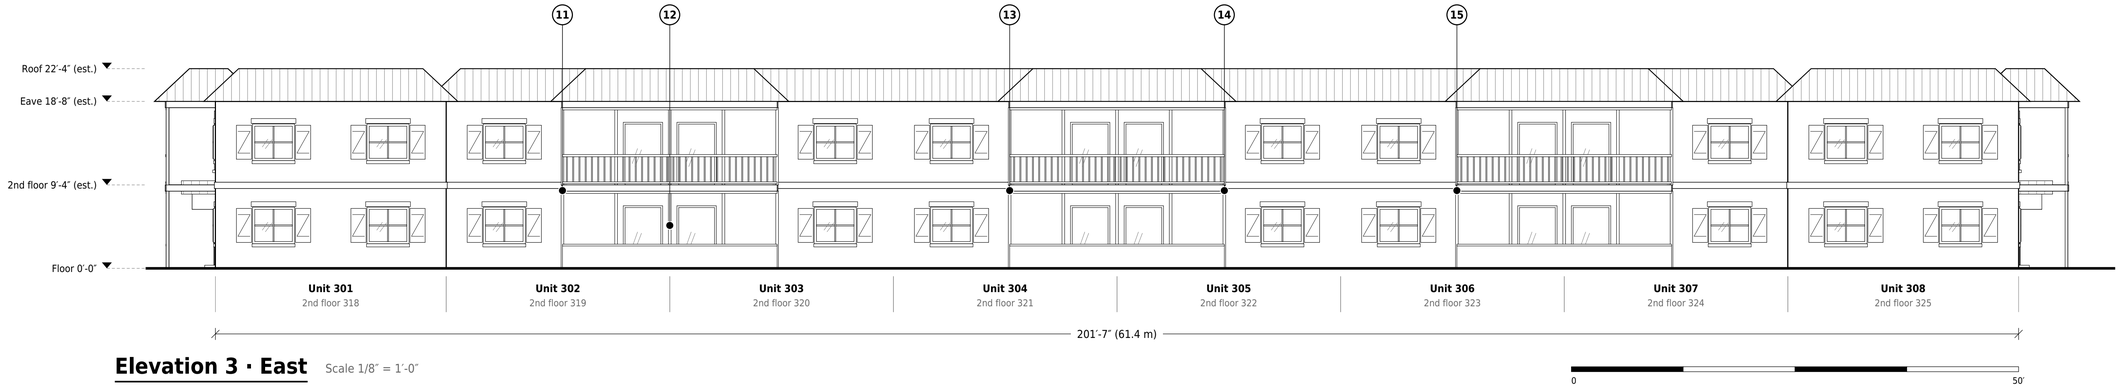
Sheet
E-202

No.	Code	Location and description	Floor	To exit
1	B/E	Beam edge, wall of unit 310	Ground	44′-11″
2	B	Beam crack. Left column, balconies 310/311	Ground	55′-5″
3	B	Beam crack. Right column, balconies 310/311	Ground	74′-3″
4	B/E	Beam edge next to column of balconies 312/314	Ground	94′-3″
5	BR	Cracked brick veneer, wall of unit 315	Ground	88′-1″
6	ST	Stucco, column between balconies 331/332	2nd	64′-5″
7	B	Beam crack. Right column, balconies 315/316	Ground	55′-5″
8	B/E	Beam edge, balcony 316	Ground	51′-0″
9	ST	Stucco, wall of unit 317	Ground	45′-5″
10	ST	Stucco, wall of unit 317	Ground	41′-1″
11	B	Beam crack. Right column, balconies 303/302	Ground	54′-10″
12	ST	Stucco, center column of balconies 303/302	Ground	63′-10″
13	E	Edge, right column of balconies 305/304	Ground	96′-10″
14	B	Beam crack. Left column, balconies 305/304	Ground	96′-10″
15	B/E	Beam edge, balcony 306	Ground	71′-4″

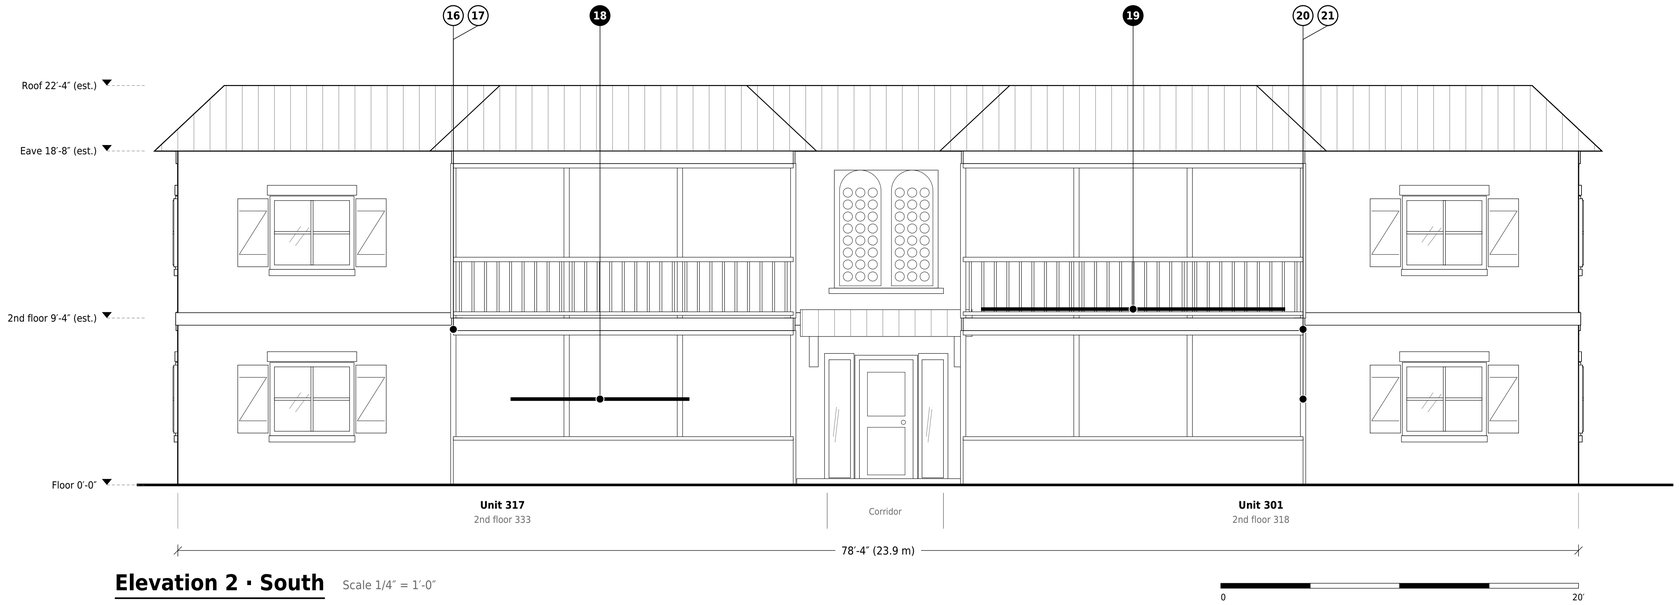
Sheet
E-301

No.	Code	Location and description	Floor	To exit
16	**B**	Beam crack. Corner of balcony 317	Ground	24′-10″
17	**B/E**	Beam edge, balcony 317	Ground	24′-3″
18	**Hatch**	Unlabeled hatch at edge of balcony 317	Ground	**12′-4″**
19	**FL**	Balcony 318 floor, waterproofing required	2nd	**6′-0″**
20	**B**	Beam crack. Corner of balcony 301	Ground	23′-11″
21	**ST**	Stucco, end wall next to balcony 301	Ground	23′-4″
22	**C**	Code “C” (not in legend), balcony 308 next to north exit	Ground	**7′-0″**
23	**B/E**	Beam edge, corner of balcony 309	Ground	24′-10″

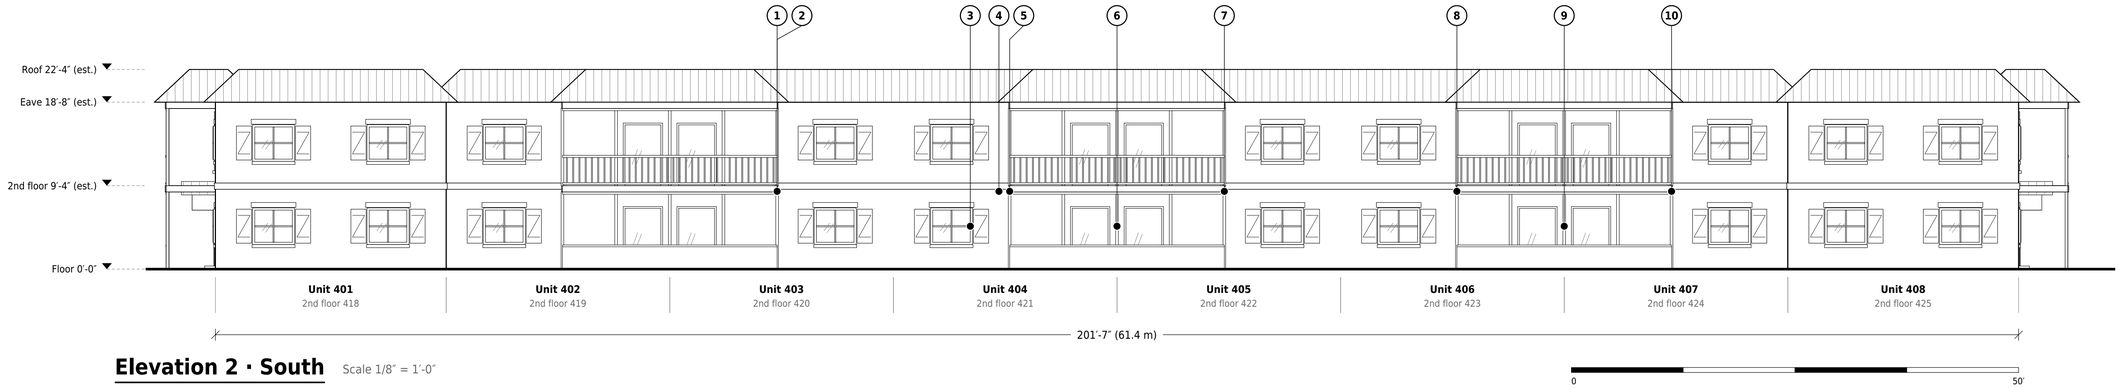
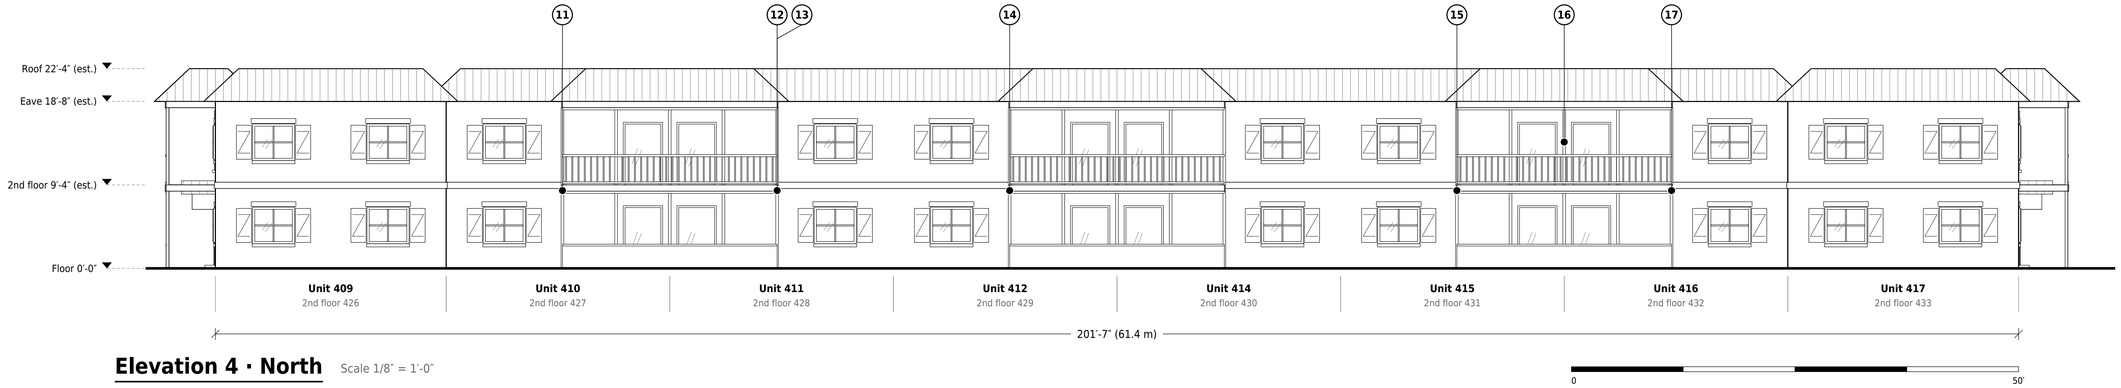
Sheet
E-302

No.	Code	Location and description	Floor	To exit
1	B	Beam crack. Left column, balconies 403/402	Ground	73′-9″
2	B/E	Beam edge, balcony 403	Ground	70′-8″
3	ST	Stucco, wall of unit 403	Ground	89′-10″
4	B/E	Beam edge next to balcony 404	Ground	93′-6″
5	B	Beam crack. Right column, balconies 405/404	Ground	96′-10″
6	ST	Stucco, center column of balconies 405/404	Ground	108′-0″
7	B/E	Beam edge, balcony 405	Ground	94′-6″
8	B	Beam crack. Right column, balconies 407/406	Ground	73′-9″
9	ST	Stucco, center column of balconies 407/406	Ground	63′-10″
10	B	Beam crack. Left column, balconies 407/406	Ground	54′-10″
11	B	Beam crack. Left column, balconies 410/411	Ground	55′-5″
12	B	Beam crack. Right column, balconies 410/411	Ground	74′-3″
13	B/E	Beam edge, balcony 411	Ground	71′-4″
14	B	Beam crack. Left column, balconies 412/414	Ground	97′-3″
15	B/E	Beam edge, balcony 415	Ground	71′-3″
16	ST	Stucco, column between balconies 431/432	2nd	64′-5″

17	B	Beam crack. Right column, balconies 415/416	Ground	55′-5″

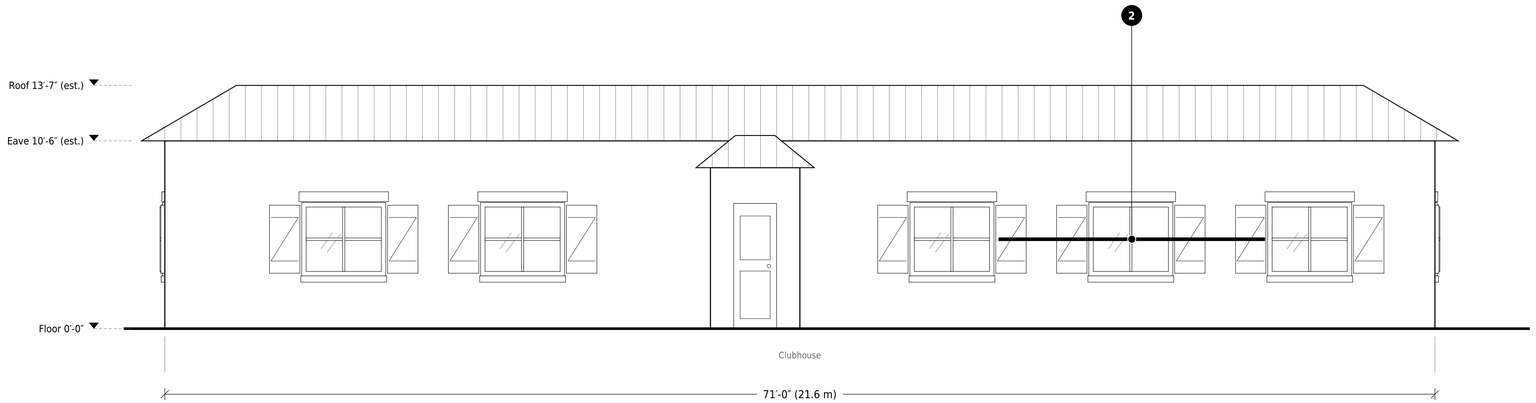
Sheet
E-402

No.	Code	Location and description	Floor	To exit
1	ST	Stucco, clubhouse south wall	Ground	8′-4″
2	ST	Stucco, clubhouse north wall	Ground	13′-7″
