Barcelona Gardens Condominium

Typical elevations by building · Concrete and stucco repair locations

Project
Barcelona Gardens Condominium
101 E McNab Rd,
Pompano Beach, FL 33060

Sheet title
Cover and index
Typical elevations by building
Concrete and stucco repairs per NV5

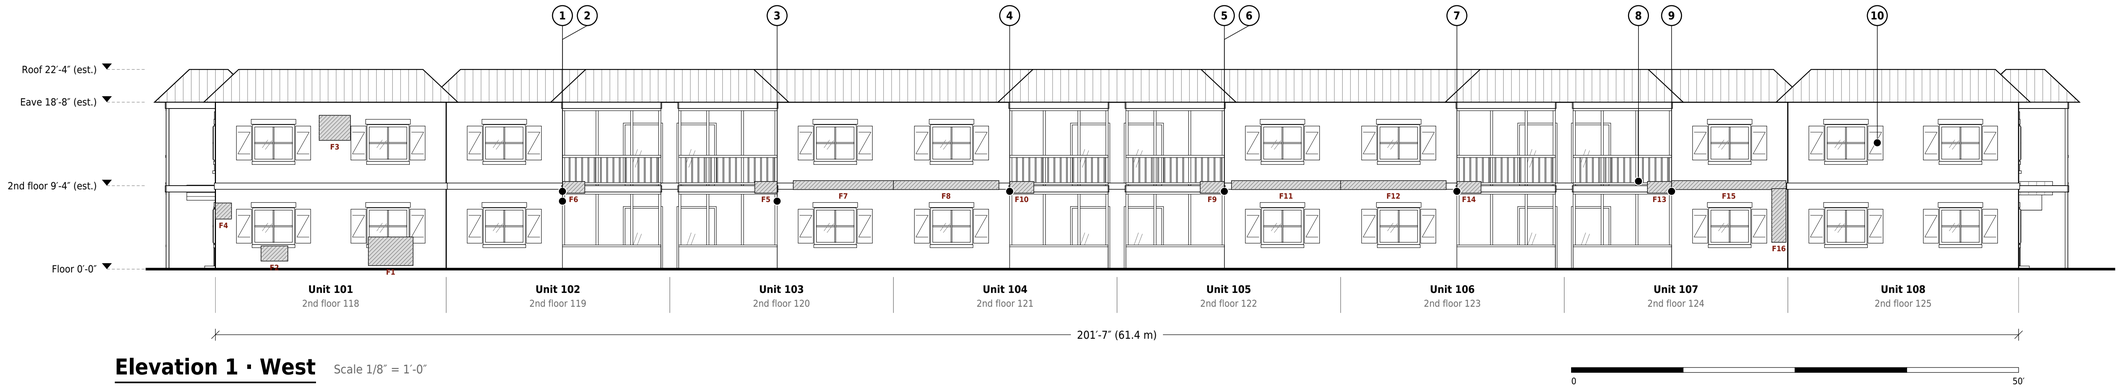
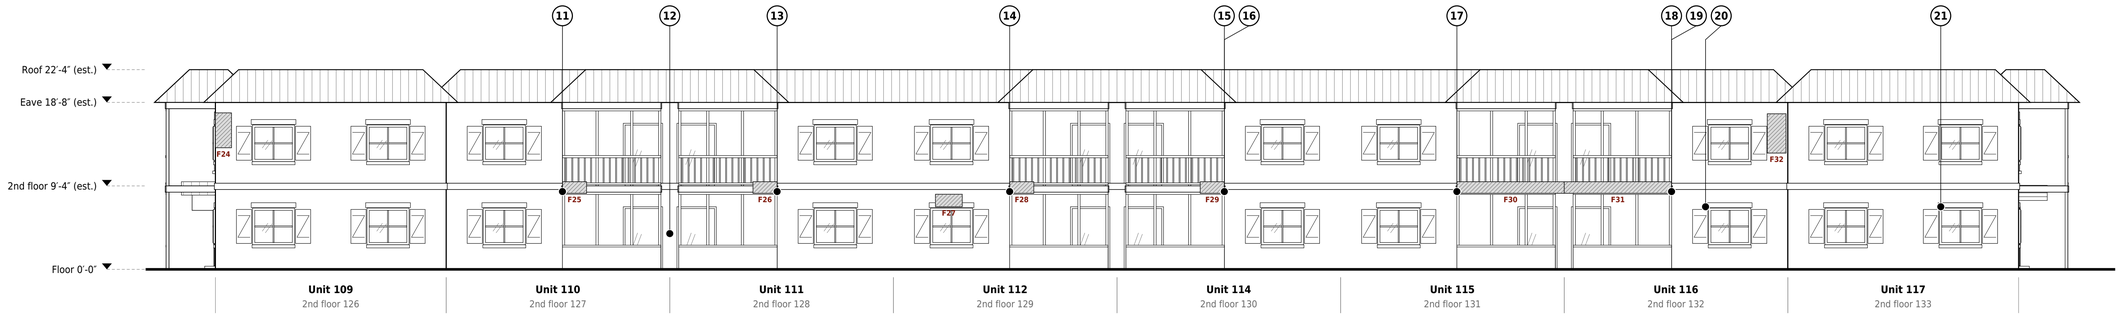
Building 100 · Elevations 1 West and 3 East

No.	Code	Location and description	Floor	To exit
1	**B**	Beam crack. Right column, balconies 103/102	Ground	54′-10″
2	**RS**	Rust, balcony 102	Ground	51′-0″
3	**RS**	Rust, balcony 103	Ground	71′-11″
4	**B**	Beam crack. Right column, balconies 105/104	Ground	96′-10″
5	**B**	Beam crack. Left column, balconies 105/104	Ground	96′-10″
6	**E**	Edge. Side edge, balcony 105	Ground	95′-5″
7	**B**	Beam crack. Right column, balconies 107/106	Ground	73′-9″
8	**FL**	Balcony 124 floor, waterproofing required	2nd	55′-2″
9	**B**	Beam crack. Left column, balconies 107/106	Ground	54′-10″
10	**ST**	Stucco, corner of unit 125	2nd	41′-10″
11	**B**	Beam crack. Left column, balconies 110/111	Ground	55′-5″
12	**BL**	Block crack between balconies 110/111	Ground	64′-5″
13	**B/E**	Beam edge, balcony 111	Ground	71′-11″
14	**B/E**	Beam edge, balcony 112	Ground	95′-5″
15	**B/E**	Beam edge, balcony 114	Ground	95′-5″
16	**B**	Beam crack. Right column, balconies 112/114	Ground	97′-3″

17	**B**	Beam crack. Left column, balconies 115/116	Ground	74′-3″
18	**B**	Beam crack. Right column, balconies 115/116	Ground	55′-5″
19	**B/E**	Beam edge, balcony 116	Ground	52′-9″
20	**BR/ST**	Cracked brick and stucco, wall of unit 116	Ground	47′-3″
21	**BR**	Cracked brick, wall of unit 117	Ground	40′-7″

No.	Location	Description	Photos
F1	Un 101	Gray stucco patch below the south ground-floor window, west wall of unit 101	4, 6
F2	Un 101	Small stucco patch below the north ground-floor window, west wall of unit 101	4, 6
F3	Un 118	Stucco patch between the 2nd-floor windows above unit 101 (unit 118)	5, 6
F4	Un 101	Patch at the northwest corner next to the red alarm box	3
F5	Un 103	Slab-edge patch at the left column of balconies 103/102 (west)	8
F6	Un 102	Slab-edge patch at the right column of balconies 103/102 (west)	8
F7	Un 103	Patched slab band between floors, recess at unit 103	9
F8	Un 104	Patched slab band between floors, recess at unit 104	9
F9	Un 105	Slab-edge patch at the left column of balconies 105/104 (west)	10
F10	Un 104	Slab-edge patch at the right column of balconies 105/104 (west)	10
F11	Un 105	Patched slab band between floors, recess at unit 105	11
F12	Un 106	Patched slab band between floors, recess at unit 106	11

F13	Un 107	Slab-edge patch at the left column of balconies 107/106 (west)	12, 14, 15
F14	Un 106	Slab-edge patch at the right column of balconies 107/106 (west)	12, 14, 15
F15	Un 107	Patched slab band between floors, recess at unit 107	13
F16	Un 107	Vertical stucco patch at the inside corner next to unit 108	16
F24	Un 126	Stucco patch at the southeast corner, 2nd floor (unit 126), next to the BLDG 100 sign	26, 27
F25	Un 110	Slab-edge patch at the left column of balconies 110/111 (east)	30, 31
F26	Un 111	Slab-edge patch at the right column of balconies 110/111 (east)	30, 31
F27	Un 112	Stucco patch above the ground-floor window arch, unit 112	32
F28	Un 112	Slab-edge patch at the left column of balconies 112/114 (east)	34, 35, 36
F29	Un 114	Slab-edge patch at the right column of balconies 112/114 (east)	34, 35, 36
F30	Un 115	Slab-edge repairs with primer along balcony 115 (east)	42, 43, 44
F31	Un 116	Slab-edge repairs with primer along balcony 116 (east)	42, 43, 44

F32	Un 132	Stucco patch at the inside corner next to unit 117, 2nd floor (unit 132)	48
