Barcelona Gardens Condominium

Typical elevations by building · Concrete and stucco repair locations

Sheet title
Cover and index
Typical elevations by building
Concrete and stucco repairs per NV5

MTD Job No.
2025-016-12

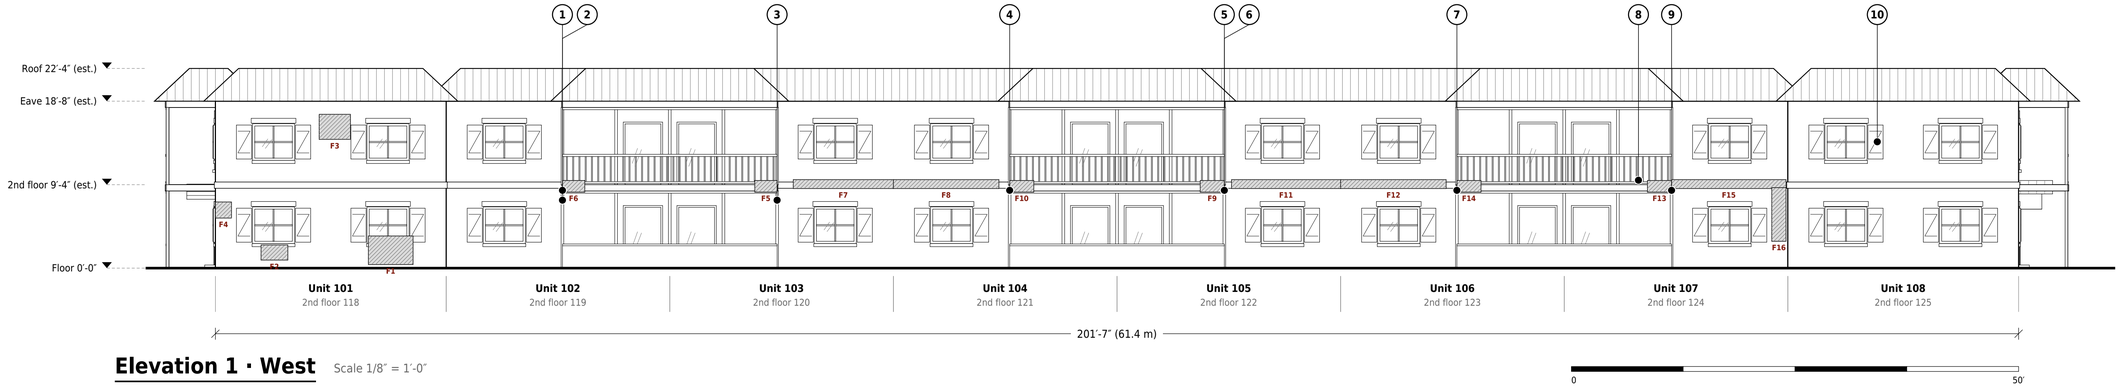
Elevation 1 · West

No.	Code	Location and description	Floor	To exit
1	B	Beam crack. Right column, balconies 103/102	Ground	54′-10″
2	RS	Rust, balcony 102	Ground	51′-0″
3	RS	Rust, balcony 103	Ground	71′-11″
4	B	Beam crack. Right column, balconies 105/104	Ground	96′-10″
5	B	Beam crack. Left column, balconies 105/104	Ground	96′-10″
6	E	Edge. Side edge, balcony 105	Ground	95′-5″
7	B	Beam crack. Right column, balconies 107/106	Ground	73′-9″
8	FL	Balcony 124 floor, waterproofing required	2nd	55′-2″
9	B	Beam crack. Left column, balconies 107/106	Ground	54′-10″
10	ST	Stucco, corner of unit 125	2nd	41′-10″
11	B	Beam crack. Left column, balconies 110/111	Ground	55′-5″
12	BL	Block crack between balconies 110/111	Ground	64′-5″
13	B/E	Beam edge, balcony 111	Ground	71′-11″
14	B/E	Beam edge, balcony 112	Ground	95′-5″
15	B/E	Beam edge, balcony 114	Ground	95′-5″
16	B	Beam crack. Right column, balconies 112/114	Ground	97′-3″
17	B	Beam crack. Left column, balconies 115/116	Ground	74′-3″

18	B	Beam crack. Right column, balconies 115/116	Ground	55′-5″
19	B/E	Beam edge, balcony 116	Ground	52′-9″
20	BR/ST	Cracked brick and stucco, wall of unit 116	Ground	47′-3″
21	BR	Cracked brick, wall of unit 117	Ground	40′-7″

No.	Location	Description	Photos
F1	Un 101	Gray stucco patch below the south ground-floor window, west wall of unit 101	4, 6
F2	Un 101	Small stucco patch below the north ground-floor window, west wall of unit 101	4, 6
F3	Un 118	Stucco patch between the 2nd-floor windows above unit 101 (unit 118)	5, 6
F4	Un 101	Patch at the northwest corner next to the red alarm box	3
F5	Un 103	Slab-edge patch at the left column of balconies 103/102 (west)	8
F6	Un 102	Slab-edge patch at the right column of balconies 103/102 (west)	8
F7	Un 103	Patched slab band between floors, recess at unit 103	9
F8	Un 104	Patched slab band between floors, recess at unit 104	9
F9	Un 105	Slab-edge patch at the left column of balconies 105/104 (west)	10
F10	Un 104	Slab-edge patch at the right column of balconies 105/104 (west)	10
F11	Un 105	Patched slab band between floors, recess at unit 105	11
F12	Un 106	Patched slab band between floors, recess at unit 106	11

F13	Un 107	Slab-edge patch at the left column of balconies 107/106 (west)	12, 14, 15
F14	Un 106	Slab-edge patch at the right column of balconies 107/106 (west)	12, 14, 15
F15	Un 107	Patched slab band between floors, recess at unit 107	13
F16	Un 107	Vertical stucco patch at the inside corner next to unit 108	16
F24	Un 126	Stucco patch at the southeast corner, 2nd floor (unit 126), next to the BLDG 100 sign	26, 27
F25	Un 110	Slab-edge patch at the left column of balconies 110/111 (east)	30, 31
F26	Un 111	Slab-edge patch at the right column of balconies 110/111 (east)	30, 31
F27	Un 112	Stucco patch above the ground-floor window arch, unit 112	32
F28	Un 112	Slab-edge patch at the left column of balconies 112/114 (east)	34, 35, 36
F29	Un 114	Slab-edge patch at the right column of balconies 112/114 (east)	34, 35, 36
F30	Un 115	Slab-edge repairs with primer along balcony 115 (east)	42, 43, 44
F31	Un 116	Slab-edge repairs with primer along balcony 116 (east)	42, 43, 44

F32	Un 132	Stucco patch at the inside corner next to unit 117, 2nd floor (unit 132)	48
