### Rail Accident Report

Investigation into station pedestrian crossings (including pedestrian gates at highway level crossings);

with reference to the fatal accident at Elsenham station on 3 December 2005

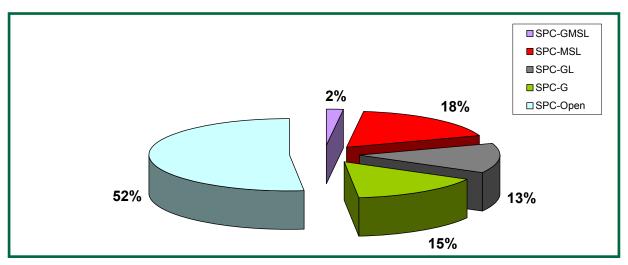
- 83 Network Rail was requested to provide a listing of all *station pedestrian level crossings* on their network for the purpose of this investigation. This data revealed a lack of consistency in the definitions that were adopted, the inclusion of some staff crossings and a number of inaccuracies. However, it proved possible to use the data to identify the distribution of various types of station pedestrian crossing. This distribution is shown in Table 1 and Figure 9.
- Table 1 indicates that the distribution of station pedestrian crossings is far from uniform. The majority of such crossings (58%) are located in the eastern part of the country (Network Rail's London North Eastern and Anglia routes). The remainder are mainly located in the West Country, Wales and western parts of the Midlands. By contrast only 3% of the total number are located to the south of the River Thames.

Figure 9: Pie chart types of station pedestrian crossing as a proportion of the total (see Table 1)

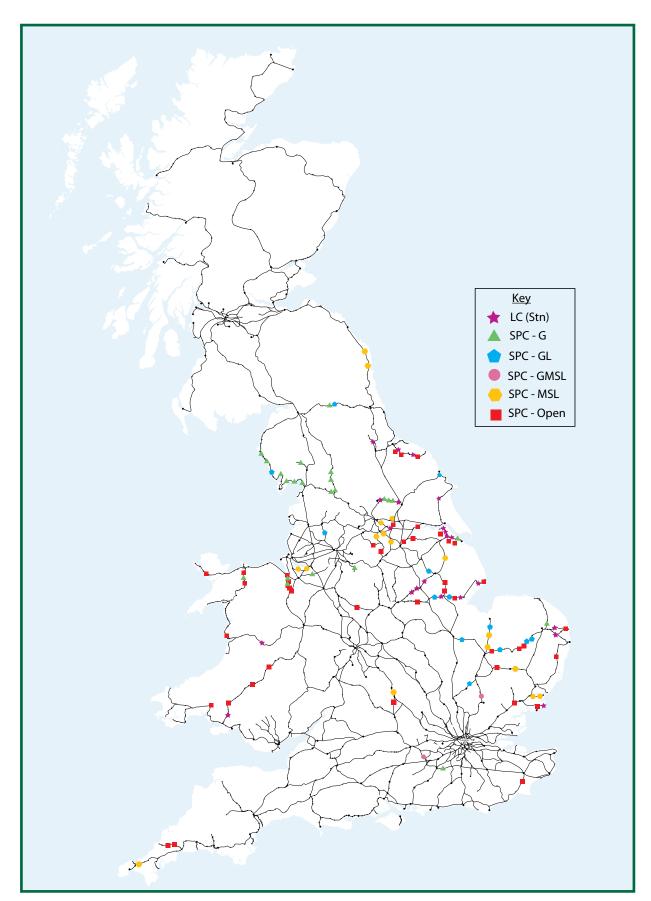
- 85 The map at Figure 10 shows even more vividly the uneven spread of station pedestrian crossings and distinct clusters in the following areas:
  - East Anglia and Lincolnshire;
  - Yorkshire;
  - Cumbrian Coast;
  - North part of the Welsh Marches.
- 86 Other parts of the country have a very low population of crossings of this type. These include:
  - London and the South-east;
  - Midlands;
  - Sheffield and Manchester;
  - Scotland
- 87 The main factors giving rise to this uneven spread are as follows:

- Level crossings of all types are more prevalent in areas of flat terrain.
- Level crossings were often built in areas of low population since the anticipated levels of road traffic were insufficient to justify the construction of bridges. In some such areas the population has since grown significantly since the level crossing was constructed (e.g. at Elsenham).

Figure 10: Distribution of station pedestrian crossings in England, Wales and Scotland

- 132 Figure 10 shows that the distribution of station pedestrian crossings on the UK mainland is uneven. The reasons for this are discussed at paragraph 87.
- 133 The uneven spread of station pedestrian crossings suggests that any measures to familiarise the users of these crossings should be concentrated on the distinct geographical areas in which these crossings are most likely to be found.
- 134 There are no evident significant differences in the way in which the Network Rail territories are managing the risks associated with station pedestrian crossings.

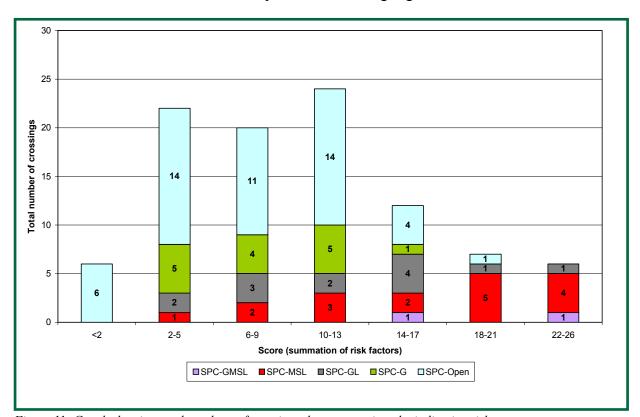
Figure 11: Graph showing total numbers of crossings, by type, against the indicative risk score

- 138 Using data relative to each of the selected inherent risk factors the RAIB has scored the risk at each of the 97 crossings. This was done using a similar scoring system as adopted by Network Rail in its station pedestrian crossing risk assessments (paragraph 121). In this way it was possible to generate an indicative risk score for every known station pedestrian crossing. In turn this has allowed the ranking of crossings by the risk score. Figure 11 shows the total numbers of station pedestrian crossings against the indicative risk score.

- 142 Using Figure 11 and Table 2 it is possible to derive some conclusions about the way in which crossing type is currently related to the severity of hazard. These conclusions are as follows:

- There is no clear correlation between the provision of locks at station pedestrian crossings and the severity of hazard. This lack of correlation may be linked to the fact that pedestrian gate locks have tended to survive on lesser used lines where mechanical signal boxes are still in use.

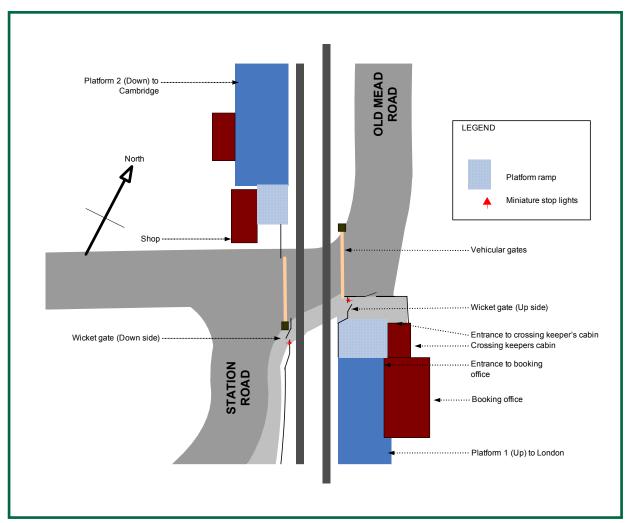
Figure 17: Sketch plan of Elsenham station

- 253 At 10:40 hrs on 3 December 2005 two young girls were struck by a fast moving train on the station pedestrian crossing at Elsenham station in Essex. Both girls were killed.
- 254 Immediately prior to the accident the two girls had purchased tickets from the booking office on the east side of the line (the Up platform) and were in the process of walking to the opposite platform to catch the 10:41 hrs service to Cambridge.
- 255 The station pedestrian crossing was fitted with miniature stop lights and an audible alarm to warn passengers of the approach of trains.
- 256 Figure 1 shows a map of the locality. Figure 17 shows a sketch plan of the station and the crossings.
