Circuit Debugging Assistant
Circuit Diagnostic Report

Report ID: ANALYSIS-0E5EB5A9
Date: 2026-10-13 23:30
Circuit: Rc Low Pass

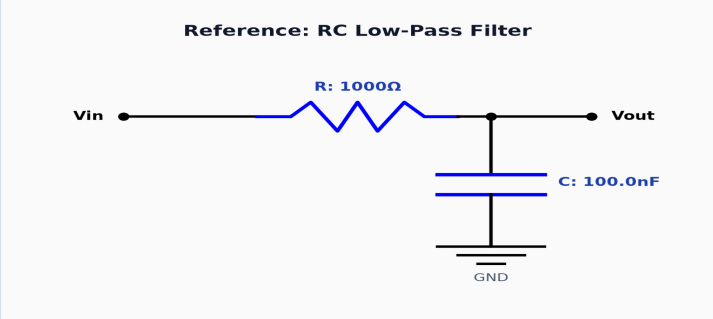
Figure 1A: Uploaded Circuit Schematic

Severity	Component / Net	Finding & Evidence	Recommended Action
Major	**Net 'in'**	Node 'in' is connected to only 1 component terminal: ['R'].	Check for missing wire or unconnected terminal on net 'in'.

1. **Physical Verification:** Perform **DMM Resistance Measurement on R1** to independently separate ambiguous parameter hypotheses.
2. **Signal Integrity:** Measure test points with a 10:1 passive probe to avoid probe capacitance loading.
3. **Post-Repair Gate:** Confirm that measured response stays within ±5% of reference cutoff before releasing design.

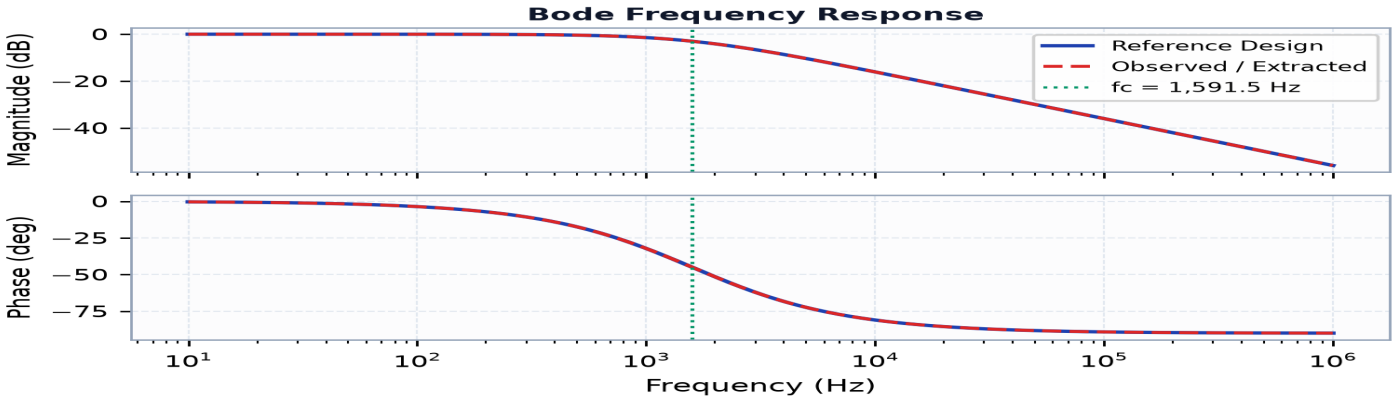
6. Numerical Simulation Curves

- **Transfer Function:** H(f) = 1 / (1 + j 2π f R C)
- **Theoretical Cutoff Frequency:** fc = 1 / (2π · R · C) = **1591.55 Hz**
- **Initial Step Current (Independent Observable):** I_step(0+) = Vin / R = **1.00 mA**
