Circuit Debugging Assistant
Circuit Diagnostic Report

Report ID: ANALYSIS-6DFC1256
Date: 2026-10-13 23:58
Circuit: Rc Low Pass

STATUS:
POTENTIAL ISSUES IDENTIFIED

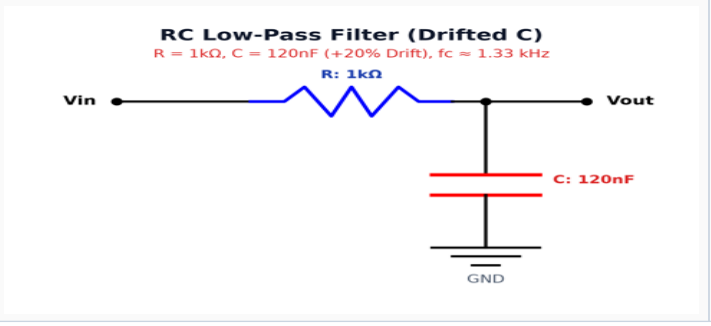
Figure 1A: Uploaded Circuit Schematic

The device under test was analyzed as a **Rc Low Pass**. Numerical multi-evidence evaluation identified a probable parameter shift on **R -20%** (normalized residual score: **25.2147**). A total of 0 structural or parameter observations were cataloged.

Severity	Component / Net	Finding & Evidence	Recommended Action
Major	**R**	Normalized residual S(f)=25.215 matches R -20% signature.	Verify R value with bench meter or replace with nominal part.

1. **Physical Verification:** Perform **DMM Resistance Measurement on R1** to independently separate ambiguous parameter hypotheses.
2. **Signal Integrity:** Measure test points with a 10:1 passive probe to avoid probe capacitance loading.
3. **Post-Repair Gate:** Confirm that measured response stays within ±5% of reference cutoff before releasing design.

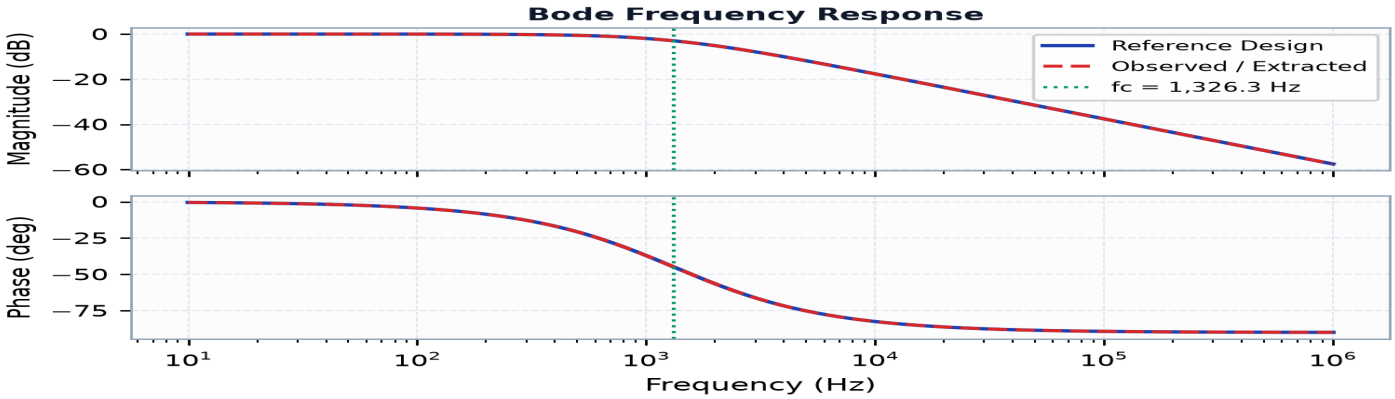
6. Numerical Simulation Curves

- **Transfer Function:** $H(f) = 1 / (1 + j\,2\pi\,f\,R\,C)$
- **Theoretical Cutoff Frequency:** $f_c = 1 / (2\pi \cdot R \cdot C)$ = **1326.29 Hz**
- **Initial Step Current (Independent Observable):** $I_{step}(0+) = V_{in} / R$ = **1.00 mA**
