Circuit Debugging Assistant
Circuit Diagnostic Report

Report ID: ANALYSIS-B69BEDF4
Date: 2026-10-13 23:29
Circuit: Rc Low Pass

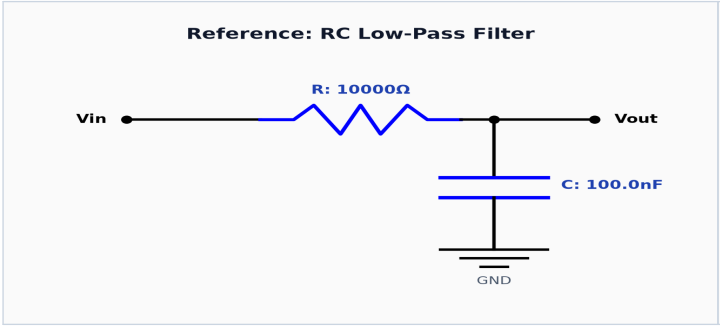
Figure 1A: Uploaded Circuit Schematic

The device under test was analyzed as a **Rc Low Pass**. Numerical multi-evidence evaluation identified a probable parameter shift on **R +20%** (normalized residual score: **14.5252**). A total of 0 structural or parameter observations were cataloged.

Severity	Component / Net	Finding & Evidence	Recommended Action
Major	**R**	Normalized residual S(f)=14.525 matches R +20% signature.	Verify R value with bench meter or replace with nominal part.

1. **Physical Verification:** Perform **DMM Resistance Measurement on R1** to independently separate ambiguous parameter hypotheses.
2. **Signal Integrity:** Measure test points with a 10:1 passive probe to avoid probe capacitance loading.
3. **Post-Repair Gate:** Confirm that measured response stays within ±5% of reference cutoff before releasing design.

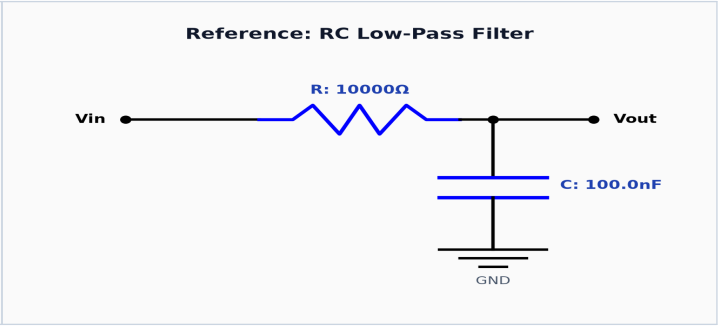
Figure 1B: Expected / Reference Circuit Model

- **Transfer Function:** H(f) = 1 / (1 + j 2π f R C)
- **Theoretical Cutoff Frequency:** fc = 1 / (2π · R · C) = **159.15 Hz**
- **Initial Step Current (Independent Observable):** I_step(0+) = Vin / R = **0.10 mA**
