Circuit Debugging Assistant
Circuit Diagnostic Report

Report ID: ANALYSIS-B85841C9
Date: 2026-10-13 23:21
Circuit: Rc Low Pass

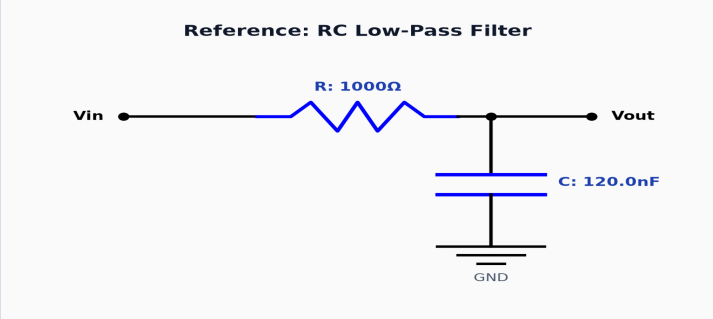
Figure 1A: Uploaded Circuit Schematic

The device under test was analyzed as a **Rc Low Pass**. Numerical multi-evidence evaluation identified a probable parameter shift on **C +20%** (normalized residual score: **0.0000**). A total of 0 structural or parameter observations were cataloged.

Severity	Component / Net	Finding & Evidence	Recommended Action
Major	C	Normalized residual S(f)=0.000 matches C +20% signature.	Verify C value with bench meter or replace with nominal part.

1. **Physical Verification:** Perform **DMM Resistance Measurement on R1** to independently separate ambiguous parameter hypotheses.
2. **Signal Integrity:** Measure test points with a 10:1 passive probe to avoid probe capacitance loading.
3. **Post-Repair Gate:** Confirm that measured response stays within ±5% of reference cutoff before releasing design.
