Circuit Debugging Assistant
Circuit Diagnostic Report

Report ID: ANALYSIS-CF687B24
Date: 2026-10-14 00:09
Circuit: Rc Low Pass

STATUS:
NO ISSUES DETECTED IN CHECKS

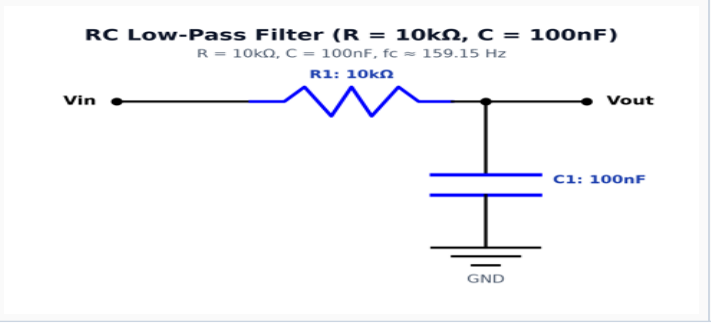
Figure 1A: Uploaded Circuit Schematic

All structural and parametric checks for the **Rc Low Pass** passed. The circuit conforms to the nominal reference topology, with closed electrical nets, designated ground reference, and component values within standard 5% manufacturing tolerances.

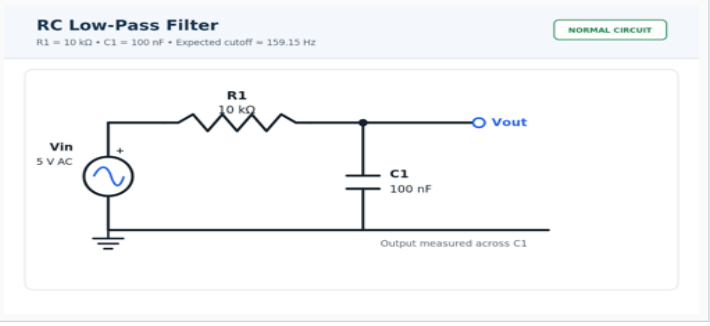
Figure 1B: Expected / Reference Circuit Model

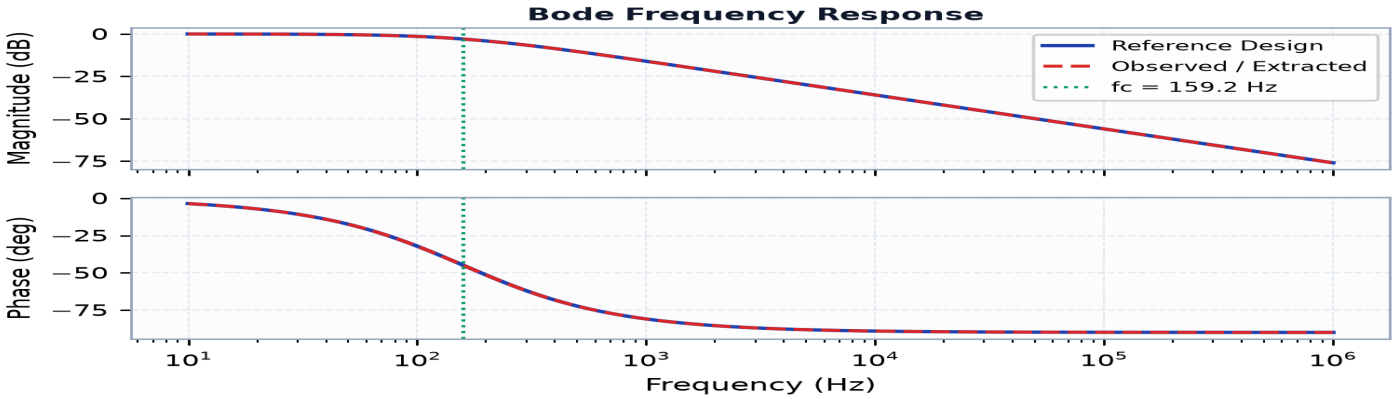
6. Numerical Simulation Curves

- **Transfer Function:** $H(f) = 1 / (1 + j\,2\pi\,f\,R\,C)$
- **Theoretical Cutoff Frequency:** $f_c = 1 / (2\pi \cdot R \cdot C)$ = **159.15 Hz**
- **Initial Step Current (Independent Observable):** $I_{step}(0+) = V_{in} / R$ = **0.10 mA**

1. **Physical Verification:** Perform **DMM Resistance Measurement on R1** to independently separate ambiguous parameter hypotheses.
2. **Signal Integrity:** Measure test points with a 10:1 passive probe to avoid probe capacitance loading.
3. **Post-Repair Gate:** Confirm that measured response stays within ±5% of reference cutoff before releasing design.
