Circuit Debugging Assistant
Circuit Diagnostic Report

Report ID: ANALYSIS-DEMO-RC
Date: 2026-10-13 01:14
Circuit: Rc Low Pass

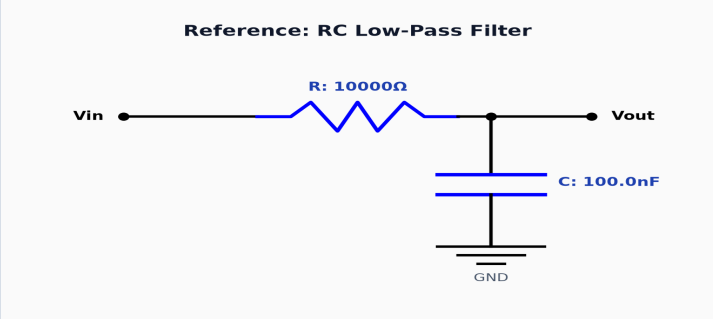
Figure 1A: Uploaded Circuit Schematic

The device under test was analyzed as a **Rc Low Pass**. Numerical multi-evidence evaluation identified a probable parameter shift on **Nominal** (normalized residual score: **0.0010**). A total of 0 structural or parameter observations were cataloged.

Severity	Component / Net	Finding & Evidence	Recommended Action
Critical	**None**	Normalized residual S(f)=0.001 matches Nominal signature.	Verify None value with bench meter or replace with nominal part.

1. **Physical Verification:** Perform **In-circuit DMM measurement** to independently separate ambiguous parameter hypotheses.
2. **Signal Integrity:** Measure test points with a 10:1 passive probe to avoid probe capacitance loading.
3. **Post-Repair Gate:** Confirm that measured response stays within ±5% of reference cutoff before releasing design.
