Circuit Debugging Assistant
Circuit Diagnostic Report

Report ID: ANALYSIS-E48A2C57
Date: 2026-10-13 23:57
Circuit: Rc Low Pass

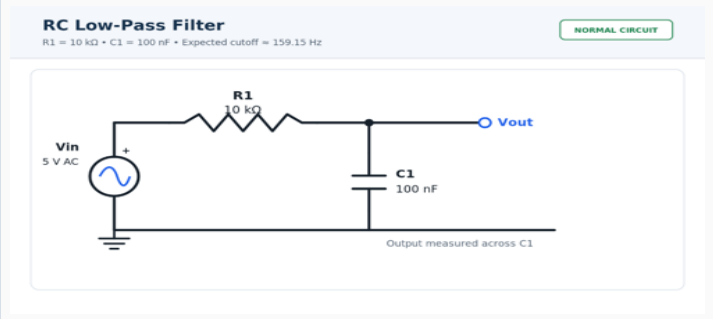
Figure 1A: Uploaded Circuit Schematic

The device under test was analyzed as a **Rc Low Pass**. Numerical multi-evidence evaluation identified a probable parameter shift on **R -20%** (normalized residual score: **25.2147**). A total of 0 structural or parameter observations were cataloged.

Severity	Component / Net	Finding & Evidence	Recommended Action
Major	**R**	Normalized residual S(f)=25.215 matches R -20% signature.	Verify R value with bench meter or replace with nominal part.

1. **Physical Verification:** Perform **DMM Resistance Measurement on R1** to independently separate ambiguous parameter hypotheses.
2. **Signal Integrity:** Measure test points with a 10:1 passive probe to avoid probe capacitance loading.
3. **Post-Repair Gate:** Confirm that measured response stays within ±5% of reference cutoff before releasing design.

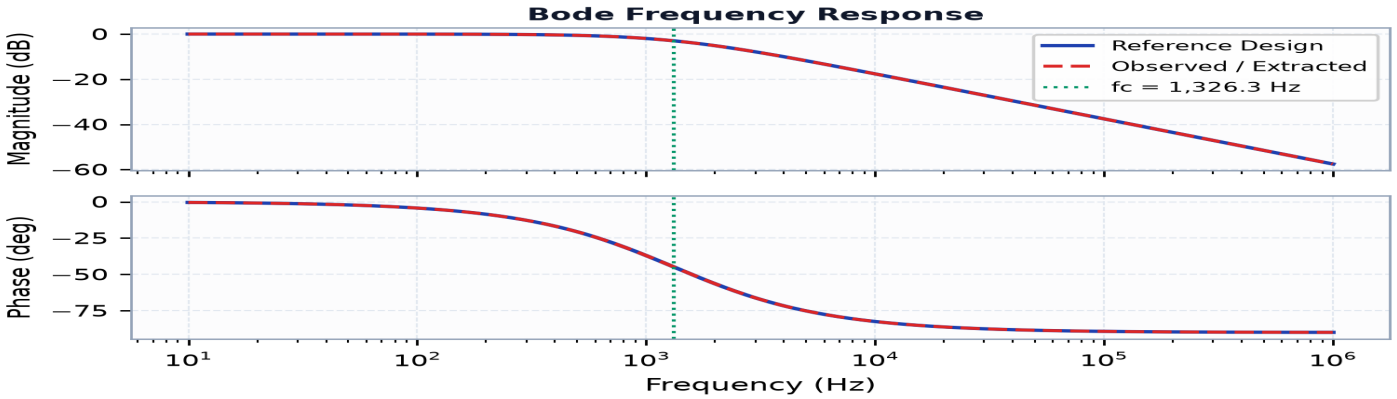
6. Numerical Simulation Curves

- **Transfer Function:** $H(f) = 1 / (1 + j\,2\pi\,f\,R\,C)$
- **Theoretical Cutoff Frequency:** $f_c = 1 / (2\pi \cdot R \cdot C)$ = **1326.29 Hz**
- **Initial Step Current (Independent Observable):** $I_{step}(0+) = V_{in} / R$ = **1.00 mA**
