AUTOINSPECT / Inspection report

Visual quality intelligence | PatchCore baseline

Inspection	90101486f9774762821c1d3fe0076559
Timestamp (UTC)	2026-10-09T18:43:11.855510+00:00
Source image	bent.png
Model	PatchCore / ResNet18
Decision	REVIEW
Anomaly score	0.898415 (threshold 0.500000)
Processing time	11.13 seconds

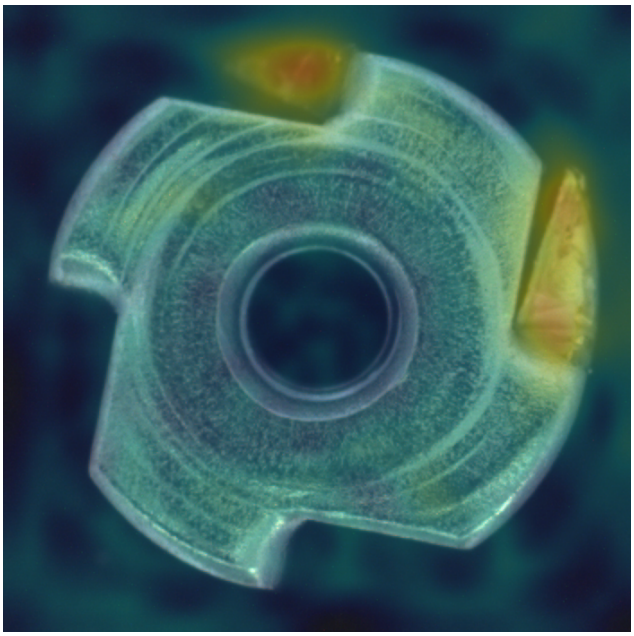
Anomaly overlay

Anomaly detected - review required. Red regions show higher anomaly response. The score is not a probability or a measurement of defect severity.
