| NIHVA TECHNOLOGIES PVT. LTD. | Vendors Inspection | | | Format No.: NIHVA-QA-F- 07 |

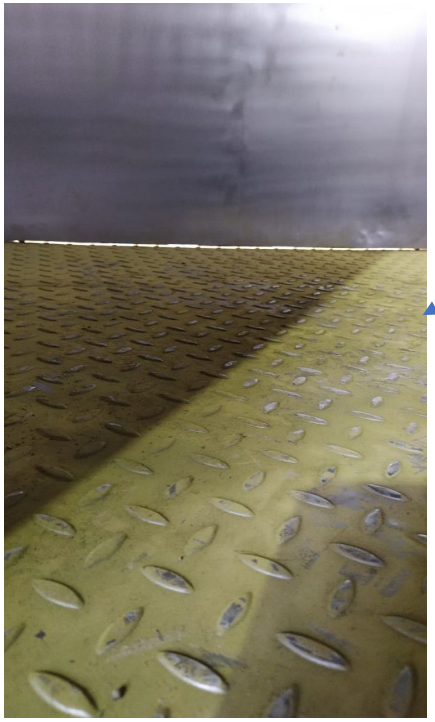
Strength of this assembly is very less

Gap observed between platform & Vertical Cabin

Outside light seen from inside

| Remark : 1) Fill the welding shown at the time of visit.<br>2) Gaps observed at the cabin corners. Need to clear these Gaps.<br>3). NRV recommonded.<br>4) Unable to take final trial & Load test of the Goods Lift because of Height Unavailability.<br>5).Need Electrical Manual with proper Electrical Connection Diagram<br>6) Other details show in manual | Suggestions |
