CUSTOMER NAME :- PAVILION MALL PUNE

PROJECT NAME :- RETRACTABLE SYSTEM

RETRACTABLE ROOF - THE PAVILION, PUNE

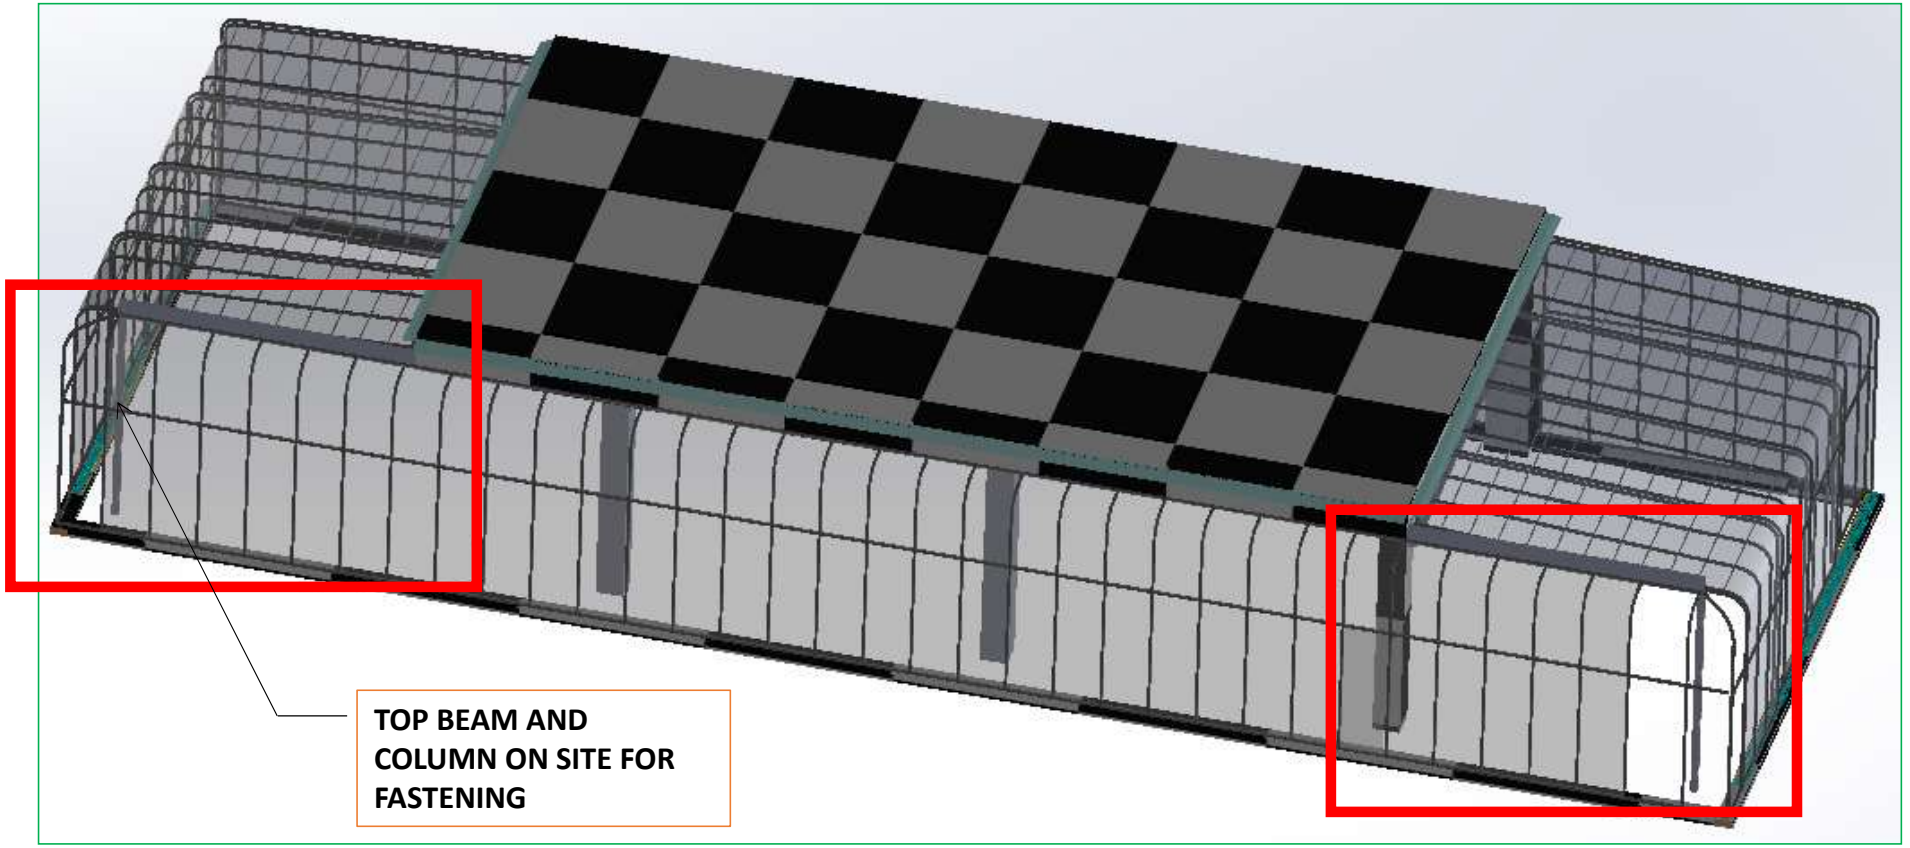
1. The top beam height from the ground is not at one level. Variations are observed from 4877 mm to 5026 mm along the periphery. It needs to be on one level for proper alignment of whole system.
2. On the LH side, there is slope on the floor which needs to be addressed.
3. Bottom concrete block to be constructed for anchoring and fastening for the whole system. It is in client scope.
