TITLE	Rio Karma Ethernet Kludge		
FILE:	ethernet-fix.sch	REVISION: A	
PAGE	1 OF 1	DRAWN BY: Micah Dowty <micah@navi.cx></micah@navi.cx>

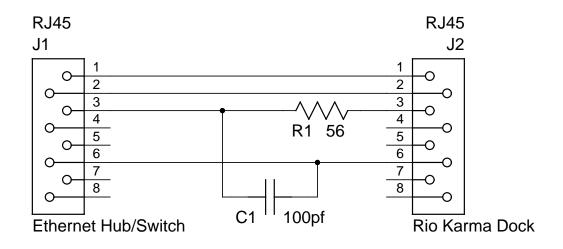
This is my potential fix for the Rio Karma's ethernet problems. Your mileage may vary, don't try this at home, etc. These values were determined experimentally. With this fix, I can reliably connect (with only one light on) where before I consistently had the two-lights-on problem.
