Short Form Report [DRAFT 1]

1, Riverside Cottages, The Dean, Alresford, SO24 9BE

Home & Commercial

Date of site visit: 02 September 2025

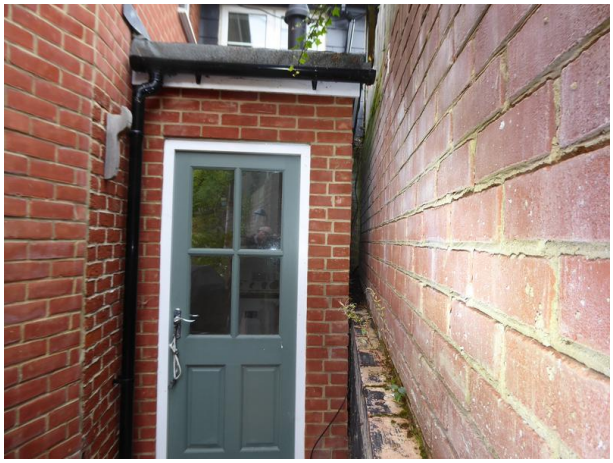
Photo 19 - Earth retaining boundary wall (black). The manhole in the foreground is understood to house a non-return valve to prevent a surcharge from the sewer.

5.2 The drainage for the Property (both foul water and surface water) should be subject to a CCTV survey to identify any blockages due to residue and/or silt from the incident, any defects, and to ensure the NRV is operating as it should to prevent future flooding issues.

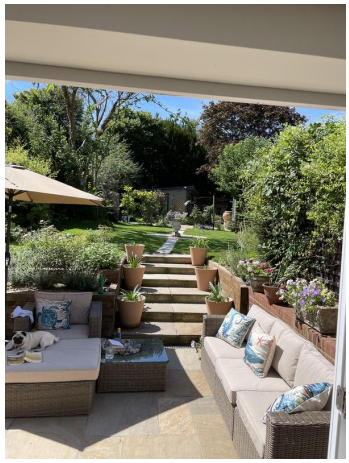
Photo 99 - Steps to raised rear garden viewed from rear through open glazed doors

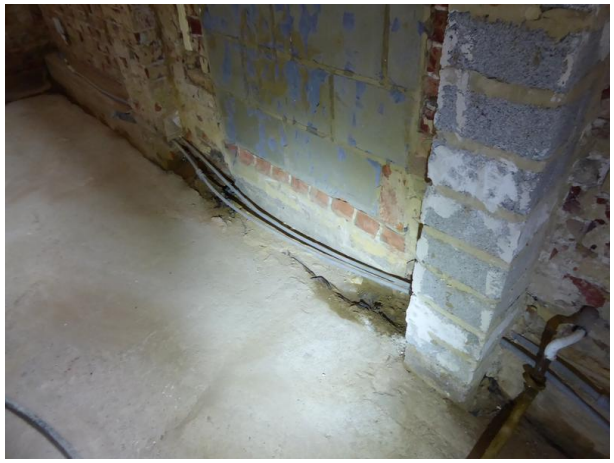
Photo 52 - View from Entrance Foyer

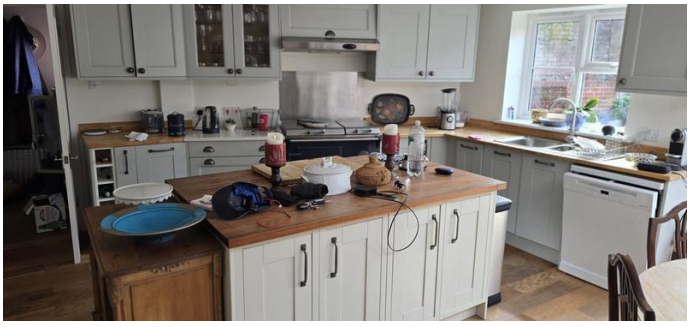
Photo 85 - Kitchen area with Utility in the background

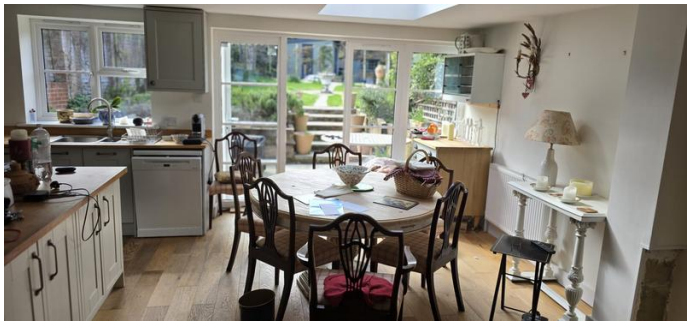
Photo 86 - Dining area looking towards the rear

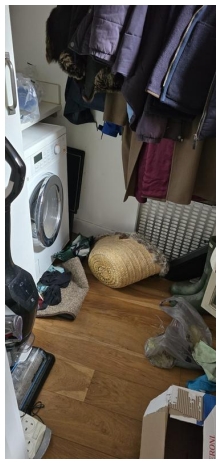
Photo 92 - Utility floor

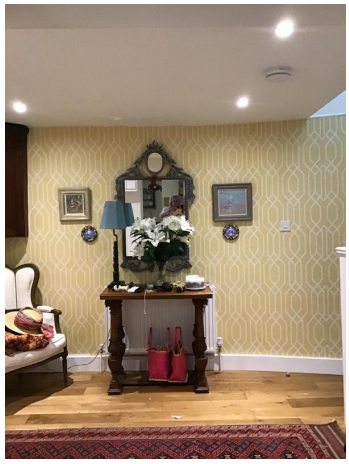
Photo 101 - Entrance Hall

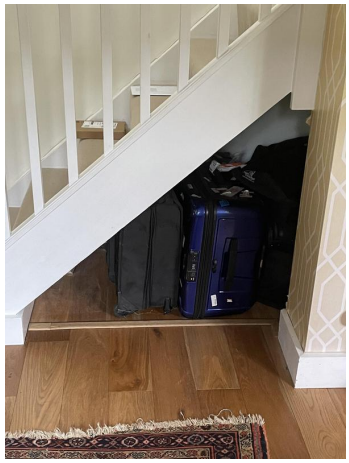
Photo 103 - Area below staircase

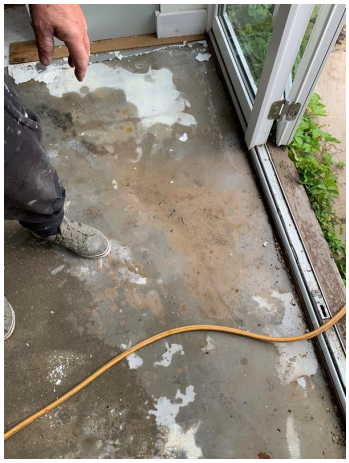
Photo 112 - Wet screed adjacent to rear glazed doors

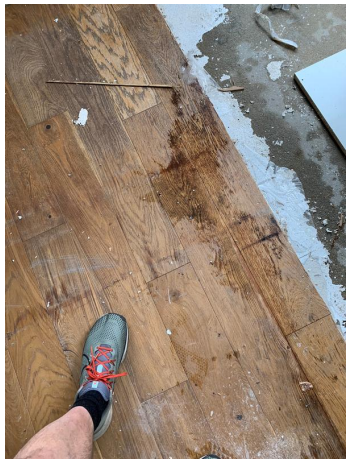
Photo 113 - Wet screed

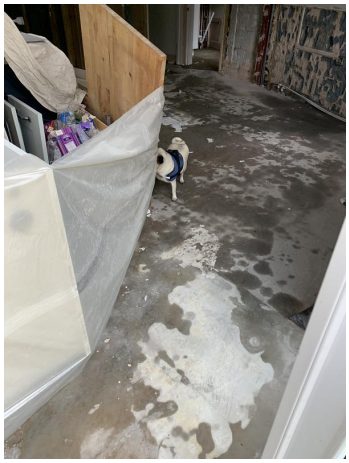
Photo 117 - Wet screed in Kitchen area

3.2.8.1 When the flooring layers (including screed and insulation board) the concrete floor slab surfaces were found to be wet. There was polyethylene sheeting evident protruding from the edges of the concrete slab sections.

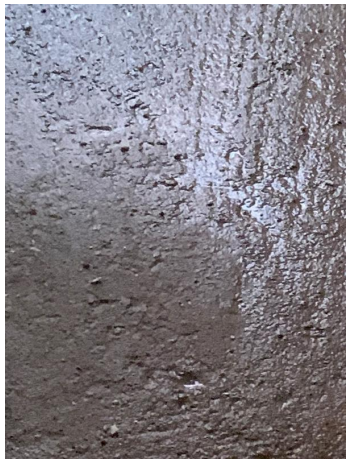
Photo 126 - Wet slab exposed in Dining area

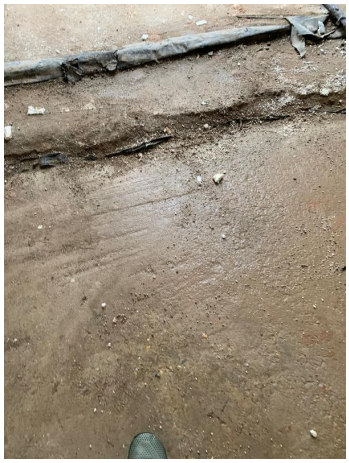
Photo 127 - Wet slab surface
