NEW HOLLAND

Service Bulletin

FILING INSTRUCTIONS	
Binder: Ag Equipment Binder	Page: 1 of 4
Binder Section: Implements	Document No.: 0607-IM1
Mach Loc Code: 55 926	Supersedes:
Issued By: Technical Support Services	Date Issued: June 27, 2007

SUBJECT: NH252 Receivers Cannot Receive L2 Signals

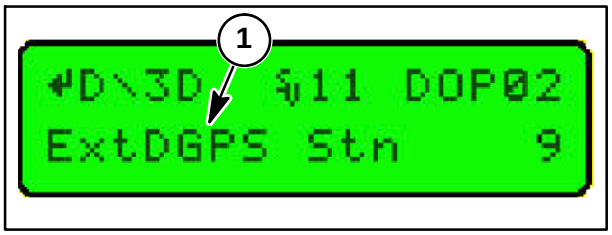
1

An internal connector defect in some NH252 receivers, can cause either a constant or an intermittent loss of L2 signal reception.

For an RTK NH252 receiver (part number 87367718), when the L2 signal is lost, the GPS status in the display does not show an RTK fix. In addition, when a laptop is connected to the NH252 receiver, 'ExitDGPS Stn', 1, appears on the AgRemote display screen.

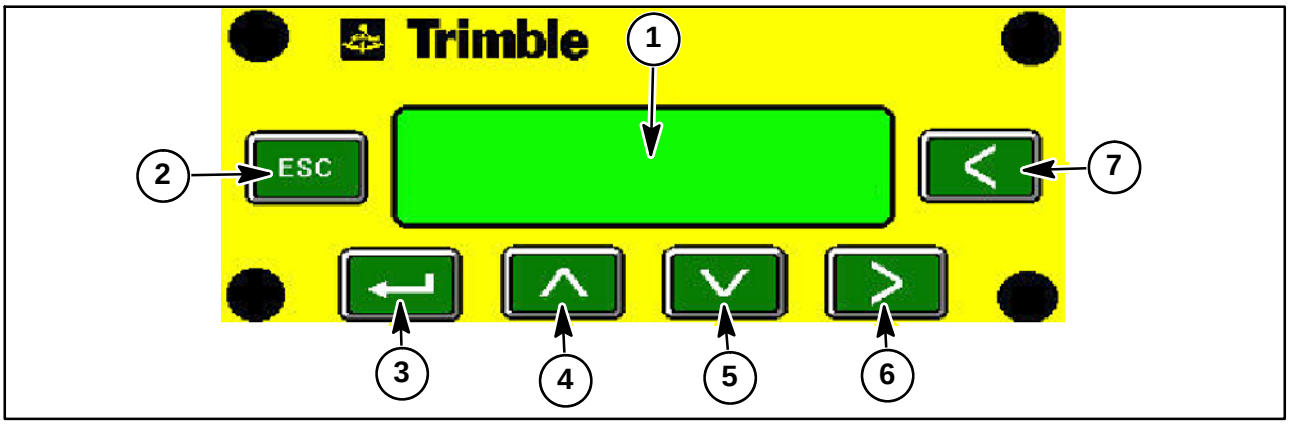
The affected NH252 receivers (part number 87367718 or 87367722) have serial numbers from 0225110127 through 0225114635 and were shipped between January 17, 2007 and March 23, 2007.

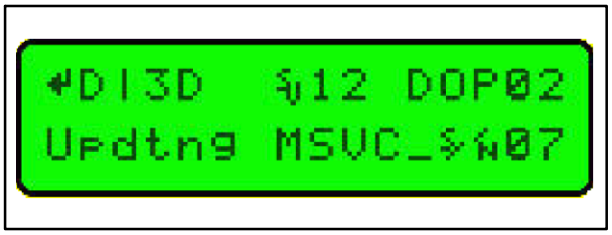
4

1. With the home screen displayed, Figure 4, press the right arrow button once to reach the Status screen, Figure 5.

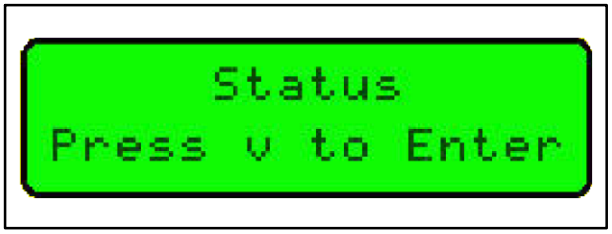
5

2. Press the down arrow button once to reach the GPS Status screen.

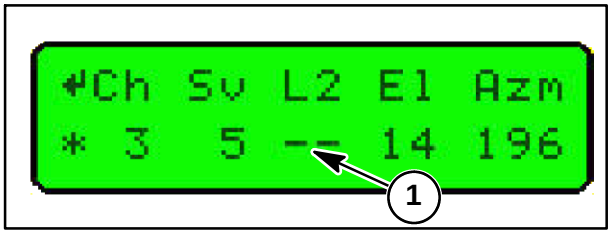
6

5. If two dashes appear for the L2 SNR, 1, L2 signal loss is confirmed.
6. If a numerical value appears instead of two dashes for the L2 SNR, and if you still cannot obtain an RTK fix or converge on OmniSTAR XP/HP, then the NH252 receiver or the correction source may have a different issue. Further troubleshooting of the NH252 receiver or correction source is required.
7. When the loss of L2 reception is the reason that the NH252 receiver does not achieve an RTK fix, or does not converge on OmniSTAR XP/HP, contact the service provider below for instructions on how to return the NH252 receiver for repair.
   - For US dealers, contact AgExpress Electronics at 515-289-2746.
   - For Canadian dealers, contact PAT Inc at 204-523-4077.
